MANAGEMENT SUMMARY

Executive Summary

Current Conditions

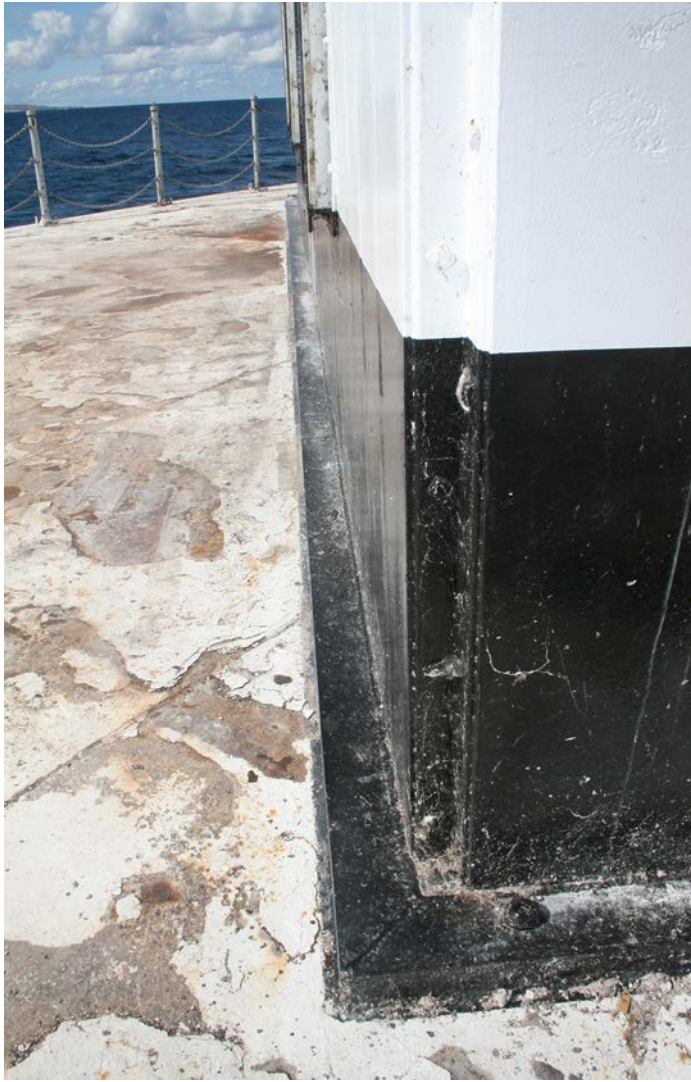
Figure 1D-10: Exterior curb between the pier deck, Level L-1, and the tower walls. Note single bolt of curb at the corner and the corner angle bolted to the end channels of each tower wall surface. The corroded steel plates on the deck surface are also visible.

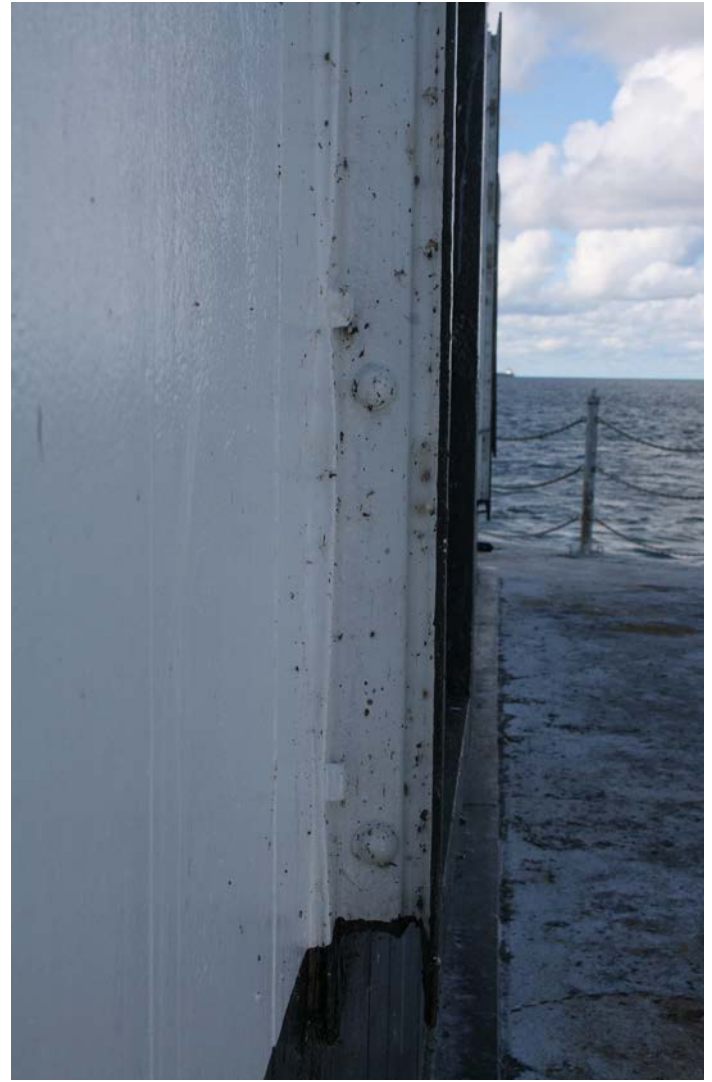
Figure 1D-11: Warped steel leg of angle at window framing bolted to wall structure related to corrosion of the steel in this area.

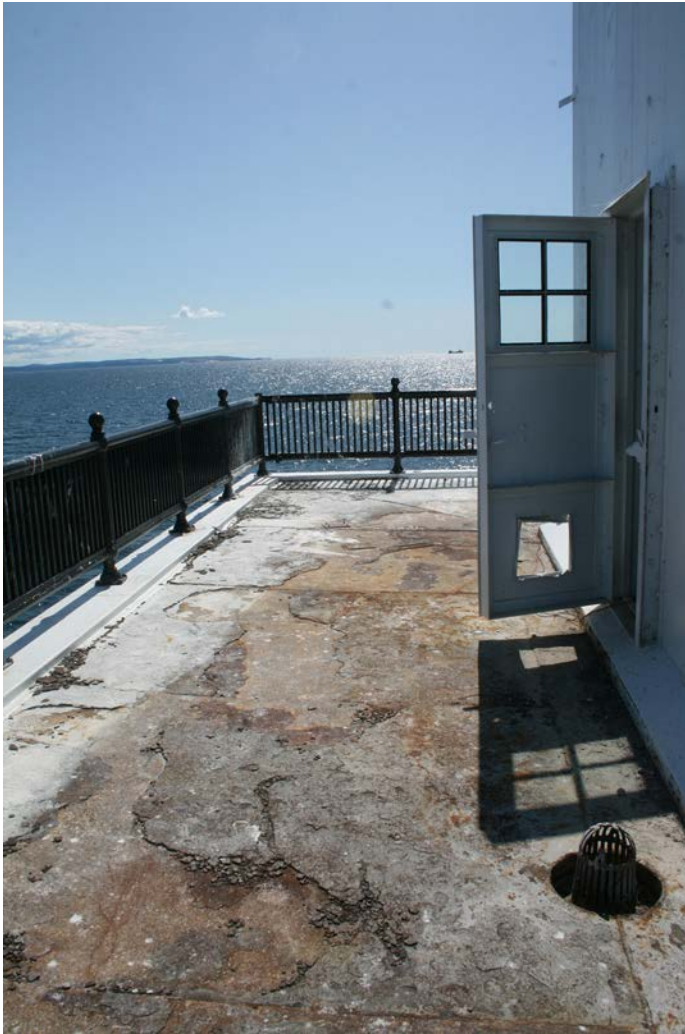
Figure 1D-15: Corroded steel plates on exterior surface of watch deck, Level L-3. Note roof drain at bottom right of photo.

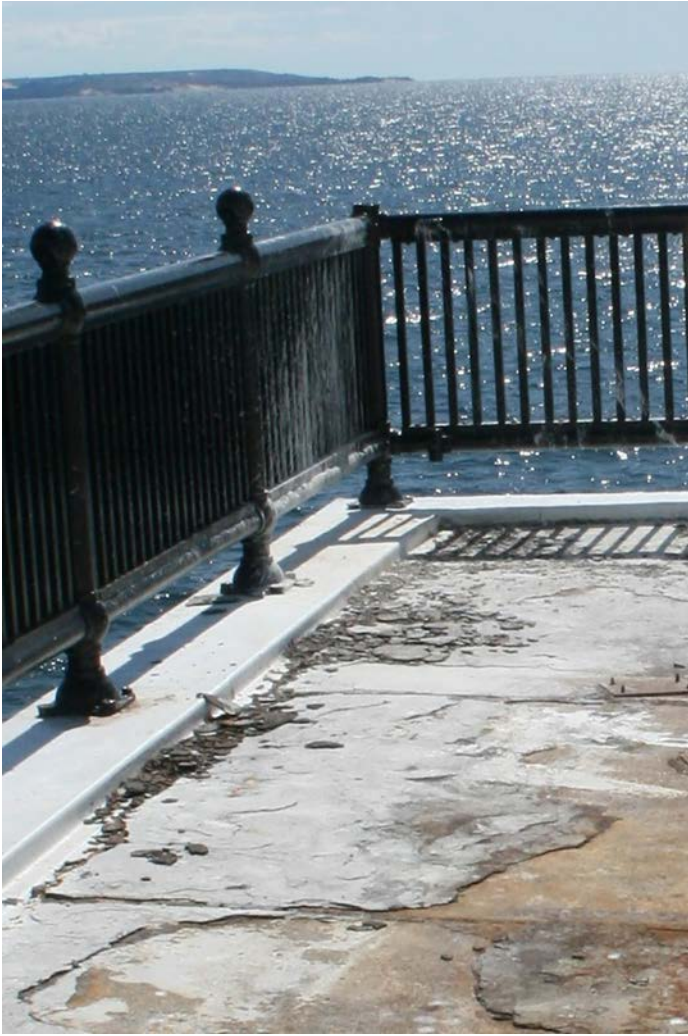
The perimeter railing at the edge of the Watch Deck level, Level L-3, is more ornate than the rail at the edge of the Pier Deck, Level L-1. Painted black, the rail extends 36 inches above the Watch Deck level with 2-7/8 inch outside diameter steel pipe sections used as both vertical posts and horizontal top and bottom rails. Square balustrades, closely spaced together, are welded to a bar that is bolted to the top and bottom rails. The vertical posts are spaced 5 feet apart and are bolted to the Watch Deck, Level L-3, with base plates that have rounded or bell-shaped cross sections. One ball spindle at a corner location is missing atop the vertical post (Figure 1D-18).

Figure 1D-18: Missing top “ball” of guard rail at corner post.

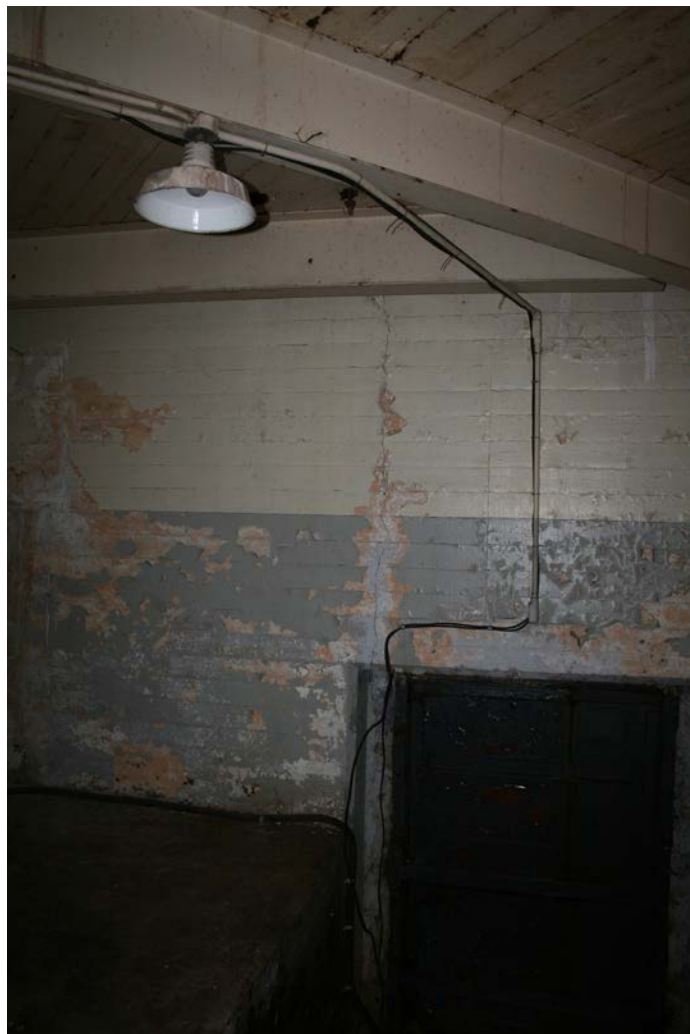
Figure 1D-22: Vertical crack in interior surface of the concrete crib wall at west end of water level access door.

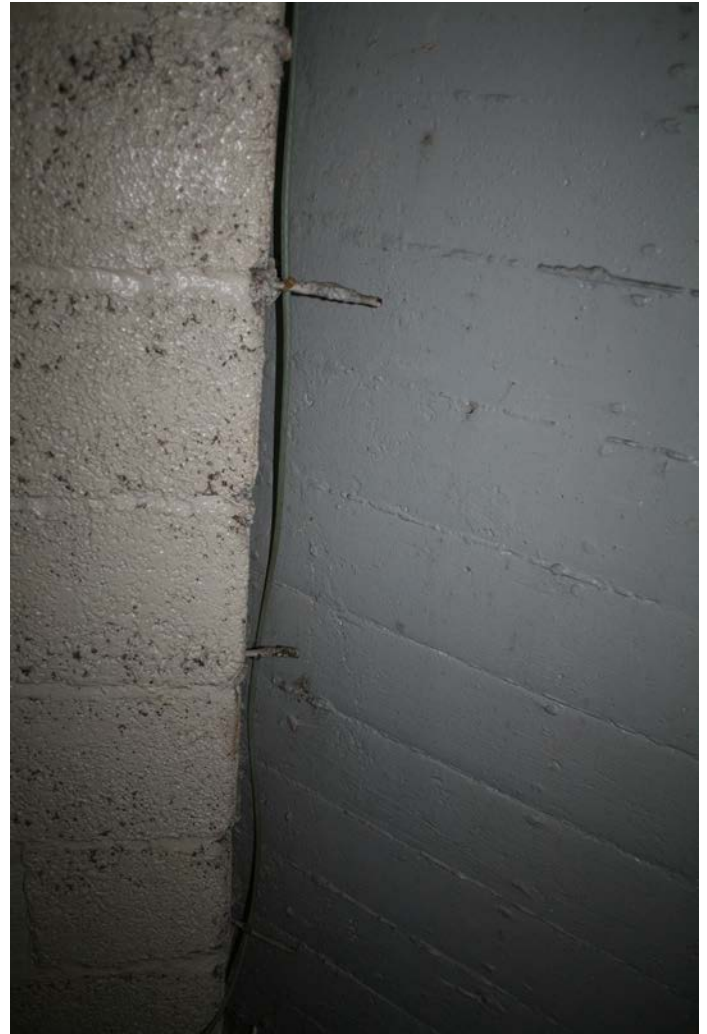
Figure 1D-21: Horizontal steel reinforcing extending past end of CMU wall at chamfered concrete corner. Lower bar is further inset into CMU than upper bar.

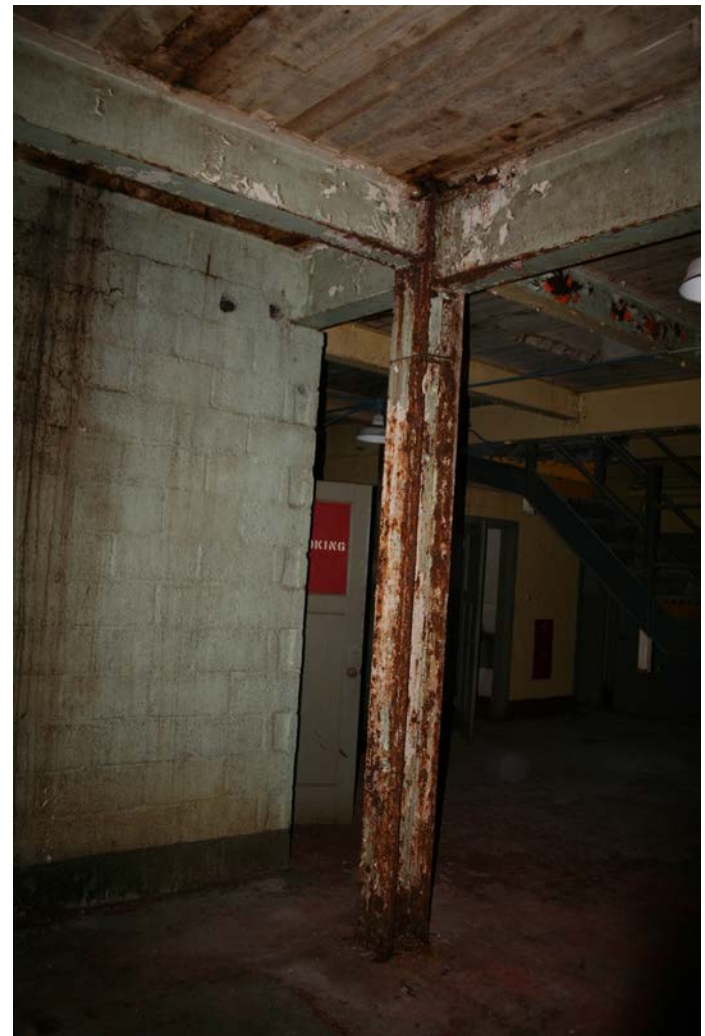
Figure 1D-24: Corroded southernmost interior column at basement level.

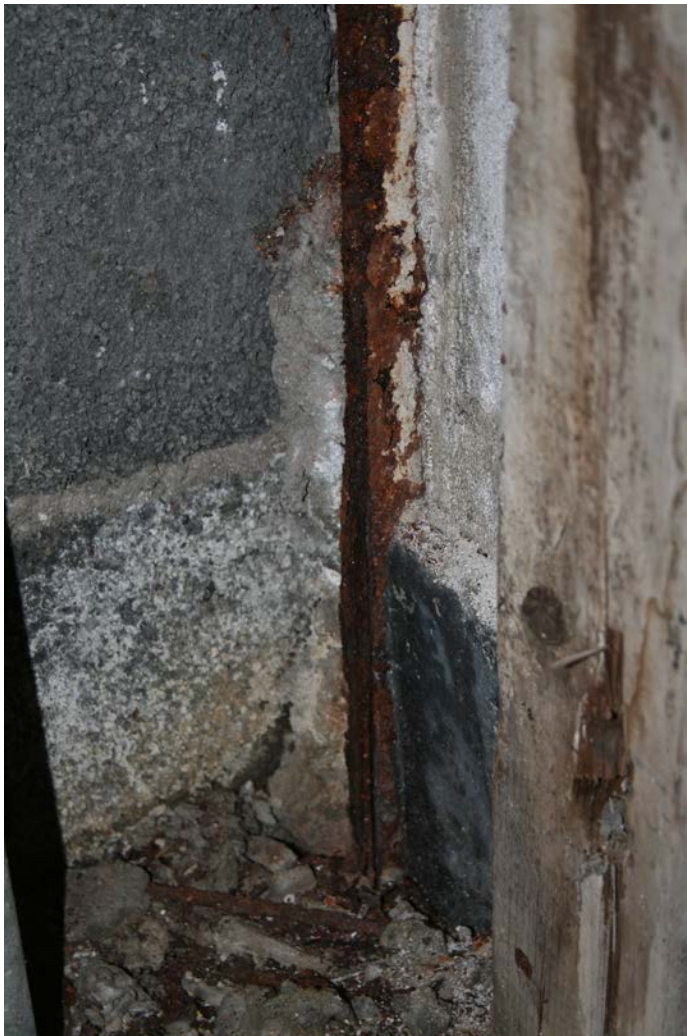
Figure 1D-43 Corroded at warped flange at southernmost interior column. Note portions of the steel column are on debris on top of floor.

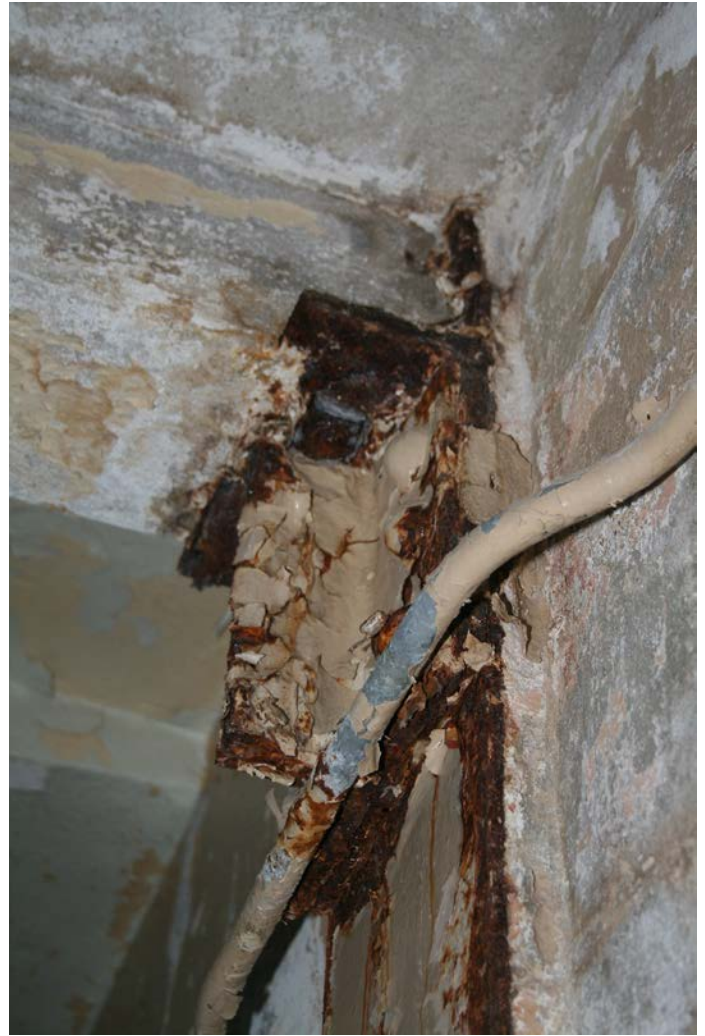
Figure 1D-44 Corroded steel connections of beam to column at watch deck, Level L-3, structure.

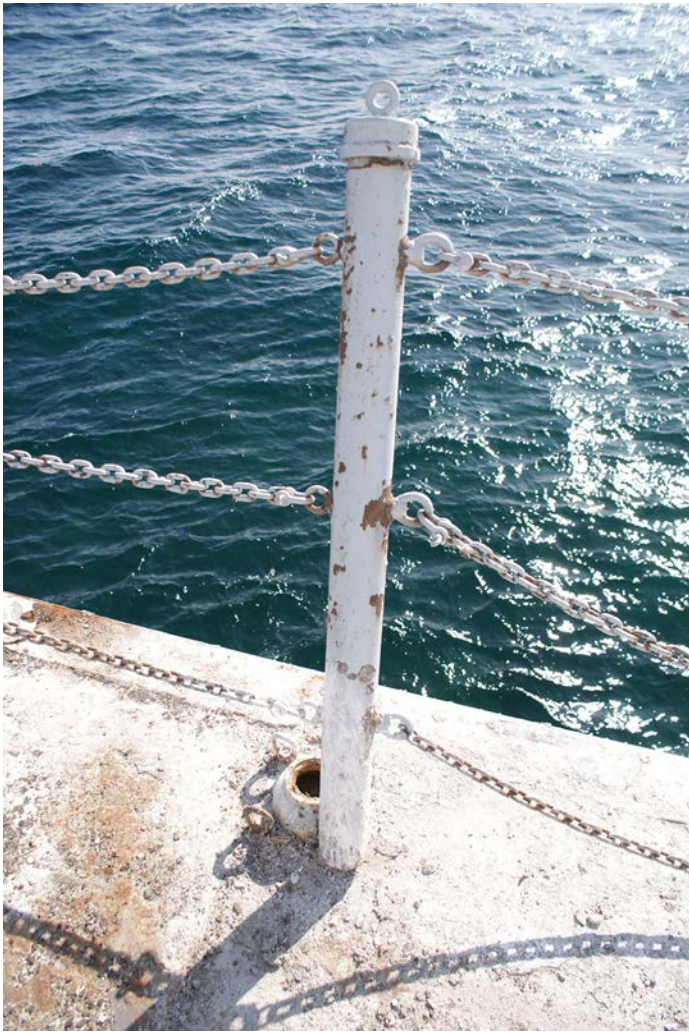
Figure 1D-82 View of damaged guardrail post broken from the base.

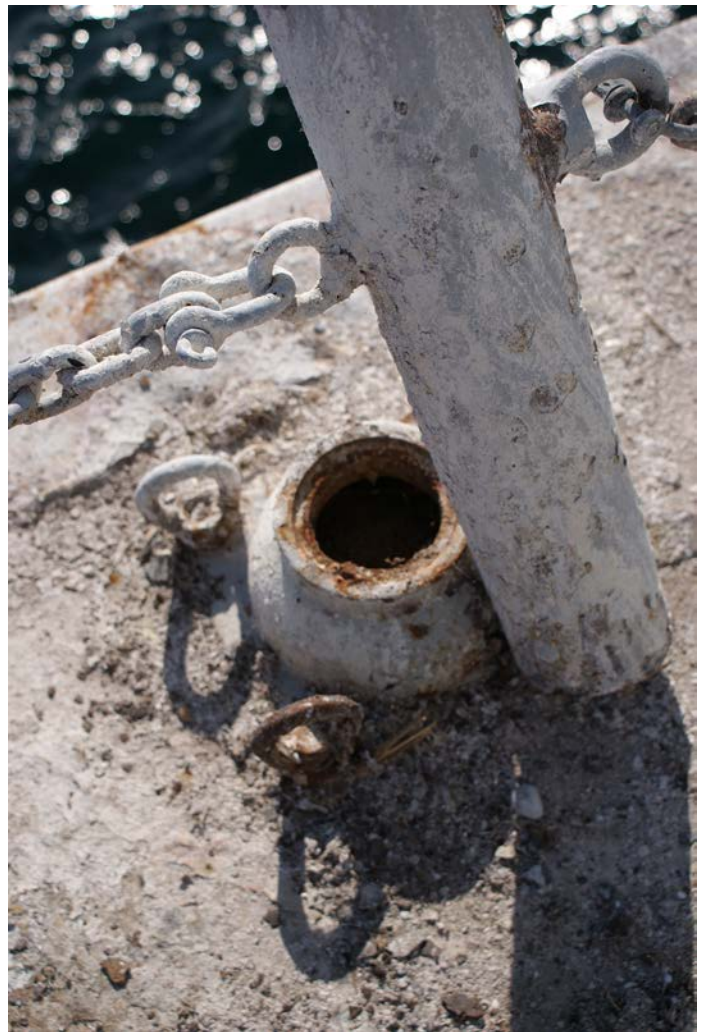
Figure 1D-83 View of damaged guardrail post broken from the base.

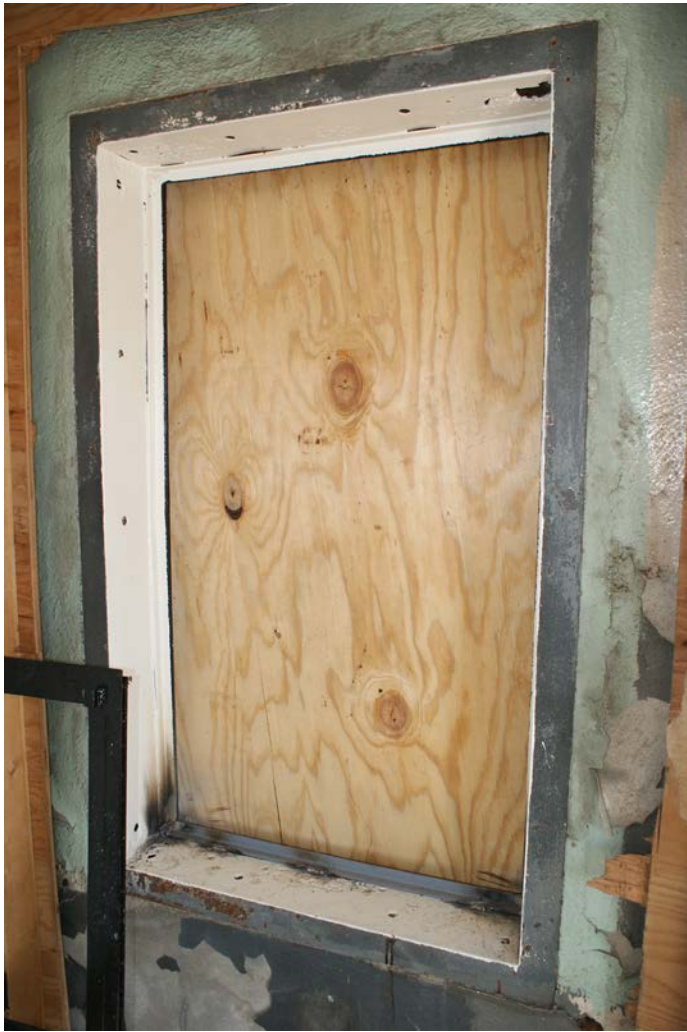
Figure 1D-101a Temporary plywood panel at a window opening.

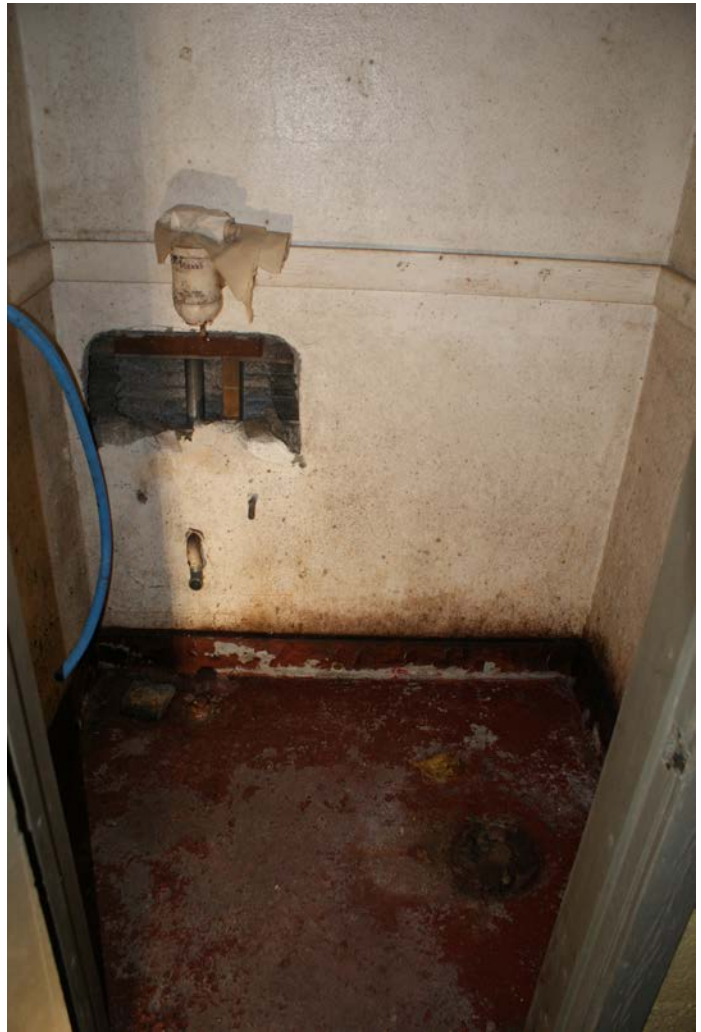
Figure 1D-154 View of Basement bathroom (note missing fixtures).

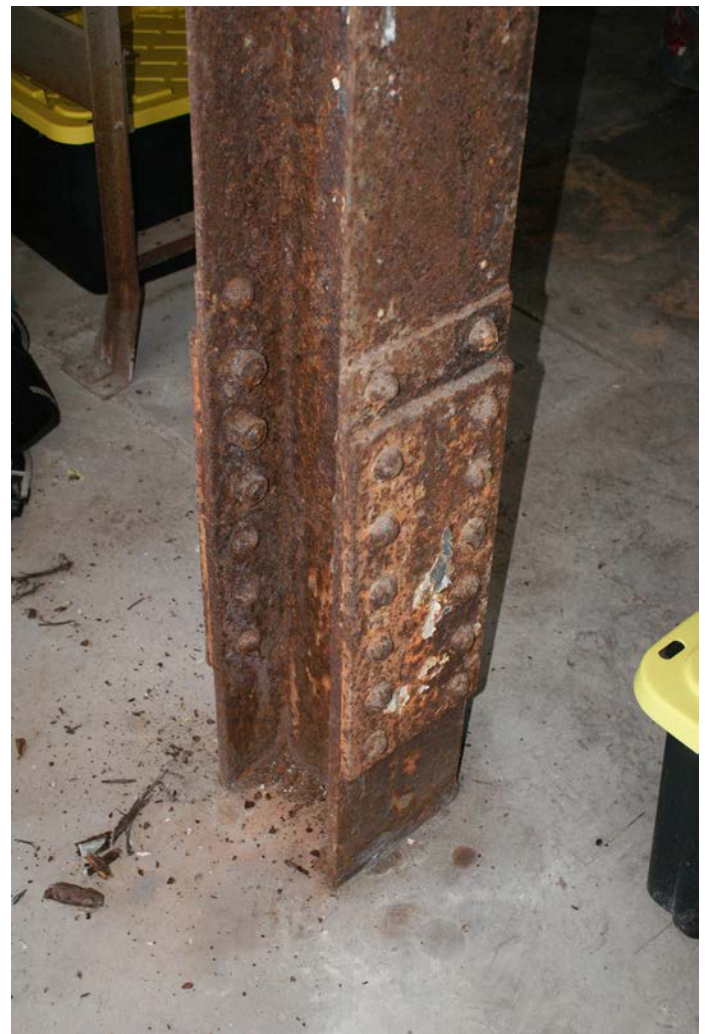
Figure 1D-182 Steel column on Level 1 with extreme rusted finish.

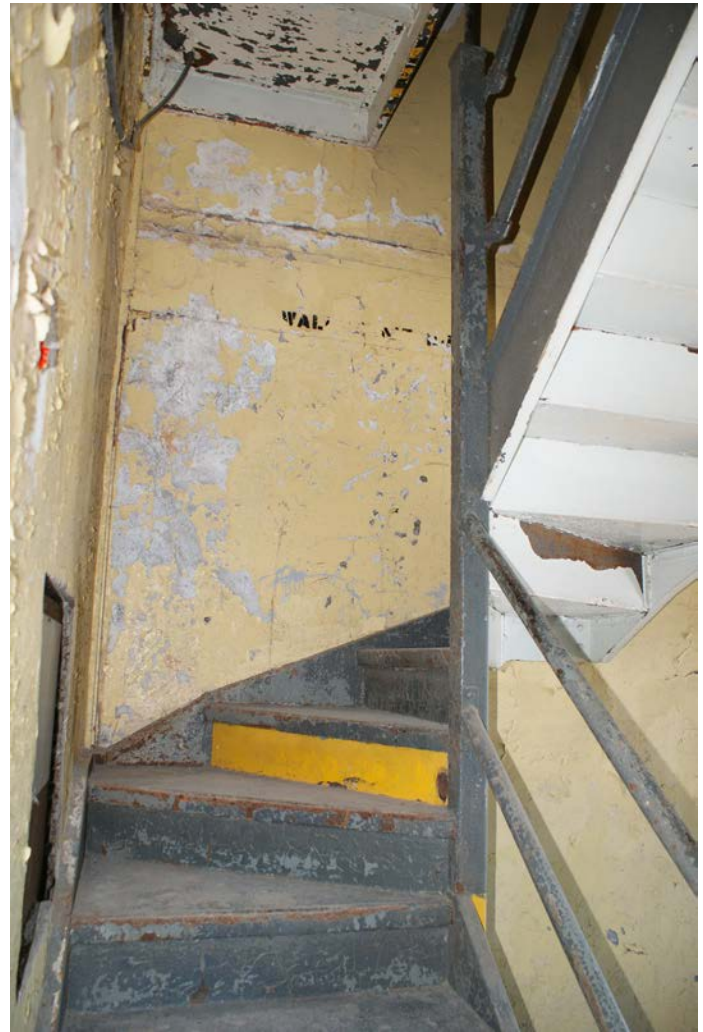
Figure 1D-185 Poor condition of interior finishes along with the winder style treads of the stair to Level 2.

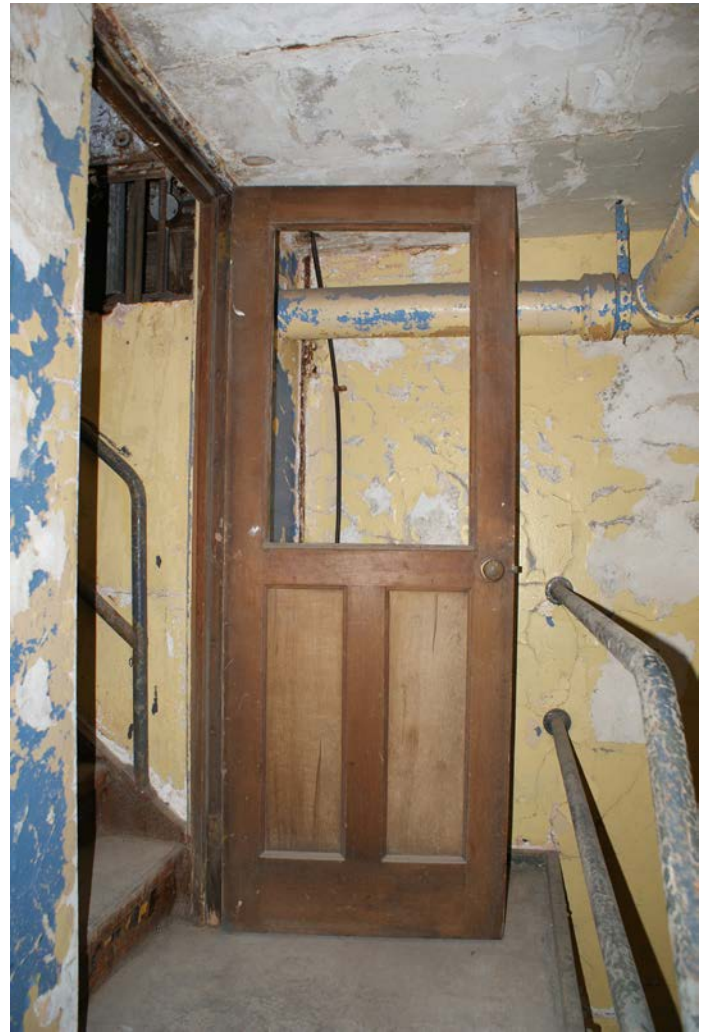
Figure 1D-210 Wood two-panel door with missing glass.
