MANAGEMENT SUMMARY

Executive Summary

Current Conditions

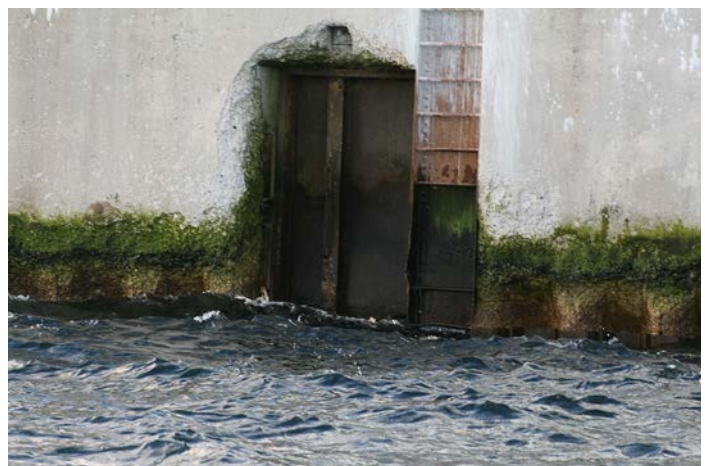
Figure 1D-04: Water level steel access door on north side of concrete crib. Note spalling of concrete around opening and heavy organic growth above the water. The top of the steel sheet piling is visible on the right side of the photo at the water level. The steel ladder is missing

Organic growth is prevalent on the concrete crib for approximately 3 feet above the current water level (Figure 1D-04). Inset on each of the four sides of the concrete crib is a riveted steel framed ladder. The steel is visually corroded. Rungs are bent in some locations, and two are missing on the north elevation, at the ladder adjacent to a door located at the water level (Figure 1D-04). This steel framed door is corroded and allows water to infiltrate into the crib structure and basement of the tower. The concrete is spalled around the perimeter of the door.

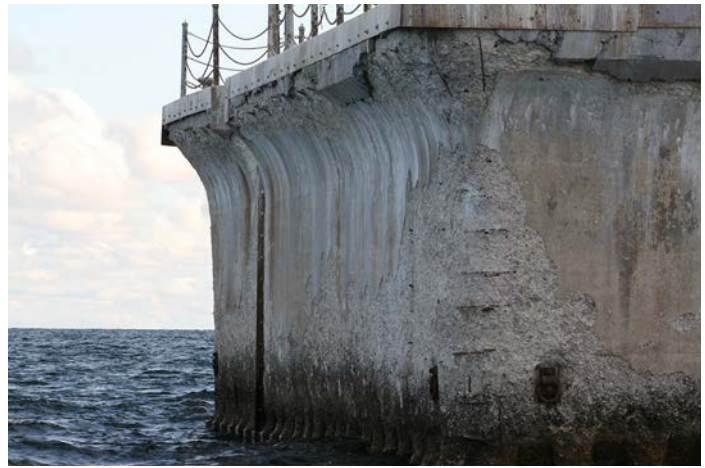
The concrete is spalled over large areas in multiple locations exposing the outermost layer of steel reinforcing bars (Figure 1D-05). The reinforcing bars were observed to be square shaped with surface corrosion present. Significant deterioration of the concrete is visible near the water line, most likely related to freeze-

Figure 1D-05: Spalling over large areas of the concrete crib exposing reinforcing bars. Note the fluted top edge of the crib and the turned down steel plate bolted to the vertical edge of the flute. The steel sheet piling is visible at the water line.

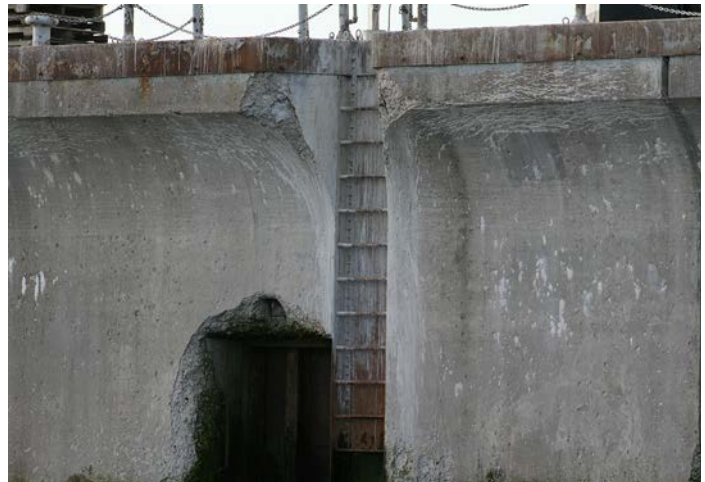
Figure 1D-06: Crazed cracking at the vertical and underside surfaces of the fluted edge of the concrete crib.

thaw damage and erosion of the concrete. Craze cracking is visible on the underside of the fluted top edge of the crib where the concrete has yet to spall (Figure 1D-06). Remnants of a painted flag can be seen on the east wall of the concrete crib.

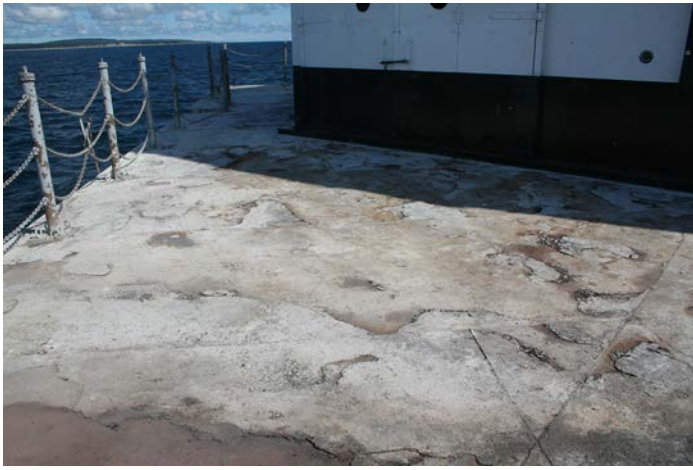
Figure 1D-08: Corroded steel plates on exterior surface of pier deck, Level L-1.

These steel plates were added as part of the USCG’s 1980s mothballing effort, and are noted on the 1980 drawings as 5/8 inch steel plates. On the top surface, the plates are buckled and deflect underfoot. The edges of the steel plates are welded to each other. The top surface of the plates may have been previously coated but is currently corroded throughout (Figure 1D-08). An approximate three square foot area in the northwestern corner deck of the crib has undergone full section loss, exposing a granular

fill between the steel and the concrete, and the top of the concrete crib surface. The thickness of the corroded plate in this area was measured to be 7/16 inches. The concrete surface was sound when struck with a hammer and exhibited no visible distress.

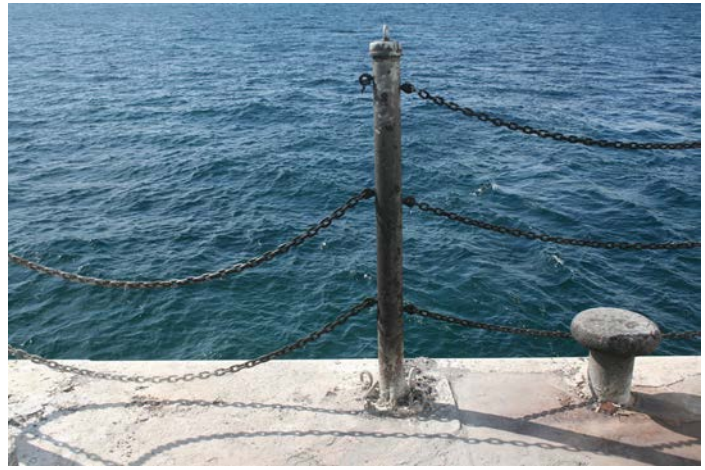
Figure 1D-09: Typical guard rail post. Note eye nuts for anchor bolts at base of column and base plate with vertical stiffeners. Note missing top chain on left side of post.

At the perimeter of the crib, three of the corners are chamfered approximately two feet. The southwest corner is square. There is a perimeter railing system in a state of disrepair that has undergone multiple repairs and replacements, although keeping intact the general concept of steel posts bolted to the top of the crib surface and three chains draping between the posts. The posts are generally spaced 6 feet on center. The style of base plate and anchor bolts vary, indicative of multiple repairs. Some plates are rounded or bell shaped in cross section, others are flat with vertical stiffener plates between the plate and post. The anchor bolts have either a square nut or an eye nut. The chain links are approximately 3/8 inch in thickness and 2 inches in length. Multiple posts are missing, and of those remaining, nearly all are corroded at the base of the post creating a “necked” section of the post. Several chains are missing or otherwise damaged (Figure 1D-09).

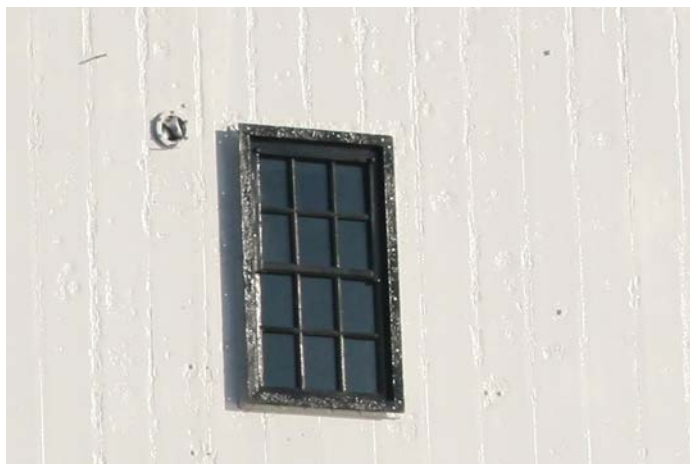
The exterior walls of the tower and punched window and door openings had been painted recently. The steel surface is non-uniform in localized areas, indicating pitting of the steel had occurred prior to the recent re-coating effort (Figure 1D-13). Section loss for the full thickness of the webs of the channels was not observed from the respective deck levels.

Figure 1D-13: Pitted exterior surfaces of the wall channels and window angle frame.

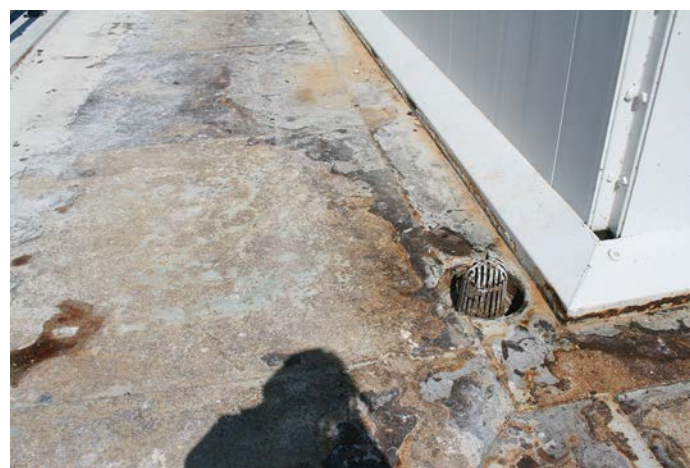
Figure 1D-14: Roof drain and corroded steel plate at the watch deck, Level L-3. Exterior curb with single anchor bolt at corner of tower is visible.

drains at Level L-3 were reported to be recently cleared to allow drainage of the Watch Deck level (Figure 1D-14). Both drain covers are broken.

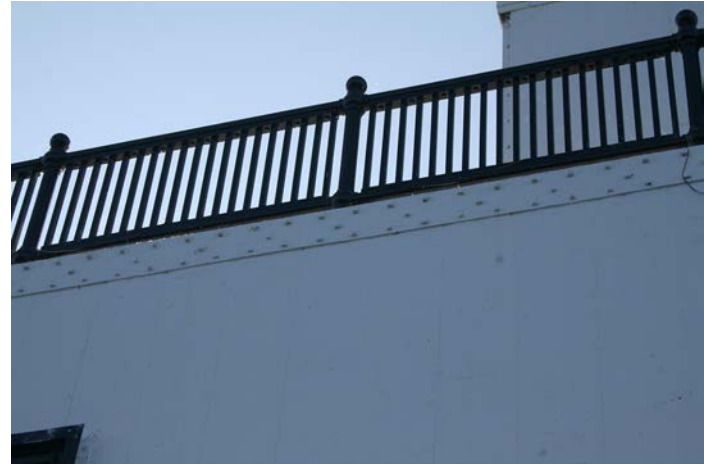
The surface of the Watch Deck level, Level L-3, is covered with steel plates, similar to the Pier Deck level, Level L-1. The steel plates at Level L-3 are corroded in multiple locations with apparent section loss occurring (Figure 1D-15). At the edge of the Watch Deck level, Level L-3, the steel plate is turned down and a five-bolt pattern secures the vertical edge of the plate to each of the steel channels of the wall below (Figure 1D-16).

Figure 1D-16: Guard rail and bolted connection of turned down steel plate at edge of watch deck, Level L-3.

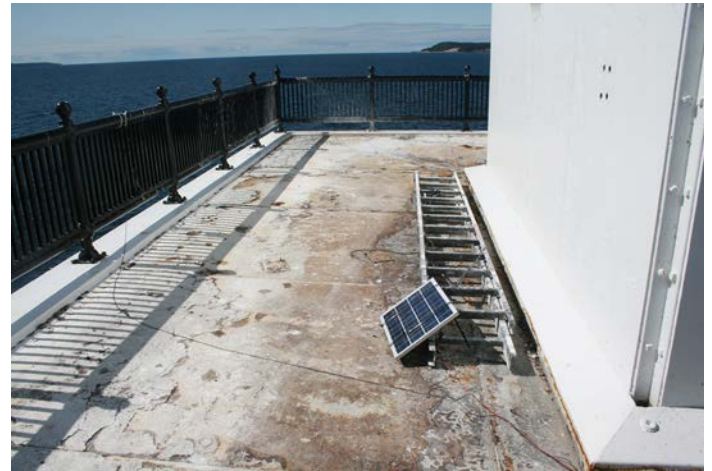
Figure 1D-17 Corroded steel plates on exterior surface of watch deck, Level L-3. Exterior curb with single anchor bolt at corner of tower is visible.

slope up toward to the tower wall than the curb at Level L-1. The metal curb is bolted to the structure below with a single bolt at each corner (Figure 1D-17).

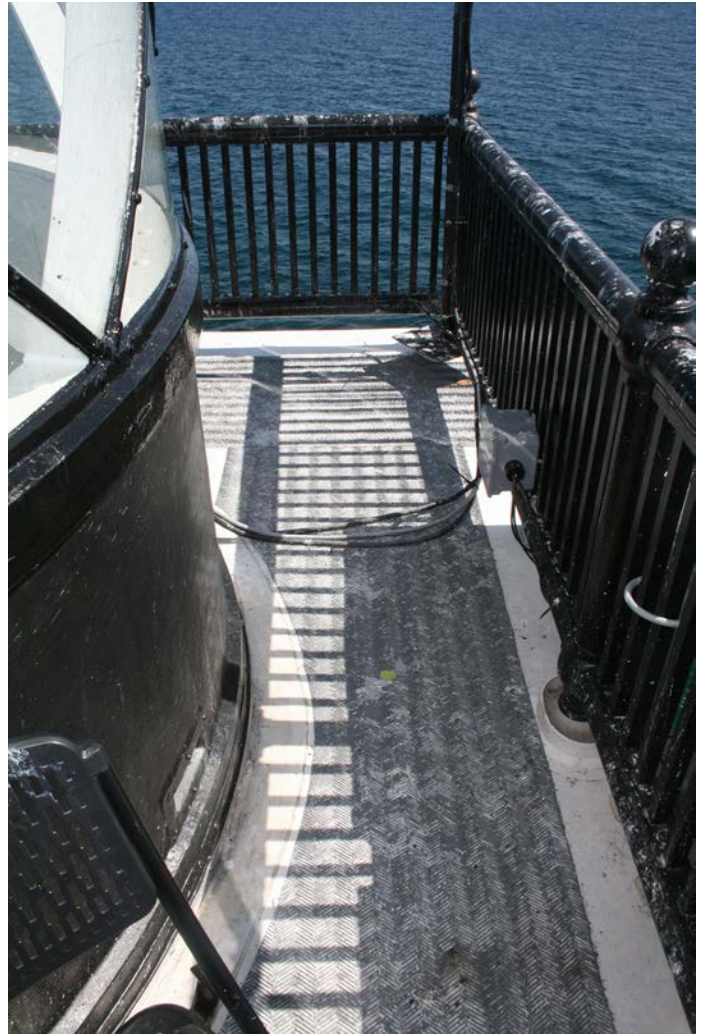
Figure 1D-19: Lantern deck, Level L-6.

the lantern have been recently re-coated. No evidence of significant corrosion prior to the recent re-coating was observed.

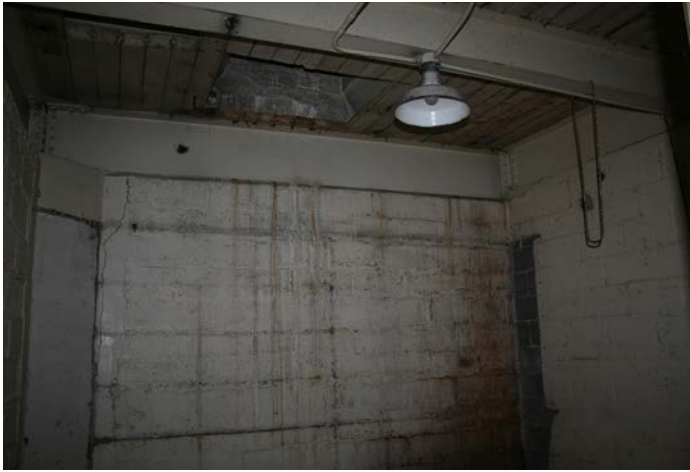
Figure 1D-20 Steel beam and CMU wall construction visible in basement. Note water staining on CMU walls and skylight opening in ceiling. Note vertical crack between chamfered concrete corner and CMU wall.

The basement walls are painted, and the paint is peeling and flaking off the walls. Water staining is prevalent on the perimeter basement walls (Figure 1D-20). The reinforcing bars designated in the construction drawings within the CMU wall mortar joints extend beyond the length of the masonry walls at the chamfered corners of the tower foundation construction (Figure 1D-21). Where the concrete chamfered basement corners intersect with the adjacent basement walls, the basement wall is typically cracked vertically, with the cracks measuring up to 3 mm in width (Figure 1D-20). At the west end of the water level access door, the concrete crib wall is cracked on the interior surface vertically; the width of the crack was measured to be 3 mm (Figure 1D-22). A minor step crack is present in the base courses of the CMU wall in the coal room (Figure 1D-23).

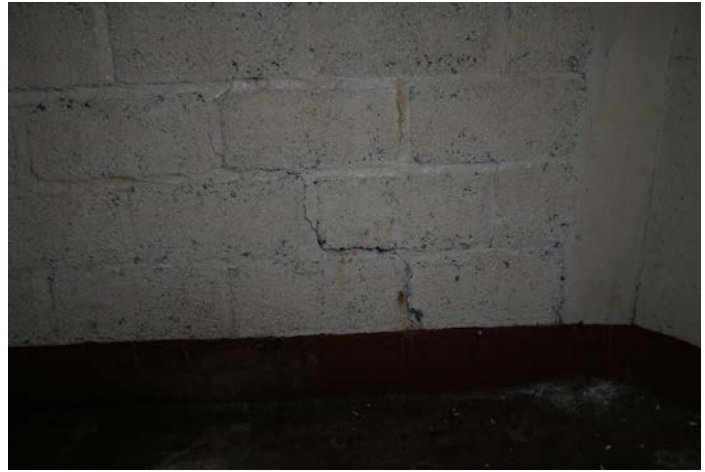
Figure 1D-23 Step cracking at base of CMU wall.

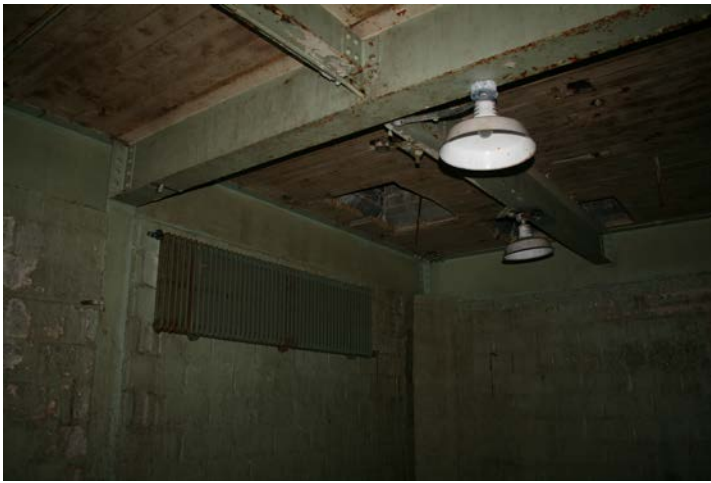
The exterior steel columns of the tower are visible within or at the top of the basement walls in multiple locations (Figures A-1 and A-2). The tower corner columns are bearing on a concrete pier, constructed integrally with the concrete crib (Figure A-3). The interior most surface of the concrete piers is visible in the basement corners, as chamfered wall corners due to the orientation of the tower with the crib structure.

Figure A-1 Exterior steel column of tower within the basement wall.

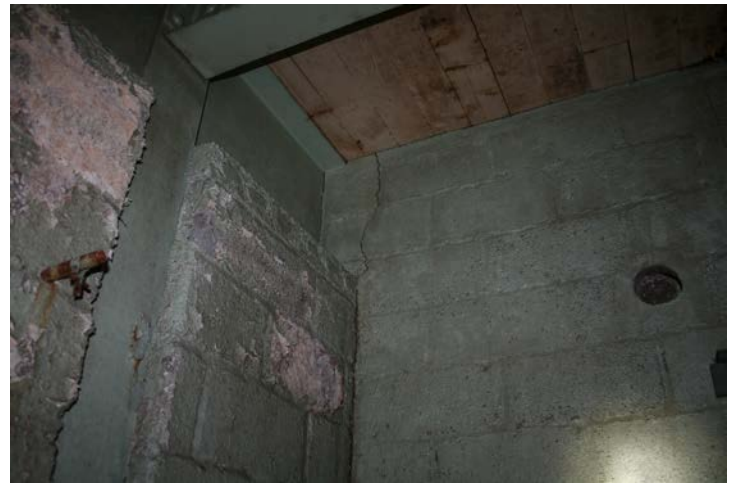
Figure A-2 Exterior steel column of tower within the basement wall.

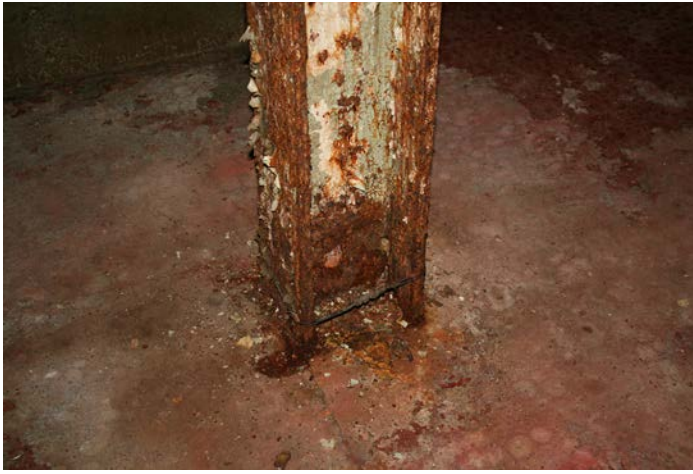
Figure 1D-25 Base of southernmost interior column at basement level.

The steel columns, where exposed, are painted. The paint is flaking, and surface corrosion is present, especially at the base of the columns. There are four central wide flange ("H") steel columns. The painted columns are 8 inches in depth, 8 inches in width, and the flanges are 3/4-inch thick with the painted coating at the basement level. The southernmost interior

column, the column that is not embedded in a CMU wall, is significantly corroded (**Figures 1D-24 and 1D-25**) for its full height. The corrosion of this column is related to water infiltration from the Watch Deck, Level L-3, above.

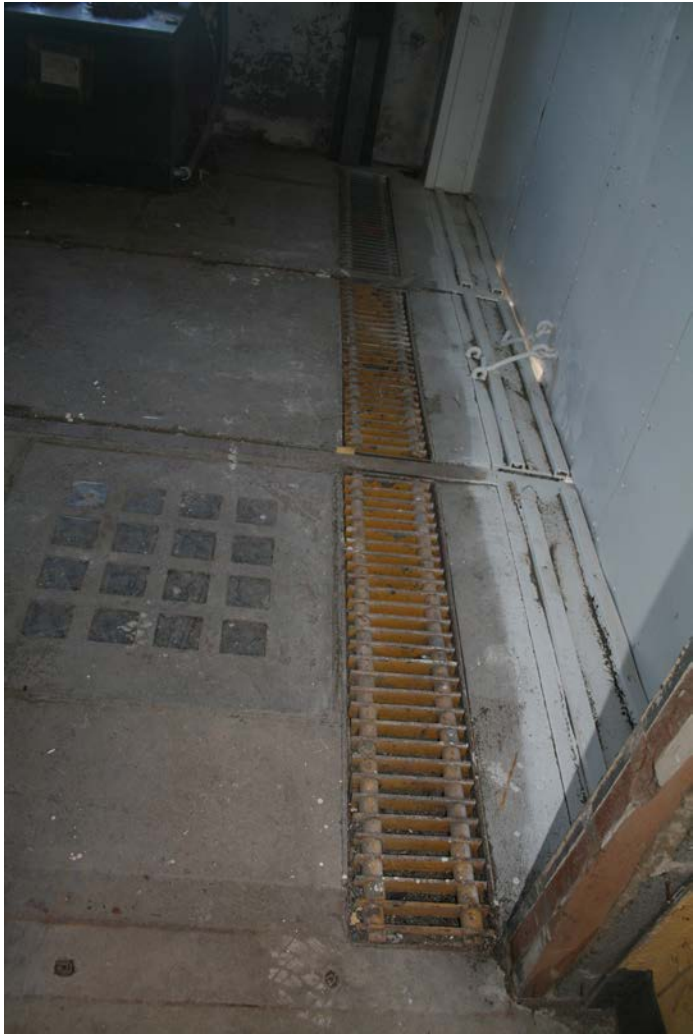
Figure 1D-26: Floor drains at boat room at pier deck, Level L-1.

In general, the floors are painted concrete, with evidence of past floor finishes on the second level, Level L-2. Glass skylights are present in multiple locations on the Pier Deck level, Level L-1. Floor drains are located in the boat room and at the main entry door on the interior of the tower at the Pier Deck level, Level L-1. The rails for transporting the boat inside the boat room are extant in the floor of the boat room (**Figure 1D-26**).

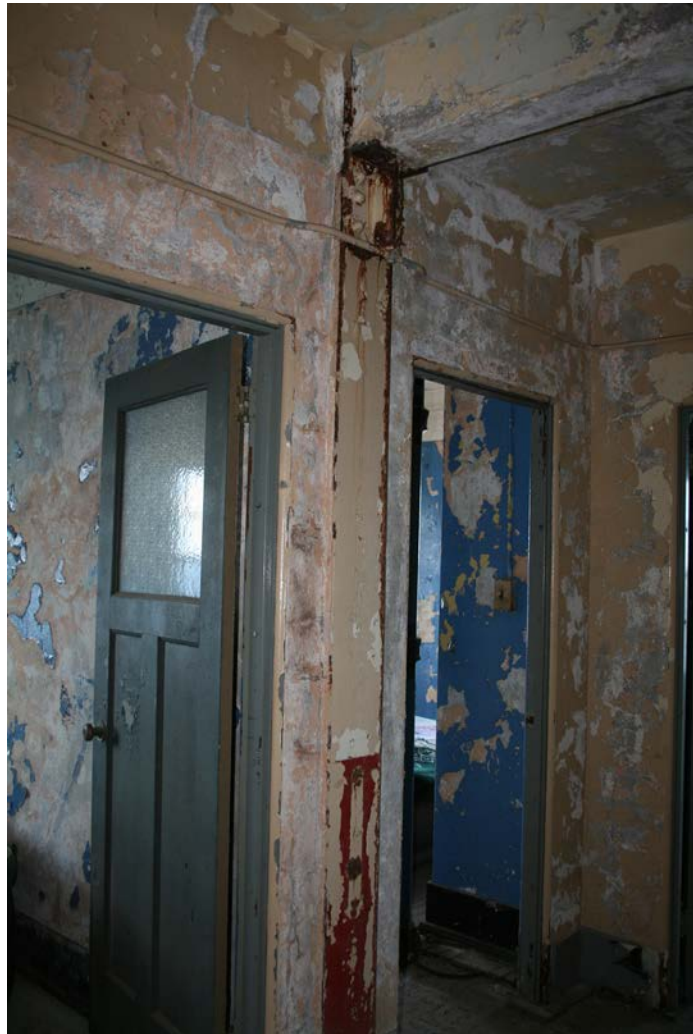
Figure 1D-27: Typical plaster finishes on interior, note painted steel column between doors.

Overall, the plaster wall and ceiling finishes on interior lower levels of the tower spaces are intact. The paint on the plaster is peeling and flaking, but the plaster is mainly sound and well bonded to the metal lath behind (Figure 1D-27). There are isolated areas of missing or damaged plaster throughout (Figure 1D-28). A vertical crack in the plaster finish extends upwards from the southwestern edge of the northeastern most interior door of the boat room on both sides of the wall (Figure 1D-29). A horizontal crack is located at the top of the wall near the ceiling of the boat room near this door (Figure 1D-29). The lath is ghosting through the plaster in the ceiling near the northernmost window of the southwest elevation at Level L-1 (Figure 1D-30). This window was boarded with plywood at the time of the assessment and there is evidence of water infiltration in this area.

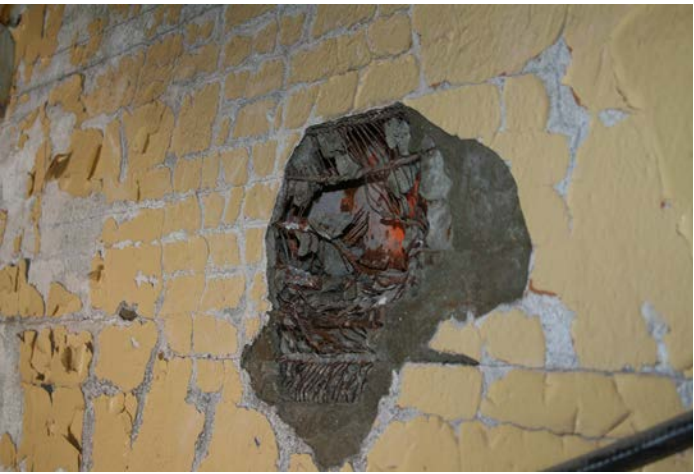
Figure 1D-28 Damaged plaster and lath in stairwell.

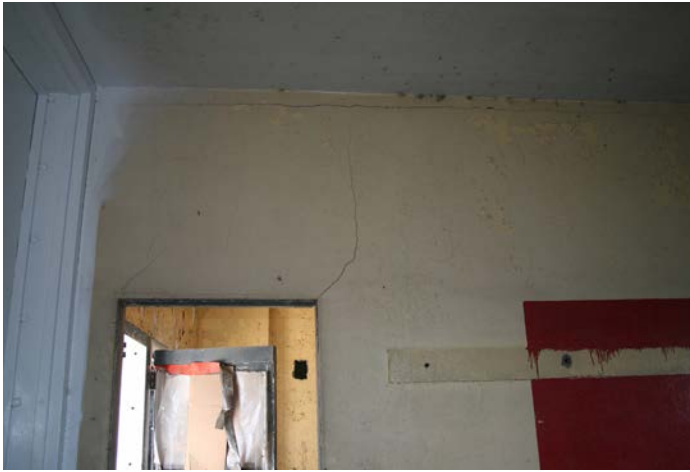
Figure 1D-29 Cracking in plaster at right side of door from boat room to entry. Note horizontal crack at top of wall near ceiling.

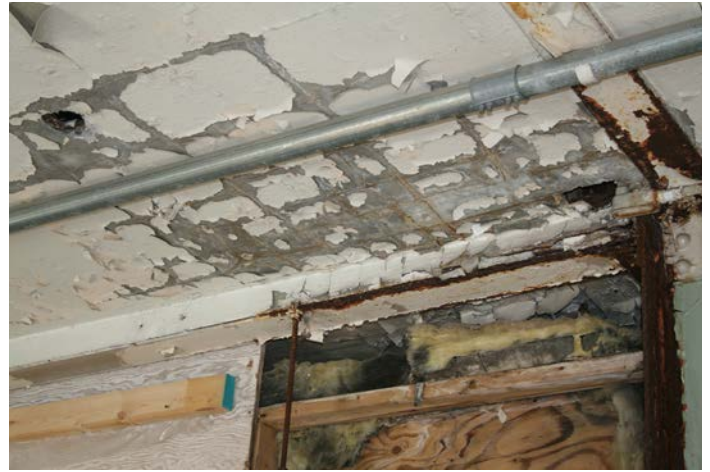
Figure 1D-30 Ghosting of metal lath through plaster ceiling. Note dark fiberglass insulation indicating potential water infiltration by boarded-up window.

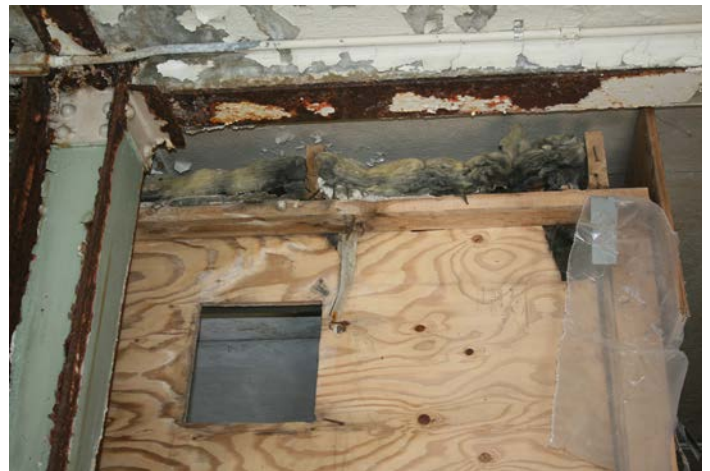
Figure 1D-32 Southern end of ceiling joists over equipment room that are supported on wood plate but wall studs are missing.

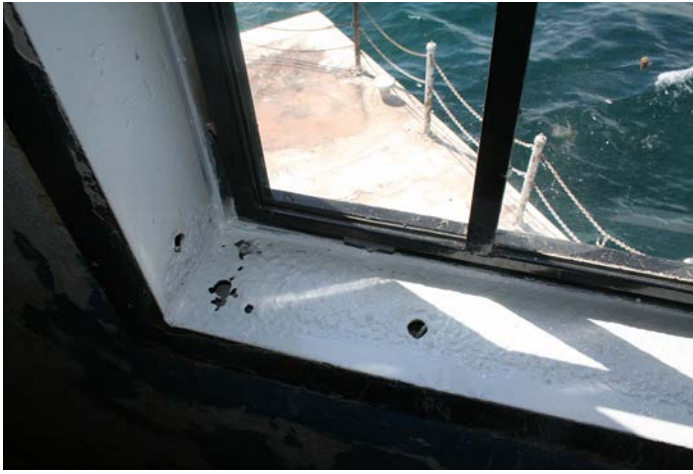
Figure 1D-33 Pitted and section loss of steel angle window framing.

The windows are framed with painted steel angles. The horizontal legs of the angles are corroded with evidence of pitting and full section loss occurring near the edges of the windows (Figure 1D-33).

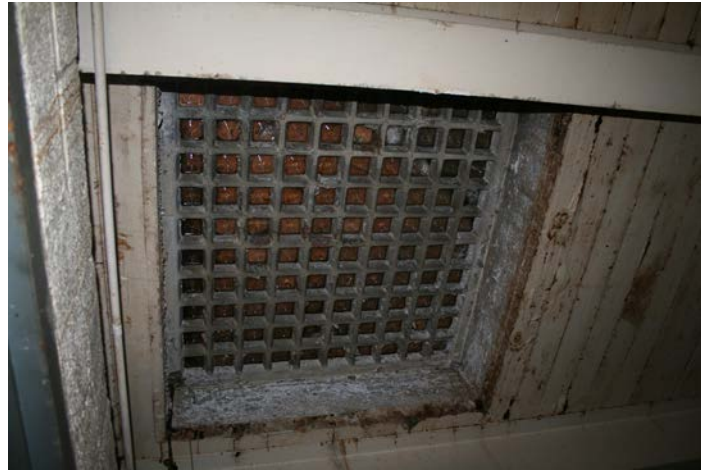
Figure 1D-34 Skylight in basement room ceiling in room for water level access door. Note cracking and deterioration of vertical edges of concrete at skylight opening.

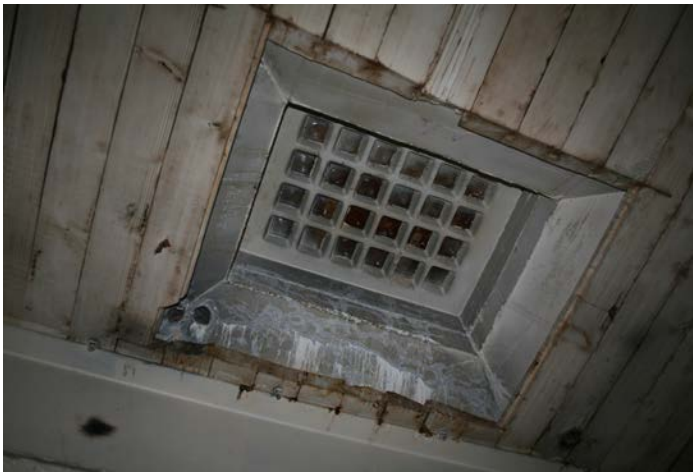
Figure 1D-35 Craze cracking and staining of concrete at glass skylight opening in pier deck, Level L-1 floor structure.

The glass skylights located throughout the Pier Deck floor structure, mainly in the interior of the tower but also in the northeast corner deck, were intended to provide light to the basement rooms. All of the skylights are covered in paint or other coverings, but appear to be intact with the exception of less than a dozen individual glass lights as observed from the underside. Cracked or deteriorated concrete is visibly present at the edges of the skylight in the northeast corner deck (Figure 1D-34). At the skylights on the interior of the tower, the 12-inch concrete slab is tapered to a wider opening at the bottom of the slab to help filter the light into the basement spaces. Craze cracking is present on this tapered concrete surface (Figure 1D-35).

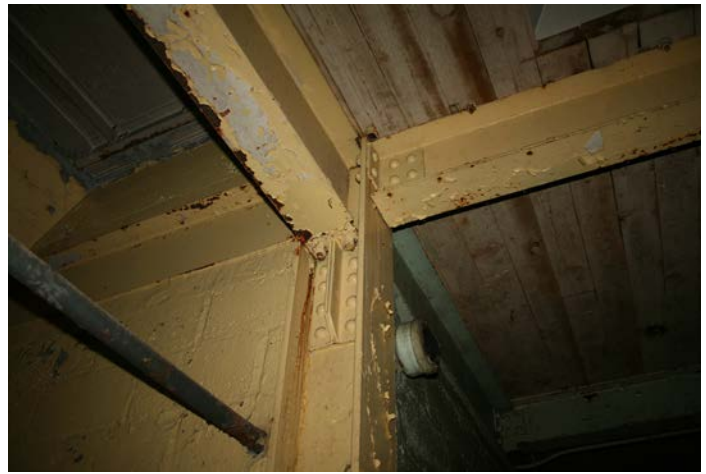
Figure 1D-36 Typical steel beam to column connections exposed in basement of pier deck, Level L-1 floor structure.

The steel I-beams are spanning to the steel columns. The sizes of the beams vary by location, ranging in depth from 10 inches to 20 inches. The beams connect with steel angles to the columns or other beams with both rivets and through-bolts (Figure 1D-36). The rivets were most likely installed on the main land in a steel fabricator's shop and the through-bolts installed

as the steel frame was erected. The beams are painted, and the paint is flaking in areas where minor corrosion of the beams is present (**Figure 1D-36**).

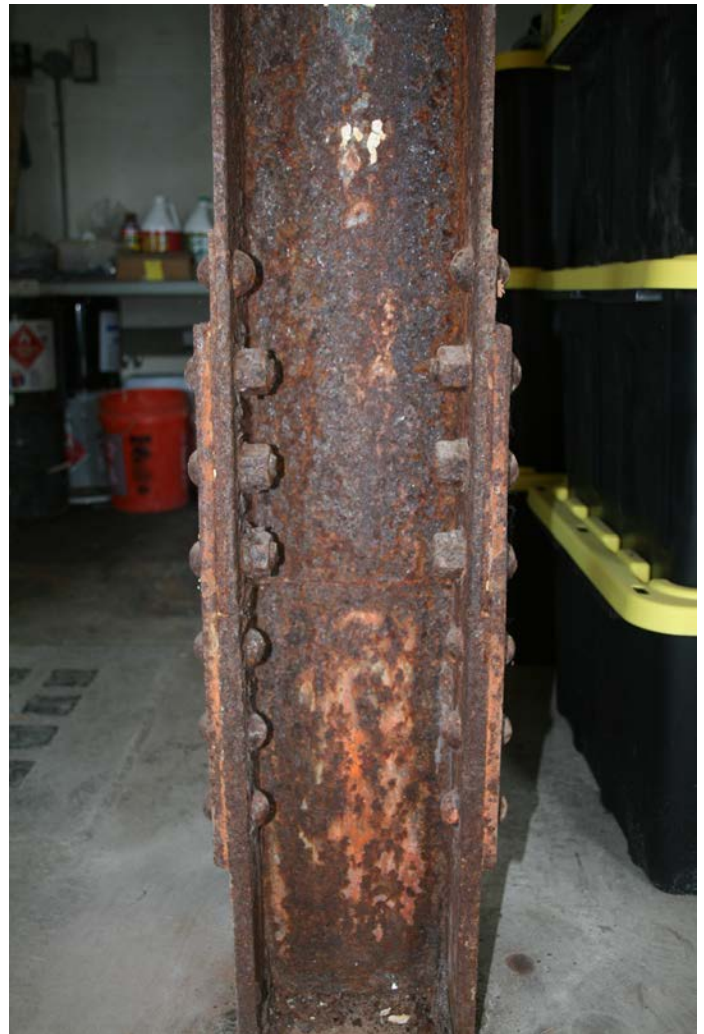
Figure 1D-37 Column splice of southernmost interior column at pier deck, Level L-1. Note riveted connection at bottom and through-bolted connections at top of splice plates. Extra rivet at top of connection for splice plate to accommodate change in flange thickness of columns.

The use of a shim plate at the column splice above the Pier Deck, Level L-1, of the southernmost interior column indicates the column size is reduced on the upper portion of the splice. The splice plates are both riveted and through-bolted to the column flanges (**Figure 1D-37**). Although the surface of the column is corroded, minimal section loss has occurred at the base of the column. The nuts of the through-bolts at the column splice connection, however, are more significantly corroded (**Figure 1D-38**).

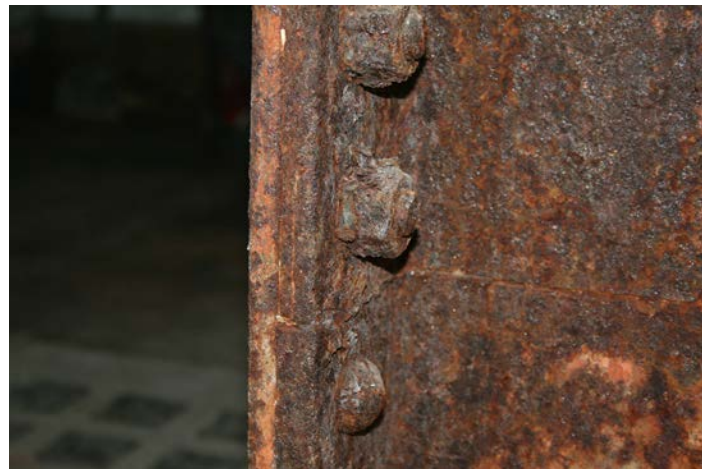
Figure 1D-38 Corrosion of nuts at through-bolt connection of column splice of southernmost interior column at pier deck, Level L-1.

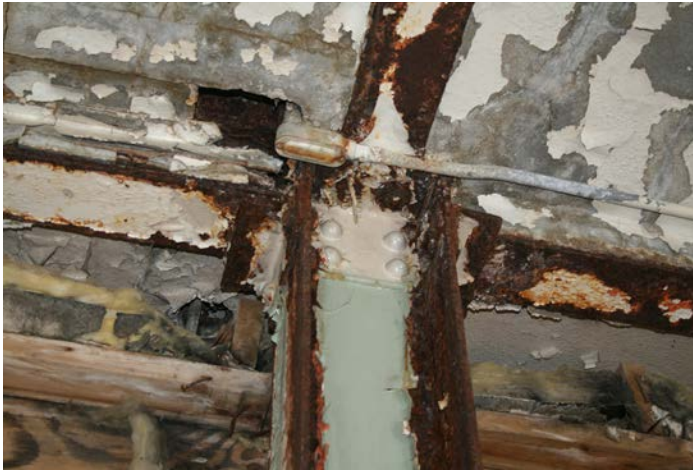
Figure 1D-39 Corrosion of steel framing members and connection at underside of second floor structure, Level L-2, at southernmost interior column.

The plaster ceiling prevented visual assessment of the Level L-2 floor structure except near the southernmost interior column where the plaster finish was damaged from water infiltration. The steel beams and column at this location are corroded (**Figure 1D-39**). The depths of the I-beams correlate with the sizes specified in the Construction Drawings.

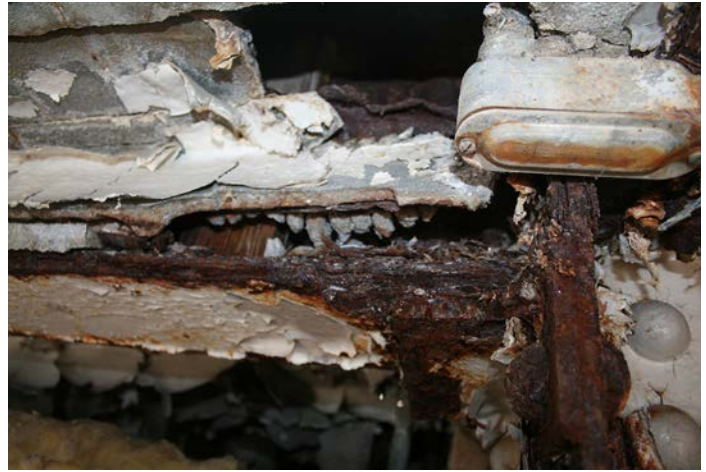
Figure 1D-40 Significant corrosion of steel flanges of beams and columns at second floor structure, Level L-2, at southernmost interior column.

The corrosion of the steel beams framing into the southernmost interior column is advanced and has caused section loss of the steel flanges that may affect the load-bearing capacity of the beam, depending on the extent of the section loss (**Figure 1D-40**). The through-bolts and clip angles of the beam to column connections have also been compromised with nearly full section loss of at least one nut in the beam to column connection (**Figure 1D-41**).

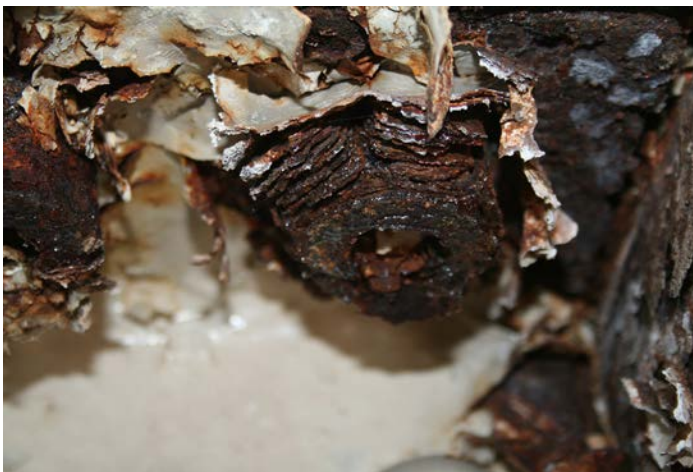
Figure 1D-41 Nearly full section loss of nut at through-bolt connection.

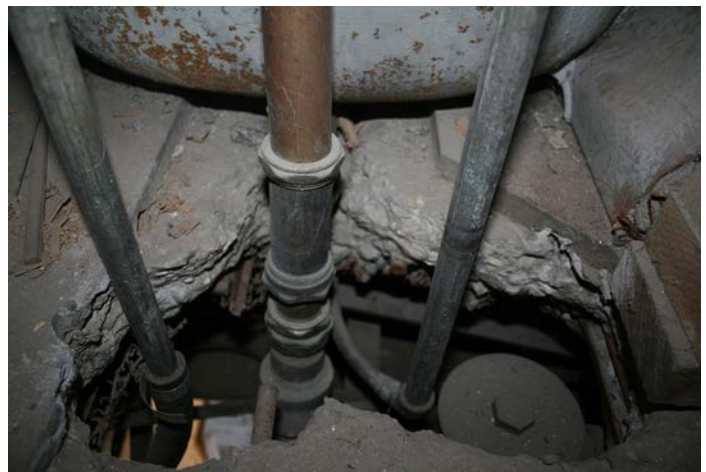
Figure 1D-42 Selective demolition of concrete slab at bathroom tub access. Embedded steel reinforcing bars are exposed at cut for utility penetration.

At the bathtub access hatch located in the wall of the stairwell between Level L-1 and Level L-2, the concrete slab for Level L-2 was previously chiseled away allowing for the piping penetrations. The small area of demolition exposed cut steel reinforcing bars embedded in the 4-1/2 inch concrete slab. The reinforcing bars are 1/2-inch diameter bars located near the bottom of the slab and oriented in both directions. A 1-inch grout bed is placed over the concrete slab in the Level L-2 bathroom (Figure 1D-42).

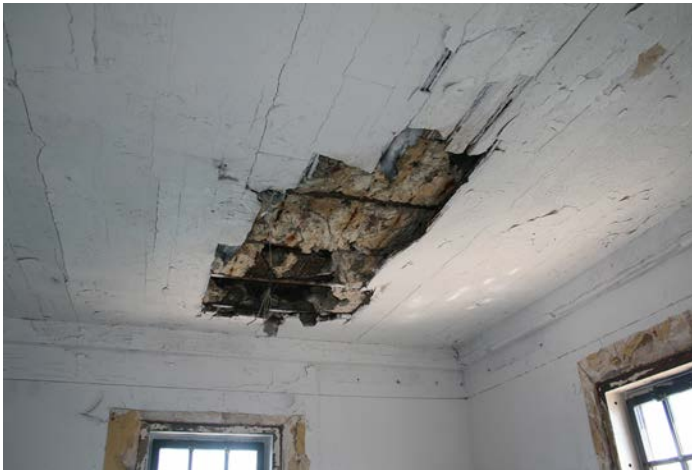
Figure 1D-45 Missing ceiling finish below watch deck, Level L-3, structure. Note insulation is tight to steel bar joists.

The ceiling finish is missing in the second level, Level L-2, easternmost and southernmost rooms exposing the Watch Deck structure (Figure 1D-45 and 1D-46). The plaster ceilings were supported with metal lath that was secured to the underside of open web bar joists. The bar joists are spaced, on average, 18 inches apart and are 8 inches in depth. Insulation is tight in the voids between and through the bar joists. The concrete slab atop the bar joists is formed with a metal form. The metal form is surface corroded where exposed (Figure 1D-47).

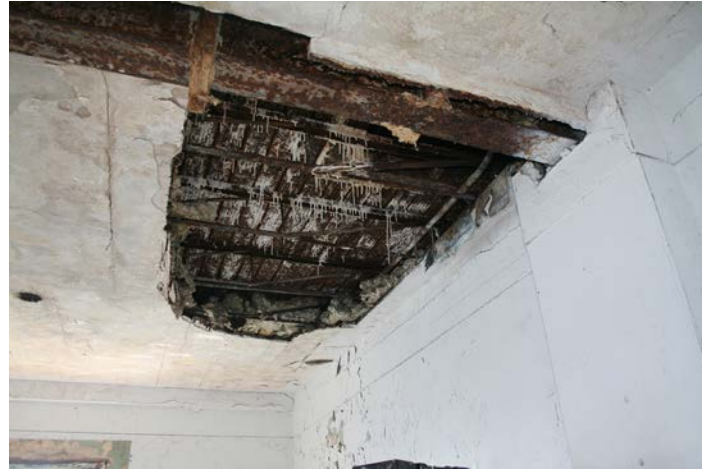
Figure 1D-46 Missing ceiling finish below watch deck, Level L-3, structure. Note stalactites forming on steel bar joist surfaces.

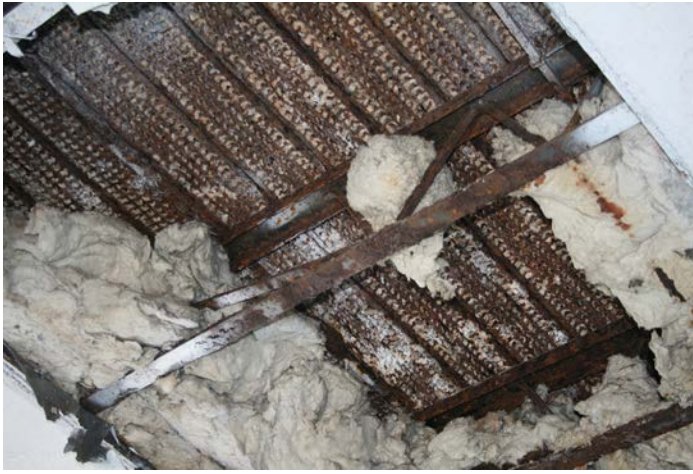
Figure 1D-47 Corroded metal bar joists.

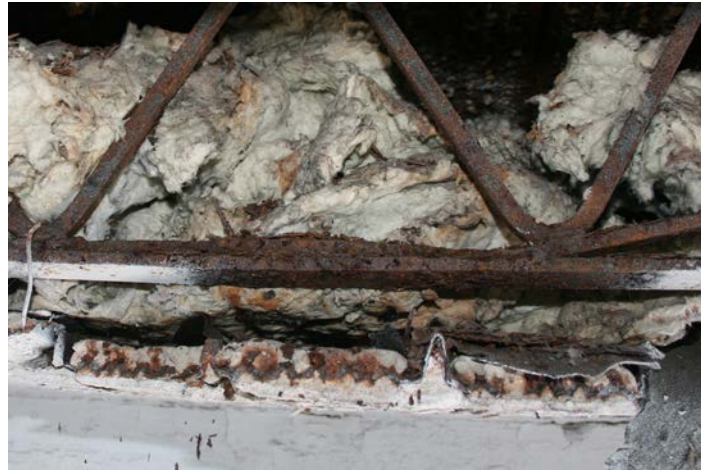
Figure 1D-48 Localized corrosion of metal bar joists.

In the area of the missing ceiling in the easternmost room at Level L-2, the steel joists are surface corroded and three of the joists have lost section of the bottom chords due to the corrosion. The joists consist of a 2 inch channel oriented flat-wise with 1-1/8 inch wide flanges; 3/8 inch square web members; and a 1-1/4 inch by 1/4 inch bar bottom chord (**Figure 1D-47**). Where the bottom chord was observed to be corroded, once the loose scale was removed, the thickness of the chord was nearly equivalent to the thickness of the chord where there was no loose scale or section loss evident, except for one location where the thickness of the chord was measured to be 0.17 inches (**Figure 1D-48**). The end web member, a 3/4 inch by 1/4 inch steel bar, is expanded in size along the bottom chord where the corrosion is greatest (**Figure 1D-48**).

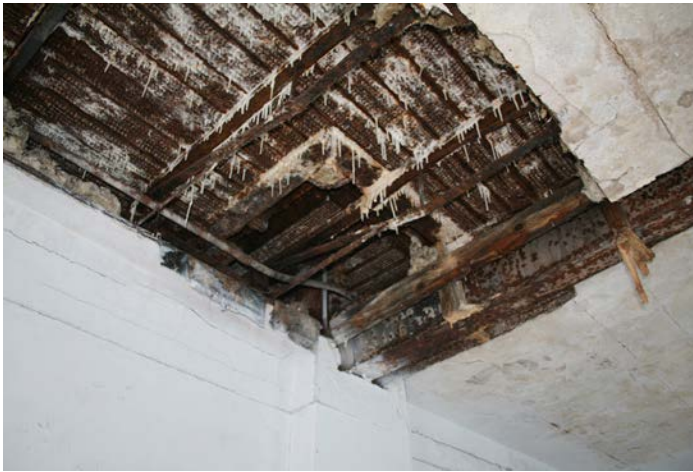
Figure 1D-49 Upper tower wall framing bearing on watch deck, Level L-3, structure. Note water staining of wood furring, corrosion of steel, and stalactites.

In the southernmost room, stalactites are hanging from the Watch Deck structure where the ceiling finish is missing (**Figure 1D-49**), near the southernmost interior column. The stalactites are evidence that water is traveling through the concrete slab above, dissolving minerals from the concrete, and redepositing them as the stalactites. In this area, all of the steel is corroded with evidence of section loss occurring. The steel bracing of the top of the wall to the bottom chord of the open web steel joists in three locations is nearly fully corroded and warped (**Figure 1D-50**). The bearing seat of the steel joists has expanded due to the corrosion activity (**Figure 1D-51**). The I-beams in this area are also corroded with pitting and section loss occurring (**Figure 1D-51**). The web members of at least one of the bar joists is visually deformed (**Figure 1D-52**).

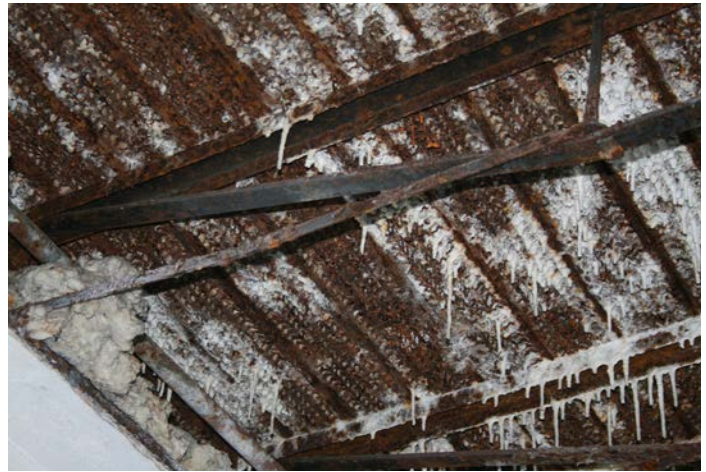
Figure 1D-50 Corroded and warped brace between top of interior wall and bar joist bottom chord.

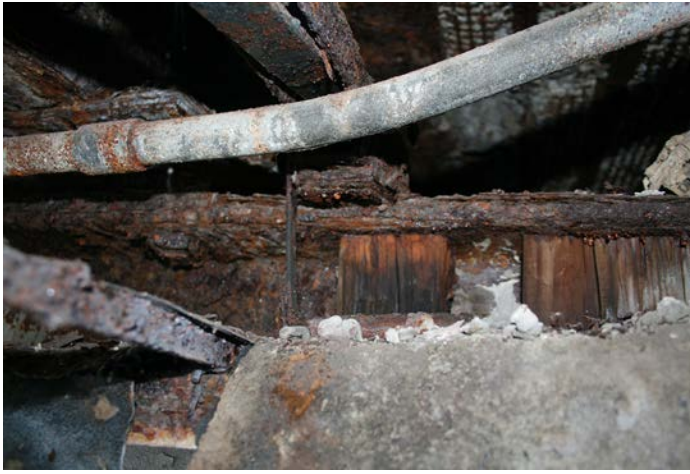
Figure 1D-51 Corroded joist bearing seat and flanges of steel support beam. Note water stained wood furring.

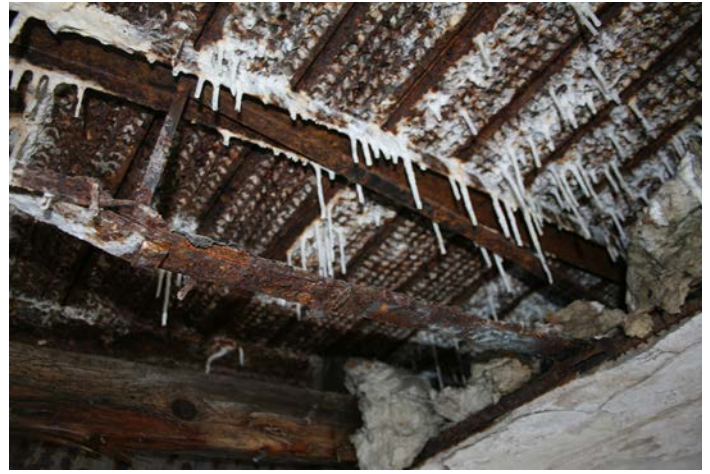
Figure 1D-52 Web member of steel bar joist is deformed, curved upward.

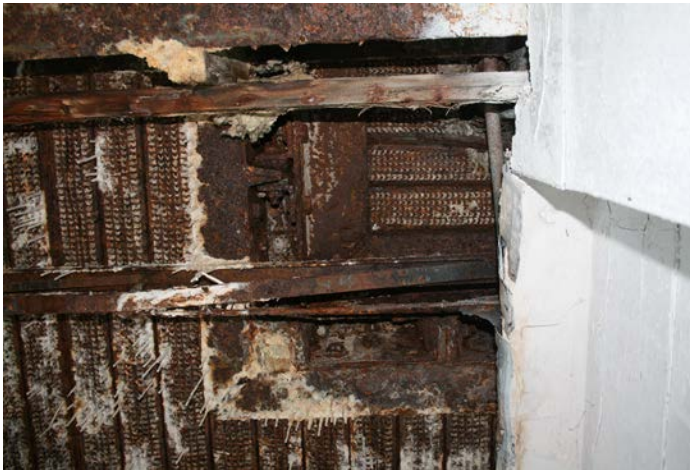
Figure 1D-53 Underside of upper tower wall framing bearing on watch deck, Level L-3, structure. Note water staining of wood furring, corrosion of steel, and stalactites.

In this same area of the southernmost room, the underside of the connection of the upper levels of the tower to the Watch Deck, Level L-3, structure is visible. The channels for the exterior walls of the upper level are visible. The channels are secured to each other and the top chord of the Watch Deck, Level L-3, bar joists with steel angles and through-bolts (Figure 1D-53). The steel clip angles and through bolts are significantly corroded; but the wall channels are only surface corroded.

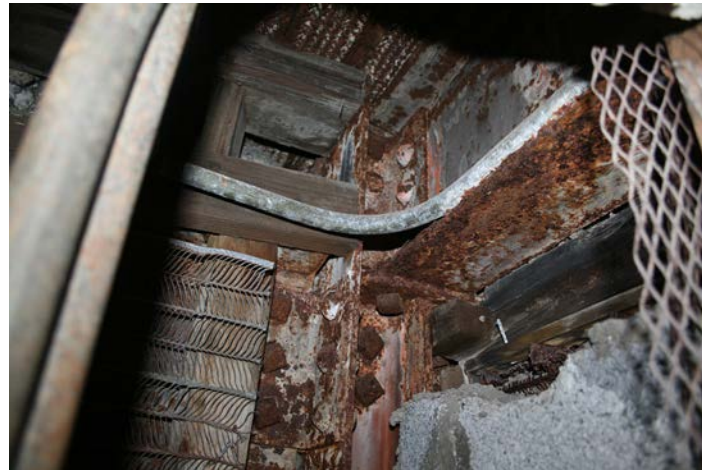
Figure 1D-54 Top of westernmost interior column and beam framing into the column. Note minor corrosion of steel.

At an opening in the plaster wall finish in the stair between Level L-2 and Level L-3, the top of the northernmost interior column was observed. The beams, connections, and column in this area are all corroded with minimal section loss (Figure 1D-54).

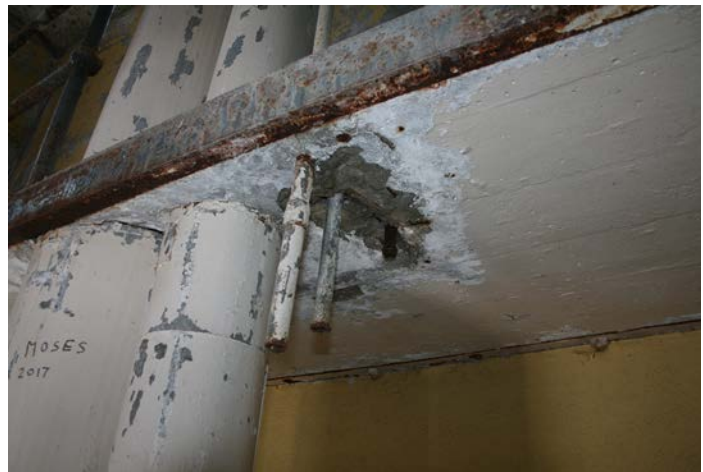
The spaces at Level L-3 and up are primarily used for equipment and to provide covered access to the lantern level. The finishes are basic with painted concrete floors, painted plaster walls, and painted board formed concrete ceilings. The plaster finish is typically cracked horizontally at mid-height of the walls and vertically in the corners of the walls. A central steel beam, parallel with the run of the stair, is located below the concrete ceiling and is supported with bolted gusset plates at the exterior walls (Figure 1D-55). The concrete slabs are 4 inches in depth. Holes have been made through the slabs for utility penetrations (Figure 1D-56). Cracking is present at the corners of the slab penetrations.

Figure 1D-56 Utility penetrations through concrete slab of floor structures of upper levels of tower.

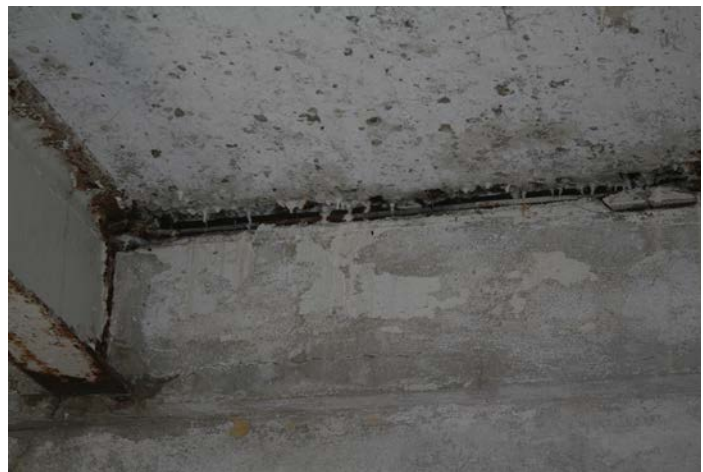
The Lantern Deck, Level L-6, floor structure is an 8 inch thick concrete slab. Stalactites are forming on the underside of the deck at the lantern wall anchor locations and at the perimeter of the exterior Lantern Deck (Figures 1D-57 and 1D-58).

Figure 1D-57 Stalactites on underside of lantern deck concrete slab at perimeter of Level L-5.

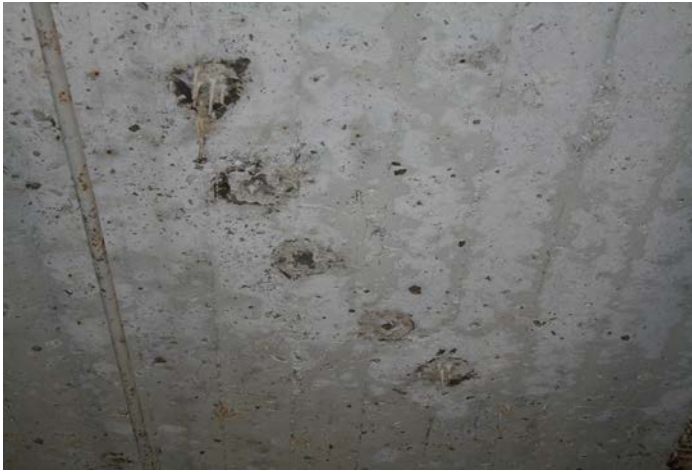
Figure 1D-58 Stalactites on underside of lantern deck concrete slab at location of lantern anchorage.

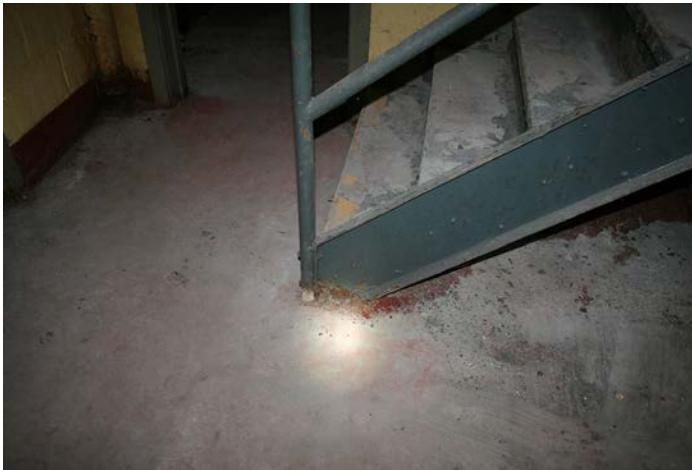
Figure 1D-59 Minor corrosion of stair stringer at basement level.

The stair structures are all steel framed with channel section stringers. Bent plate treads and risers are secured with clip angles to the stringers. Between the Pier Deck level, Level L-1, and Level L-2, the treads are 10-1/2 inches wide and the risers are 8 inches tall. All of the stairs are painted, and the paint is flaking. Minimal corrosion of the steel members is present at the uppermost and basement levels (Figure 1D-59).

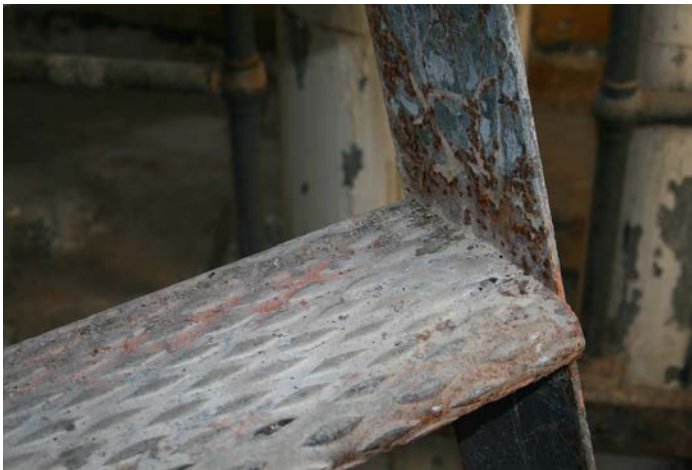
Figure 1D-60 Stair tread and plate stringer on ladder between Level L-5 and Level L-6.
