MANAGEMENT SUMMARY

Executive Summary

Current Conditions

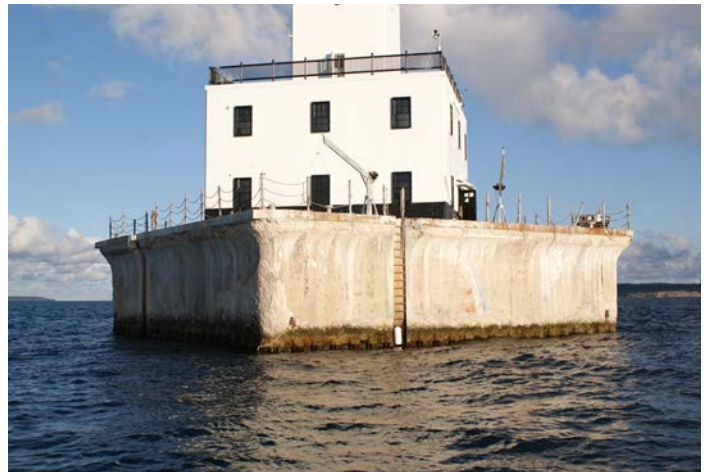
Figure 1D-61 East face of the concrete crib.

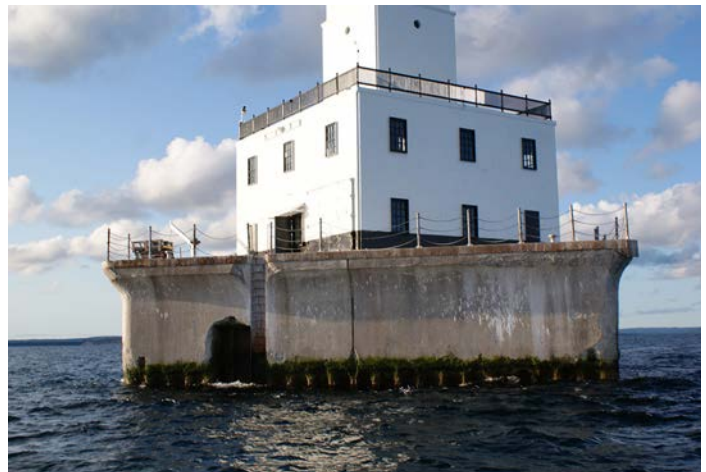
Figure 1D-62 North face of the concrete crib.

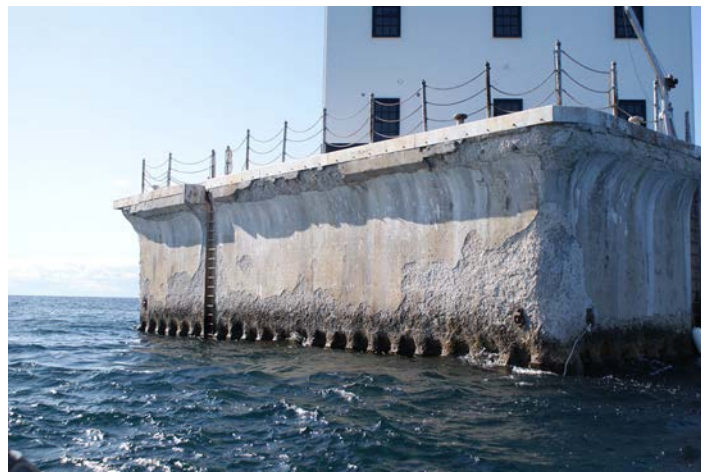
Figure 1D-63 South face of the concrete crib.

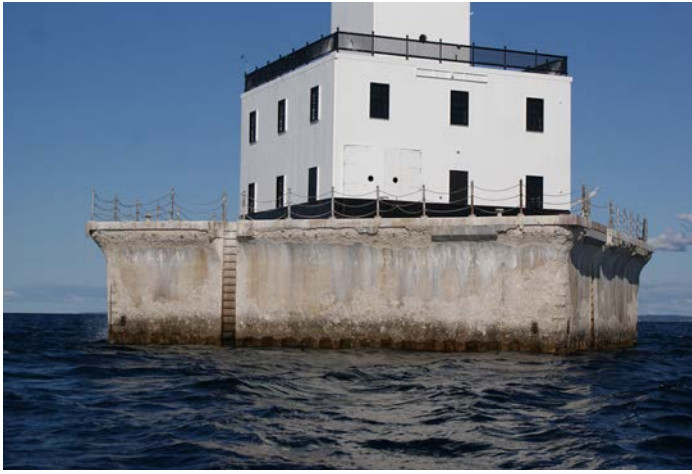
Figure 1D-64 West face of the concrete crib.

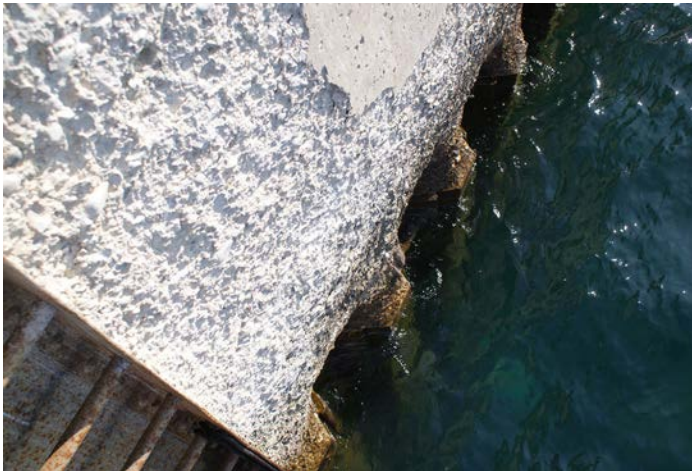
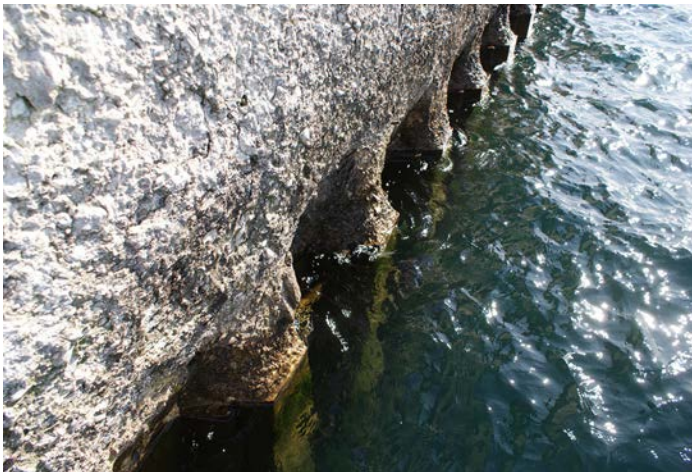
Figure 1D-65 Deteriorated concrete near the water surface above the steel sheet piling.

Figure 1D-66 Deteriorated concrete near the water surface above the steel sheet piling.

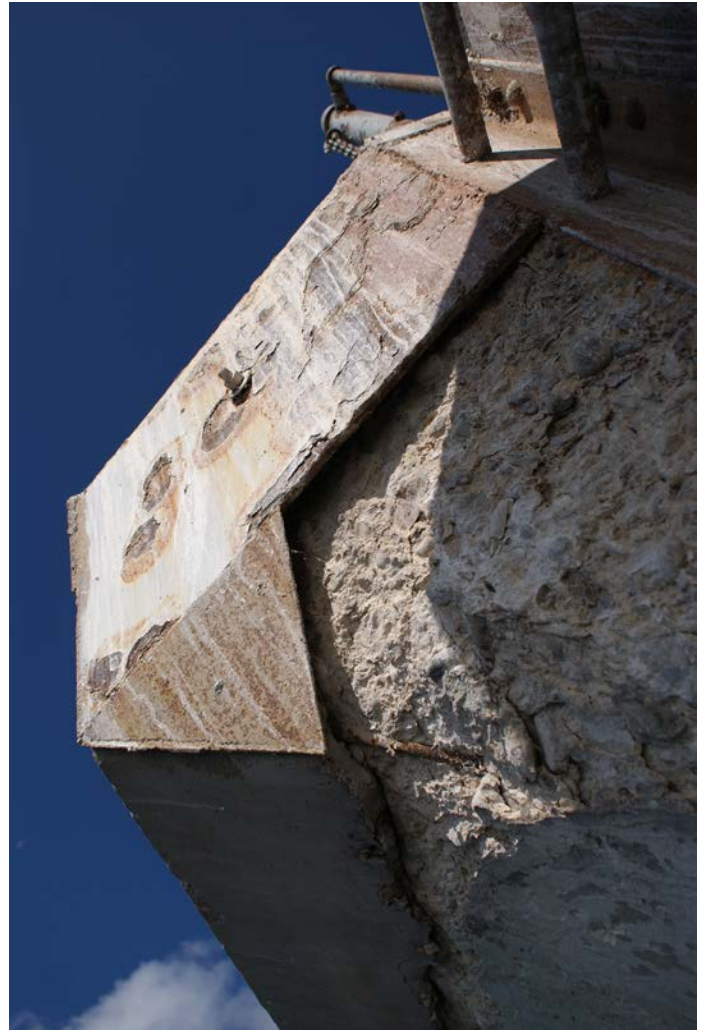
As previously discussed in the structural section, the surface of the vertical concrete walls of the concrete crib are in poor to fair condition with considerable spalling and damage in many areas. Heavy damage to the concrete surface from water and ice has occurred on all sides, with significant deterioration and loss of material on the south and west faces. The north face of the crib is seen in Figure 1D-62; the east face in Figure 1D-61; the south face in Figure 1D-63; and the west face in Figure 1D-64. Close-up views of the deterioration at the base of the concrete where it transitions from the steel sheet piling face are seen in Figures 1D-65 and 1D-66. The large indentations at the base of the concrete where it meets the sheet piling are part of the original design and are not due to deterioration. Conditions at the wave edge, which extends 2 feet from the vertical face and is located at the top of the concrete crib, are seen in Figures 1D-67 and 1D-68. Exposed steel reinforcing bars

Figure 1D-67 Transition of steel deck plate at ladder.

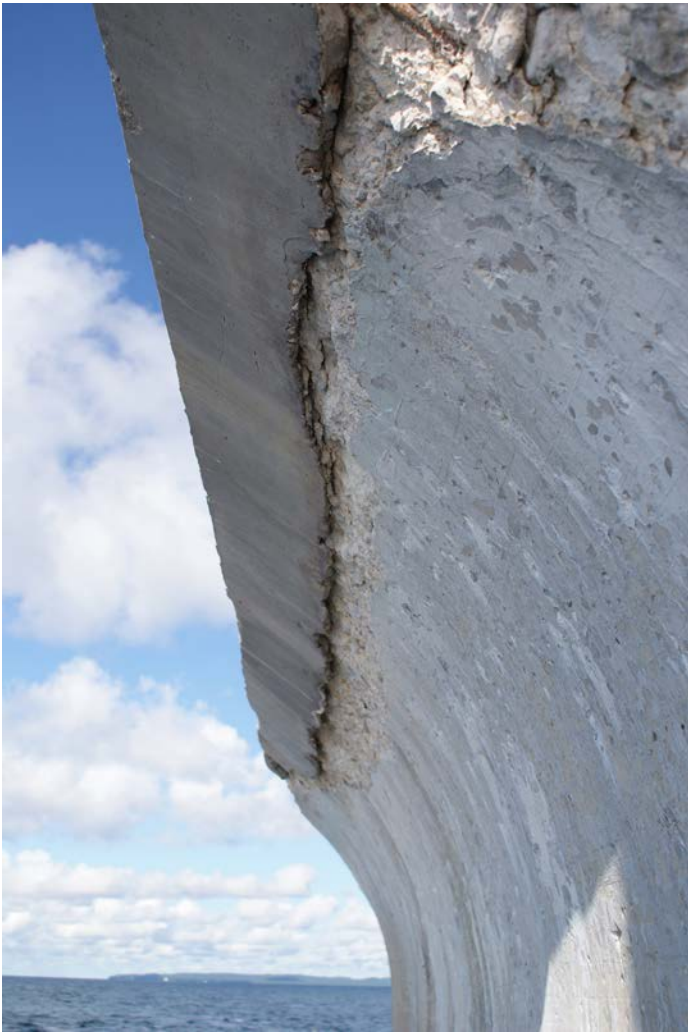
Figure 1D-68 Concrete repair at wave edge.

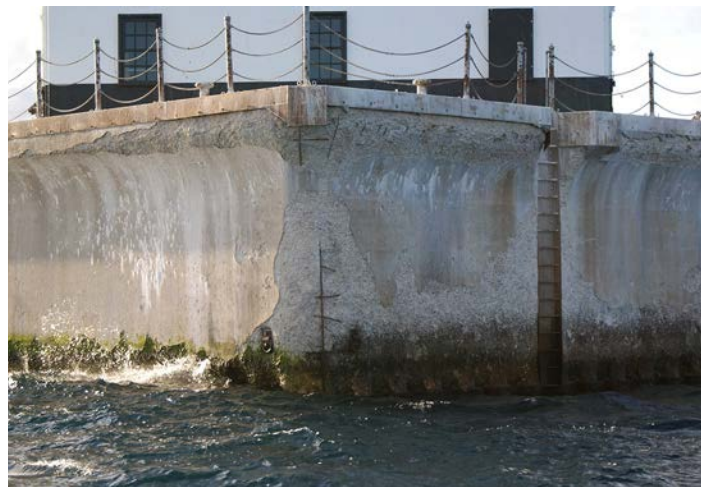
Figure 1D-69 Deteriorated concrete and exposed reinforcing bars on the northwest corner.

can be seen on the northwest, [Figure 1D-69](#), and southwest, [Figure 1D-70](#), corners.

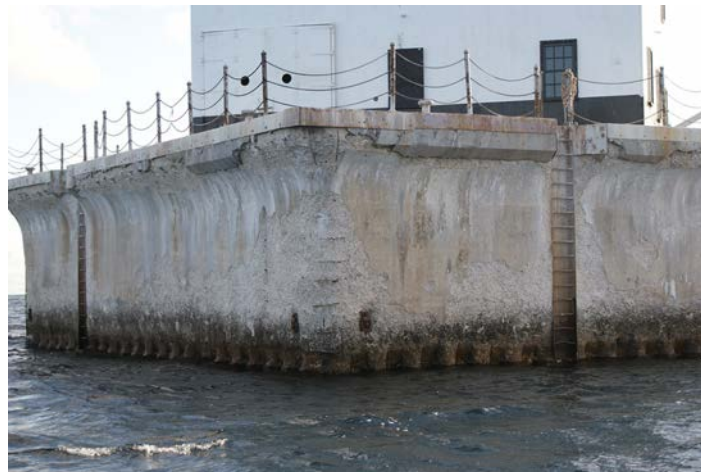
Figure 1D-70 Deteriorated concrete and exposed reinforcing bars on the southwest corner.

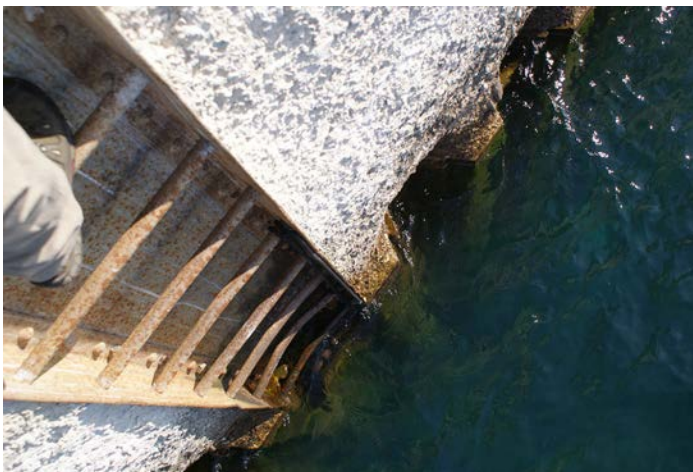
Figure 1D-71 Vertical steel ladder. Bent rungs are visible near the water surface.

There are four steel ladders, one on each side, set into the vertical concrete face of the crib for access. Ladder rungs are 1-½ inch diameter steel bars spaced 12 inches on center vertically fixed to steel angles set into the concrete structure. The finish on the ladder rungs and embedded angles is in very poor condition. The majority of the steel rungs are intact, however there are some bent rungs near the water level, as seen in [Figure 1D-71](#). The ladder on the north face, adjacent to the sea door that provides access to the basement, has two rungs missing at the bottom. This condition, along with deterioration of the concrete around the sea door, is seen in [Figure 1D-72](#).

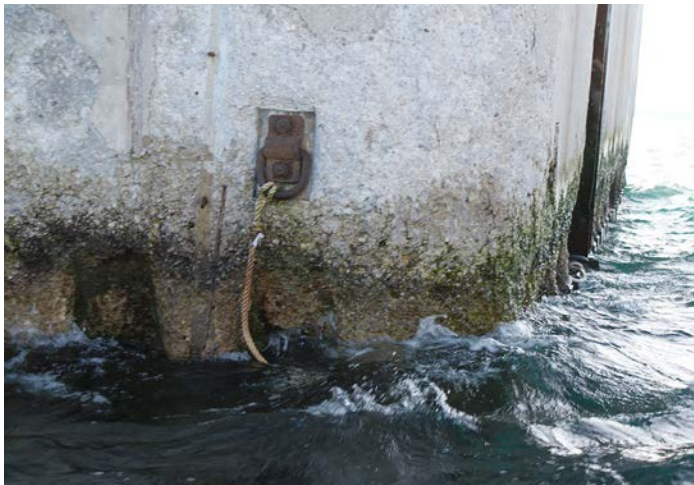
Figure 1D-73 Steel mooring anchors near the corner of the crib.

Two steel mooring anchors, [Figure 1D-73](#), are located near each corner of the crib. The anchors appear in good condition, however there is considerable damage to the concrete at two corners.

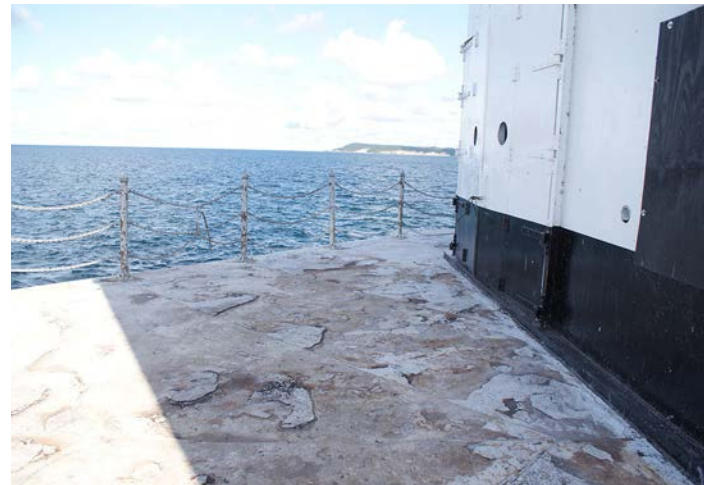
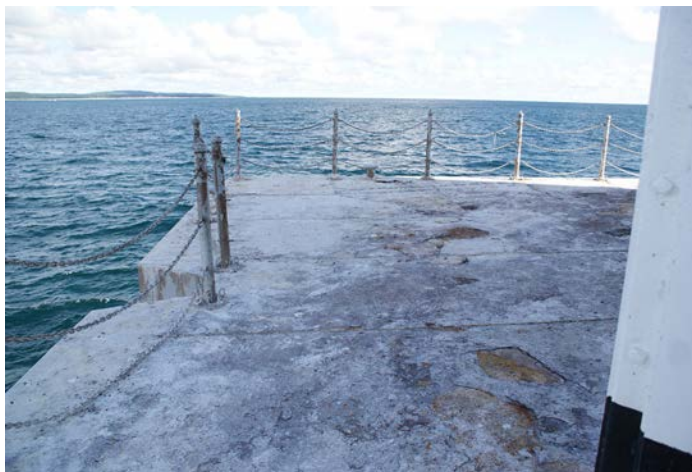
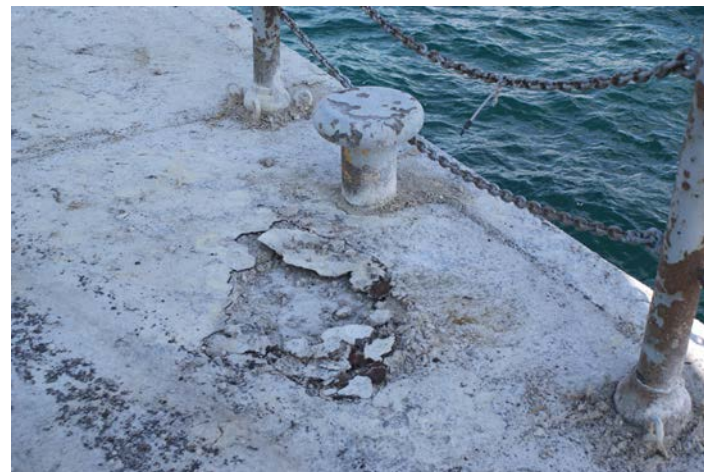
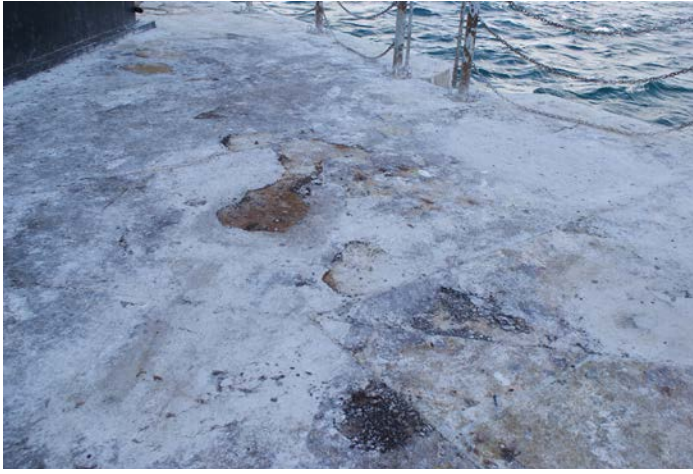
Figure 1D-74 View of the deteriorated surface of the steel plate on the Pier Deck.

Figure 1D-75 View of the deteriorated surface of the steel plate on the Pier Deck.

Figure 1D-76 View of the deteriorated surface of the steel plate on the Pier Deck.

The Pier Deck, the main deck surface surrounding the multi-level steel structure, is approximately 16 feet - 1 inch above the surface of Lake Michigan on the date of this inspection, which is at a record high level in 2019. Originally an exposed concrete deck surface, the Pier Deck has been covered with steel plate to protect the original concrete surface. The condition of the concrete deck surface will not be known until the steel plate is removed. The steel plate, which has been painted and covered with other coatings, is in very poor condition as seen in [Figures 1D-74](#), [1D-75](#), [1D-76](#) and [1D-77](#), with open seams

Figure 1D-77 View of the deteriorated surface of the steel plate on the Pier Deck.

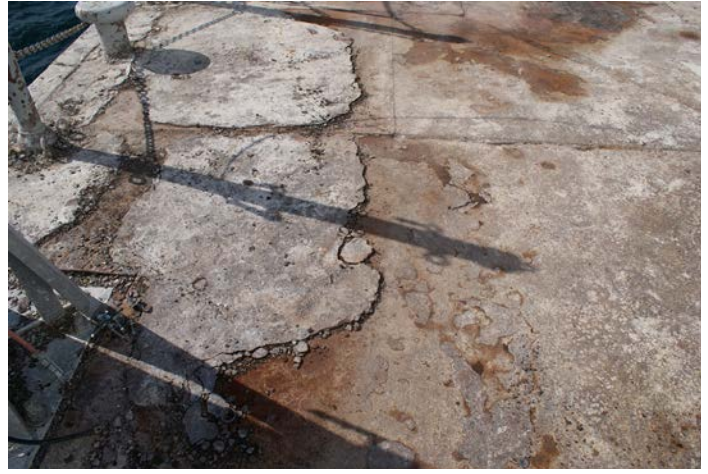
Figure 1D-78 View of the deteriorated surface of the steel plate on the Pier Deck.

and rust on the steel plate surface. A close-up view of the deck surface is seen in Figure 1D-78. The steel plate extends vertically approximately 12 inches down the face of the structure and is secured with anchor bolts. This edge condition is seen in Figure 1D-79.

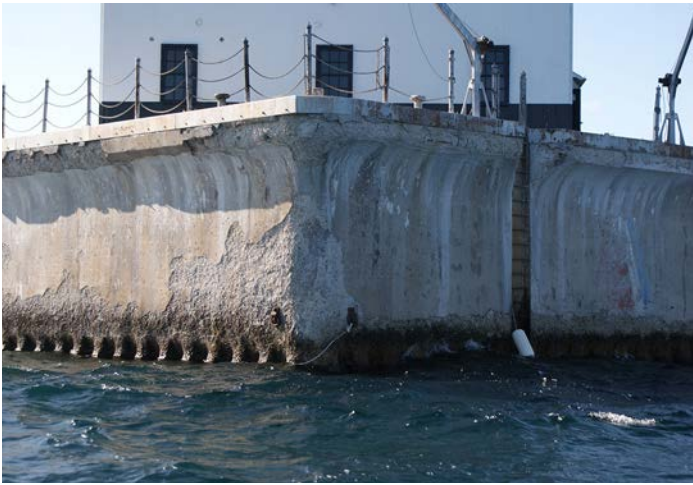
Figure 1D-79 View of the steel deck plate turned down and bolted to the concrete structure at the edge.

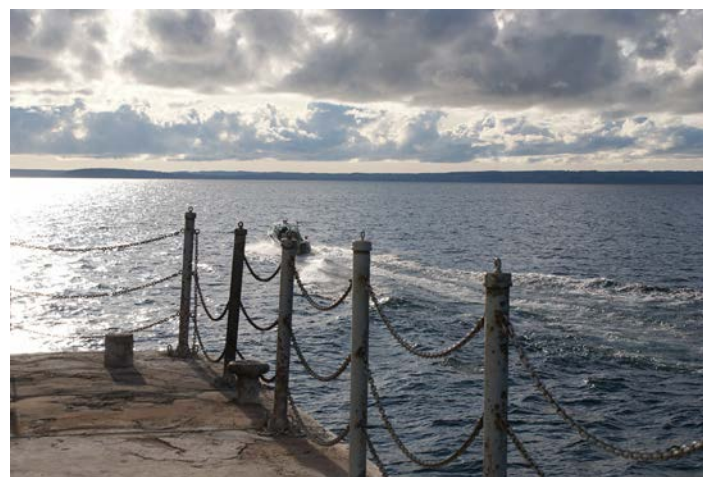
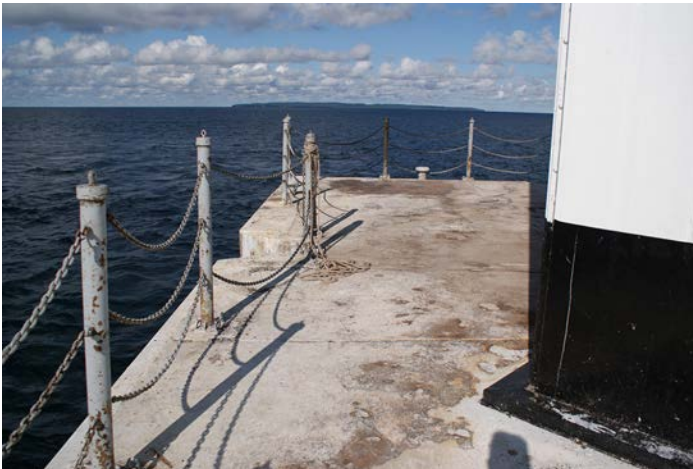
Figure 1D-80 Steel pipe posts and chain link guardrail at the perimeter of the Pier Deck.

Figure 1D-81 Steel pipe posts and chain link guardrail at the perimeter of the Pier Deck.

A guardrail with steel posts and chain link rail is intended to provide fall and safety protection along the perimeter of the Pier Deck. This rail system is in poor condition with damaged and missing components, including posts and chain link rails. The paint finish is in extremely poor condition. Views of the guardrail system, which consists of 3-½ inch outside-diameter (O.D.) steel pipe posts spaced approximately 6 feet on center and three horizontal rails of chain link, are seen in Figures 1D-80 and 1D-81. A damaged

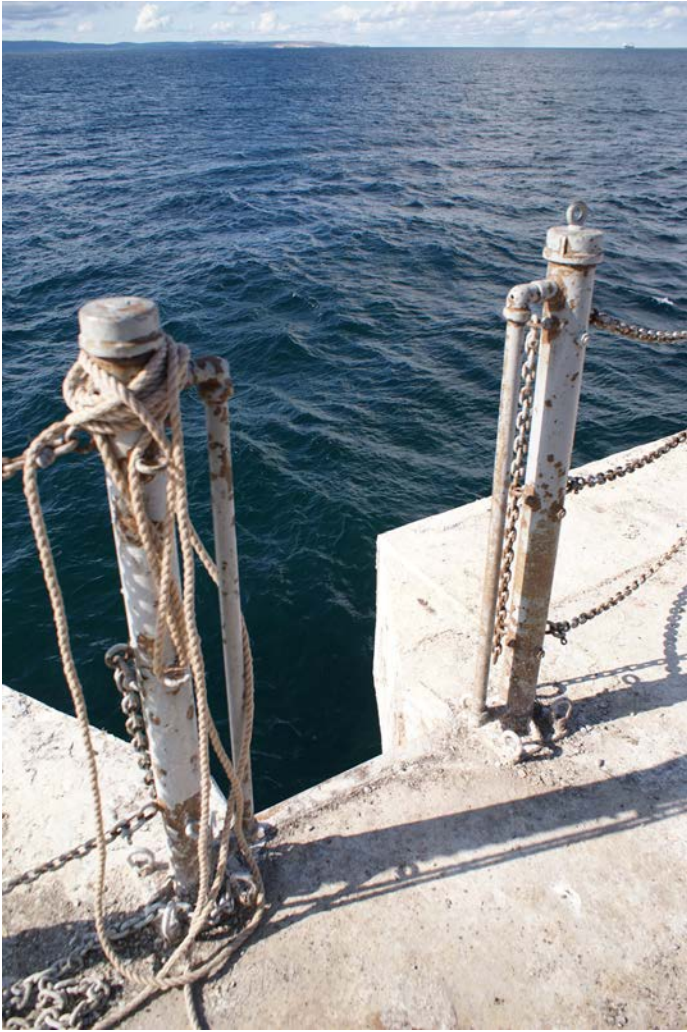
Figure 1D-84 Guardrail posts with hand-holds at one of the vertical ladders.

post broken from its base is seen in Figures 1D-82 and 1D-83. The guardrail posts are slightly offset at the four vertical ladders, Figure 1D-84.

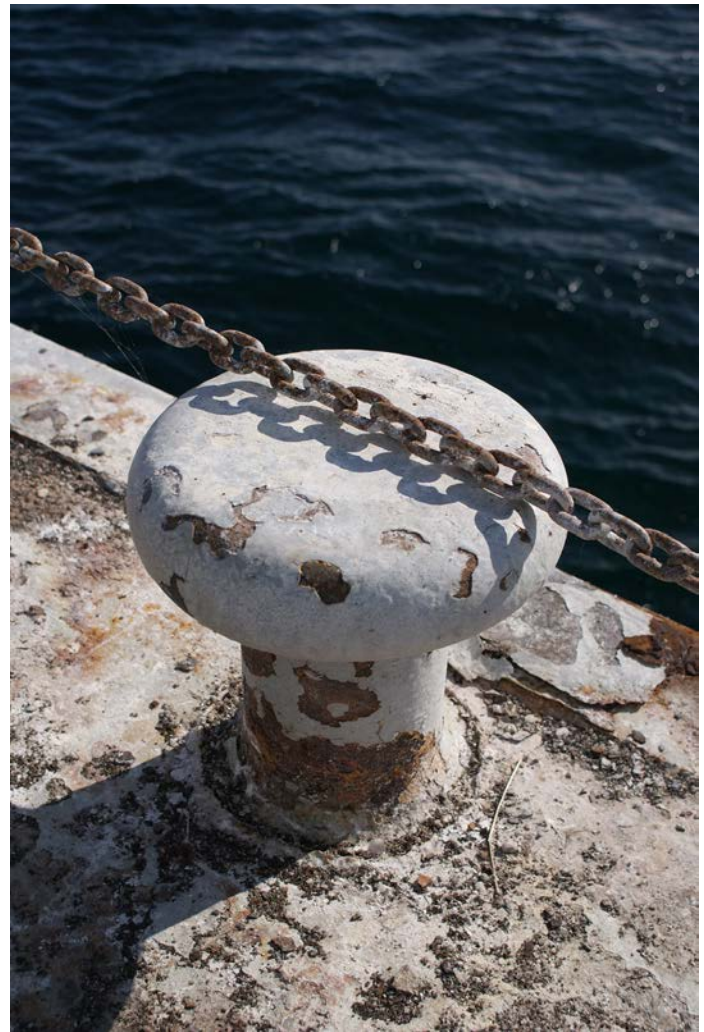
Figure 1D-85 A typical stanchion located near the edge of the Pier Deck.

There are eight steel bollards located on the top of the Pier Deck near the edge and in alignment with the guardrail system, as seen in Figure 1D-85. The paint finish is in poor condition on all bollards.

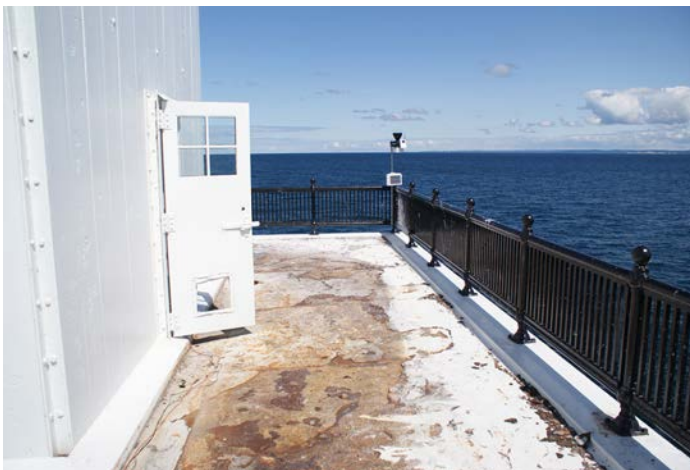
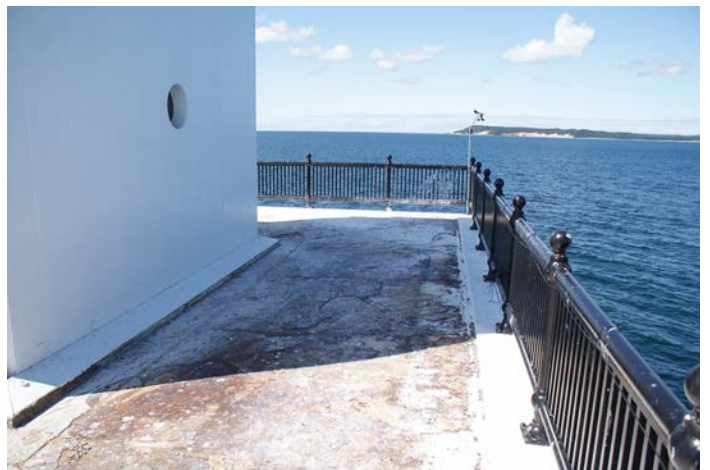
Figure 1D-88 View of the steel plate deck surface at the Watch Deck, Level 3.

Figure 1D-89 View of the steel plate deck surface at the Watch Deck, Level 3.

The next deck level, at the third level (L-3) of the tower and also referred to as the Watch Deck, is accessed from a door at the base of the tower. This deck is approximately 10 feet wide and is also the roof of the second level of the metal structure. Views of this deck are seen in [Figures 1D-88 and 1D-89](#). A metal guardrail is located around the perimeter of the deck, [Figure 1D-90](#). It is constructed with 2-7/8 inch O. D. metal posts spaced approximately 5 feet on center with a 4-1/2" diameter decorative ball, and 2-7/8 inch O. D. top and bottom horizontal rails with 1 inch x 1 inch square metal bar balustrades spaced 3 inches on center. The guardrail is 3 feet high from the deck level to the top of the upper horizontal rail. The guardrail was recently painted as part of the exterior restoration work and is in very good condition, although somewhat dirty with bird droppings. The decorative ball is missing at one corner post, as seen in [Figure 1D-91](#).

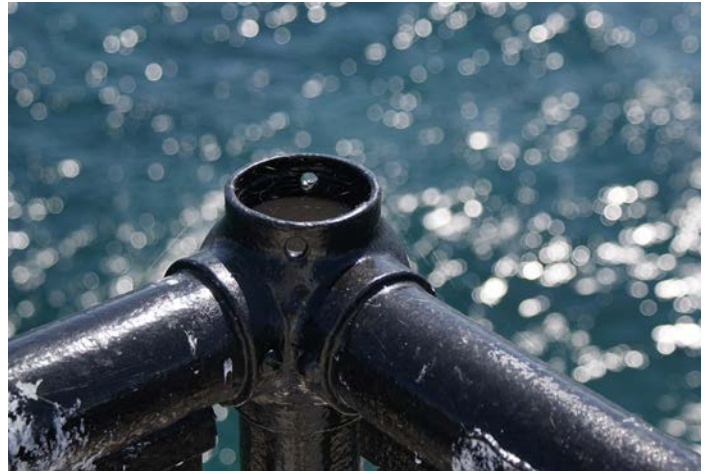
Figure 1D-91 Missing decorative ball at a corner post.

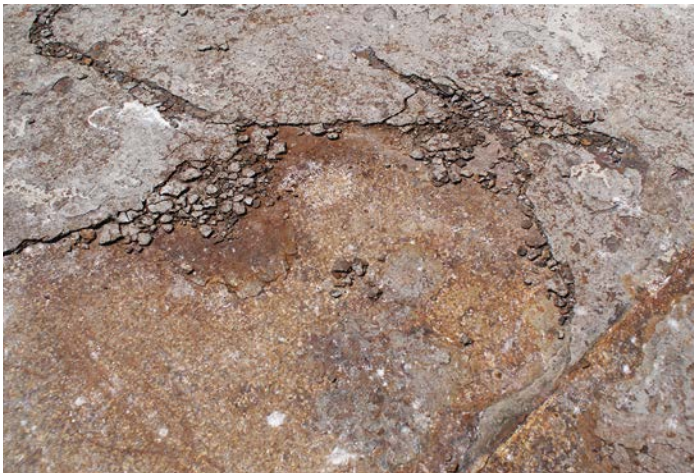
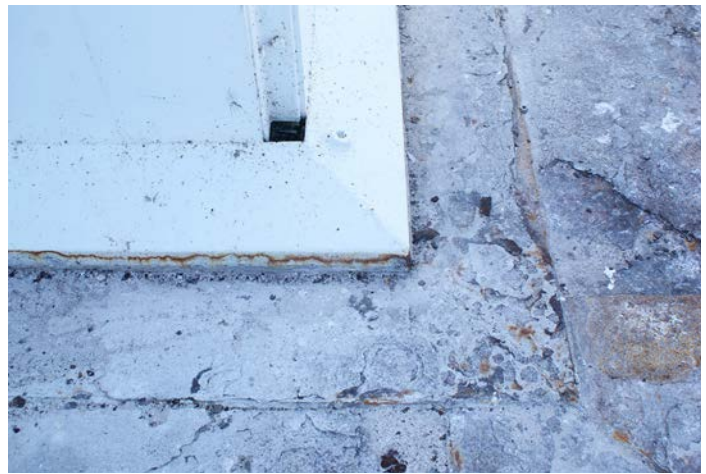
Figure 1D-92 Deteriorated surface condition of the steel deck plate at the Watch Deck.

Figure 1D-93 Deteriorated surface condition of the steel deck plate at the Watch Deck.

This deck surface is also covered with steel plate, similar to the Pier Deck. Paint and other waterproof coatings applied to this steel plate surface are in very poor condition, as seen in [Figures 1D-92 and 1D-93](#), where the deck surface meets the tower walls. Rust on the surface of the steel plate is also present. Significant roof leaks into the space below are attributed to the poor condition of this deck surface and possibly the structure underneath. The condition of the concrete surface below the steel plate will not be known until the steel plate is removed. A flat metal coping 1 foot - 4 inches wide all around the perimeter is slightly raised above the deck surface and forms the base for the guardrail posts. This coping appears to be in good condition and was recently painted. A somewhat unique construction feature of this roof structure/roof deck is that it slopes from

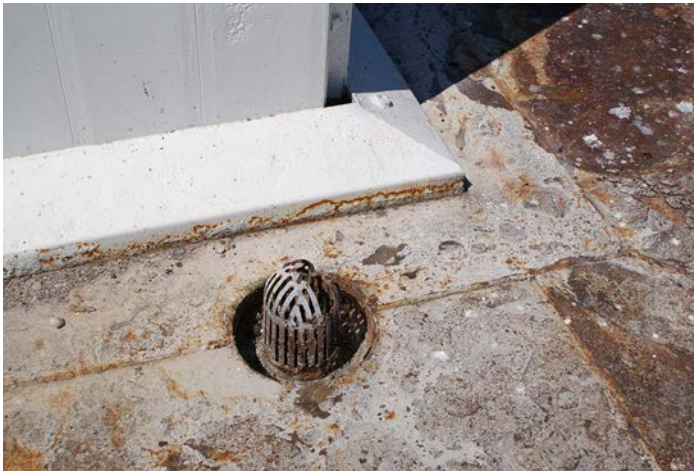
Figure 1D-94 One of two roof drains on the Watch Deck.

the outermost edge back to the tower where two roof drains are located, one near the east corner and one near the west corner. A roof drain is seen in [Figure 1D-94](#). It was reported that these drains were plugged with debris and non-functional, but were cleaned as part of the recent exterior restoration work and now appear to be working properly.

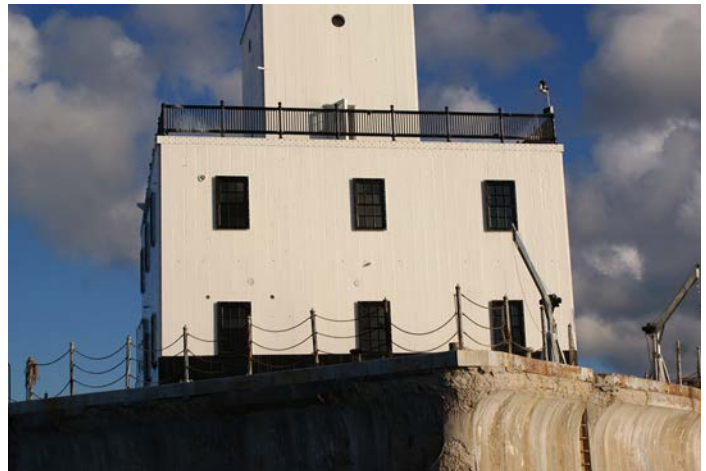
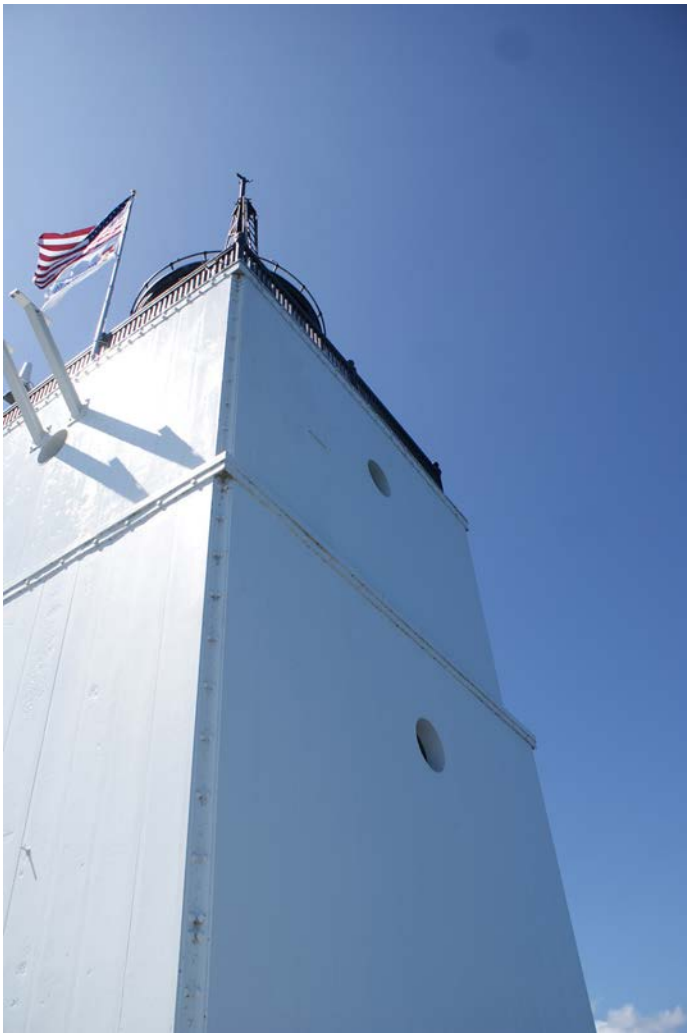
Figure 1D-95 View of recently restored exterior wall surfaces.

Figure 1D-96 View of recently restored exterior wall surfaces.

The exterior walls of the structure above the concrete base are steel C-channels bolted together. The exterior face of all walls was restored and painted in 2017-2018 as part of the initial restoration work. All walls, including the paint, are in very good condition. Views of the exterior walls are seen in many previous photographs and in [Figures 1D-95 and 1D-96](#).

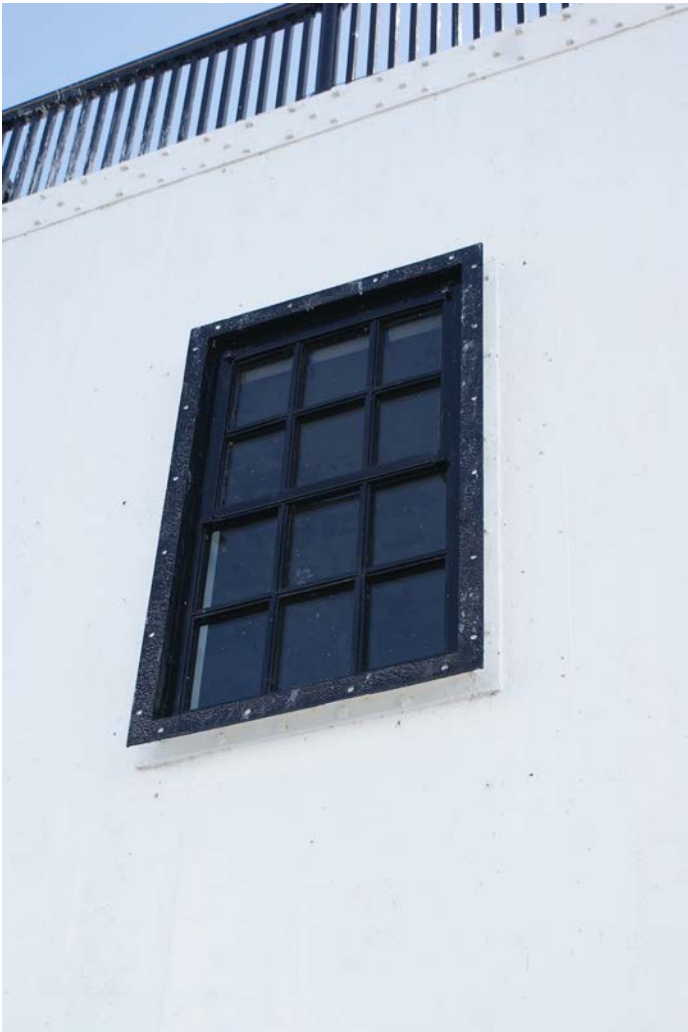
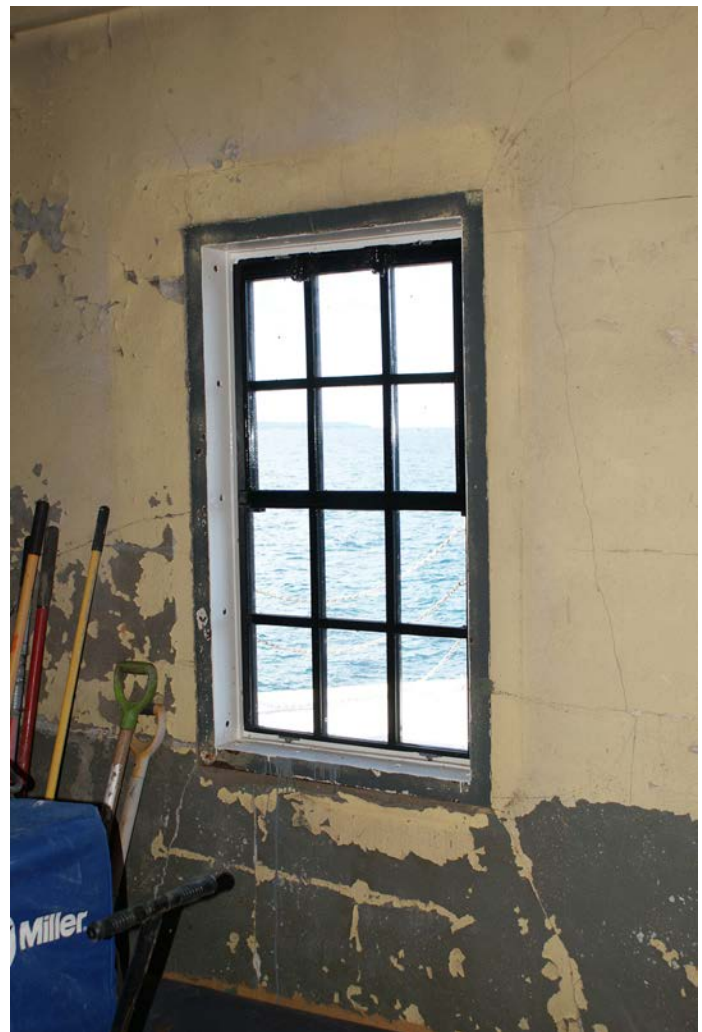
Figure 1D-99 Exterior view of a typical metal window.

Figure 1D-100 Interior view of a typical metal window.

the exterior, [Figure 1D-99](#), and from the interior, [Figure 1D-100](#). All windows have been restored as part of the initial exterior restoration work. Restoration included removing all glass, blasting of all metal surfaces to white metal, prime and finish paint coats and replacement of glass. New glass was installed where existing glass was broken or missing. At three window locations on Level 1, temporary plywood panels are in place at the window opening, [Figure 1D-101a](#), and the restored window sashes are stored in the Boat Room on Level 1, as seen in [Figure 1D-101b](#). A steel plate covers one window opening on the southwest face. The steel C-channel that forms the window frame is also seen in [Figure 1D-101a](#). Two slightly smaller windows of the same type are located on either side of the main entry door into the structure on Level 1. These 6/6 units measure 2 feet 3 inches wide by 4 feet 4 inches high, refer to [Figure 1D-102](#).

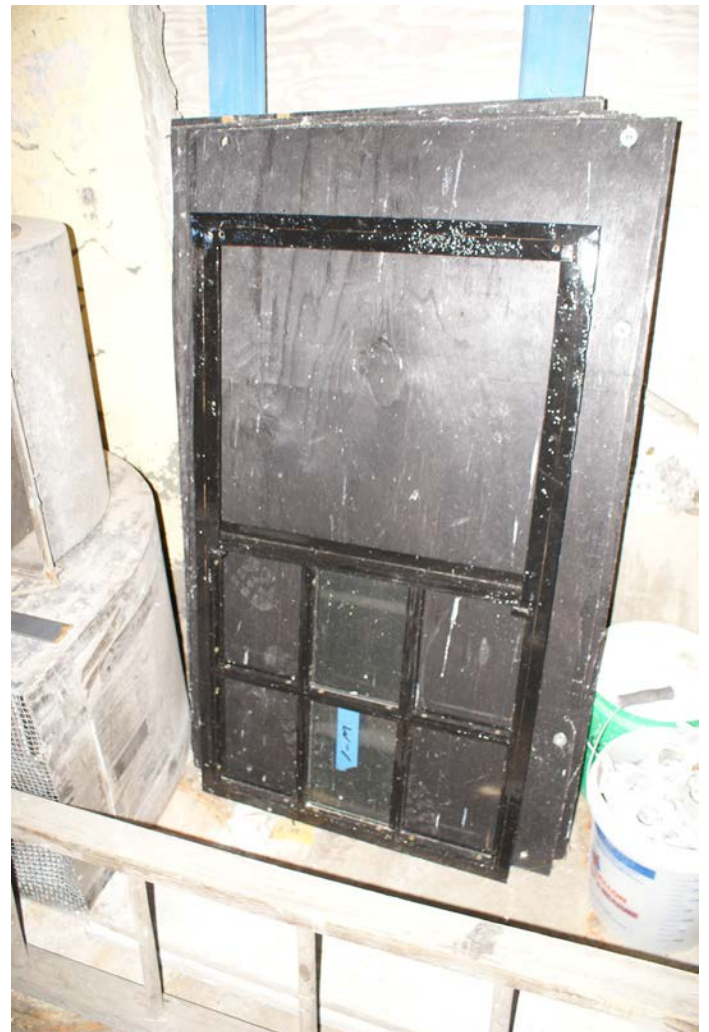
Figure 1D-101b Metal window stored inside to be installed.

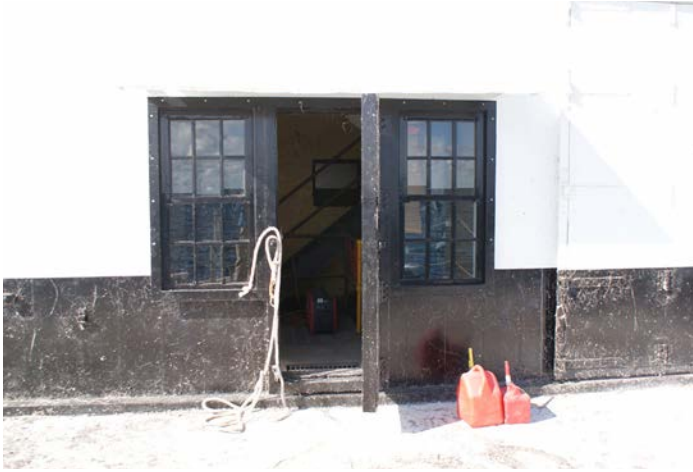
Figure 1D-102 Metal windows flanking the tower entry door at the Pier Deck.

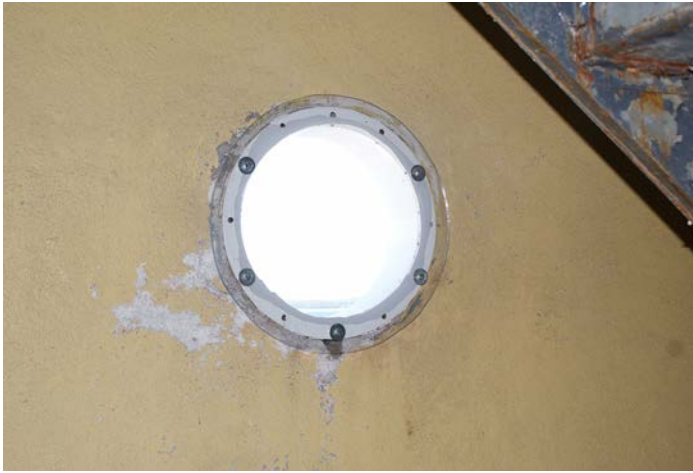
Figure 1D-103 Interior view of a typical porthole window.

Porthole style windows are found in the upper tower at Levels 3, 4 and 5, typically one on each wall. The window opening measures 1 foot 4 inches in diameter. It is presumed that all porthole windows had the typical brass unit allowing the window to open and swing in, however all are missing. The window opening is covered with plexiglass screwed to the interior face as seen in [Figure 1D-103](#). A simple circular opening in the outside face of the steel wall panels frames the round opening, [Figure 1D-104](#).

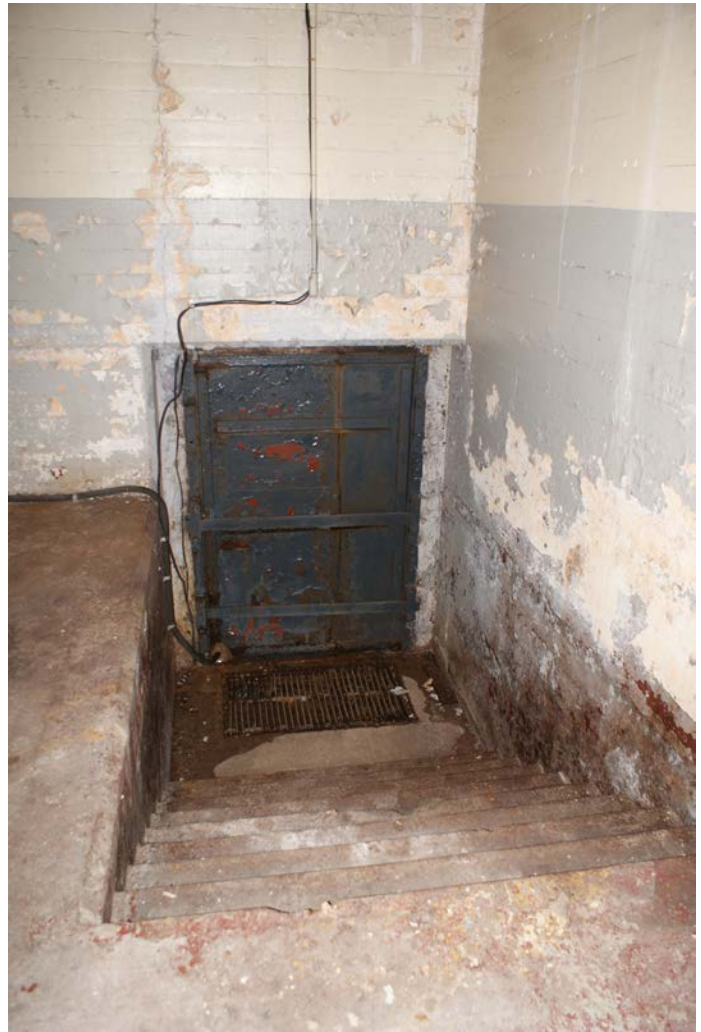
Figure 1D-105 Interior view of the metal sea door and interior concrete stair.

The sea door is a unique feature of the North Manitou Shoal Light Station only found in a few other crib-style structures. When it was operational, this door would have allowed the easy movement of personnel, equipment and supplies from boats onto the light station at water level. The landing inside the sea door is 4 feet 7 inches below the Basement level and is accessed by a small concrete stair as seen in **Figure 1D-105**. The door opening is 4 feet 6 inches wide x 7 feet high and is framed with a steel C-channel cast into the concrete structure. The door originally had two leaves, one 3 feet wide and one 1 foot 6 inches wide, but both leaves have been removed and the opening closed with steel plate welded to miscellaneous

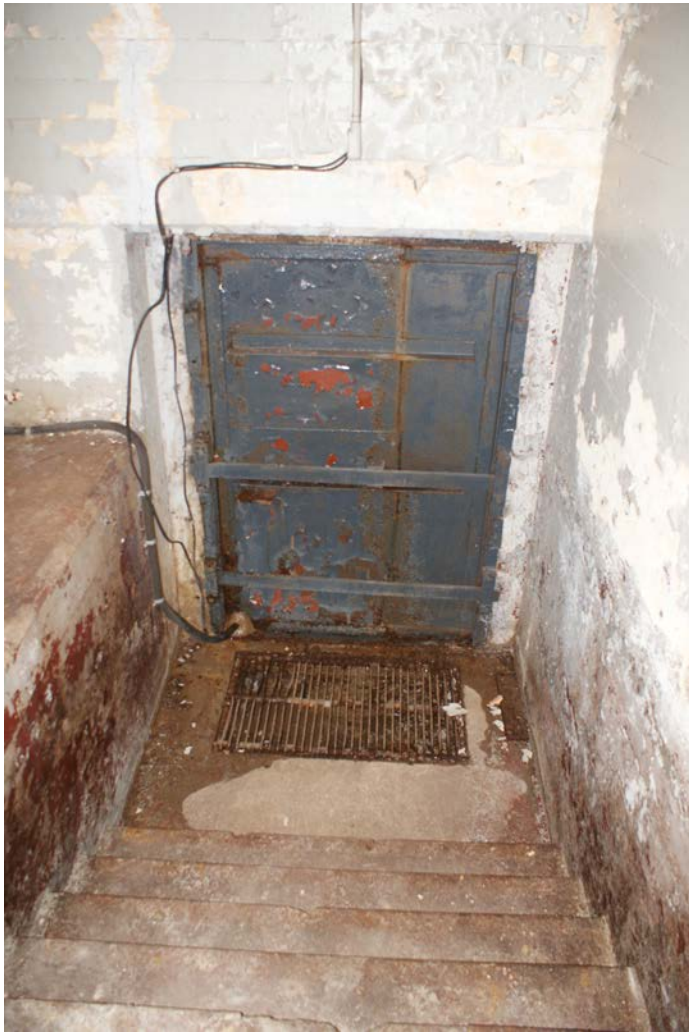
Figure 1D-106 View of landing and floor trench drain inside the sea door.

steel framing. An interior view of the door is seen in Figure 1D-106 and exterior views in Figures 1D-107 and 1D-108. Vertical steel pipe grab bars are fixed to the concrete walls on both sides of the door. A close-up inspection of these grab bars did not occur due to high waves, but they appear in fair condition. The 1 foot 6 inch wide door leaf is laying on the Basement floor, Figure 1D-109, near the sea door opening. The steel plate face is welded to a 3 inch wide steel angle frame. This door leaf is in poor condition.

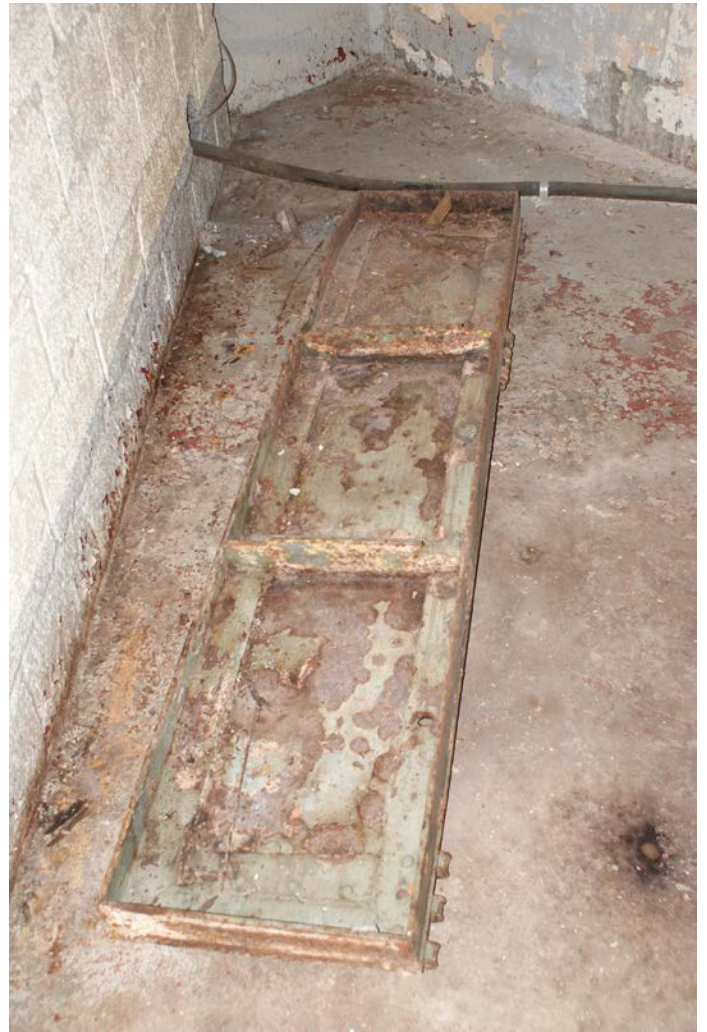
Figure 1D-109 Small door leaf of the sea door inside the basement.

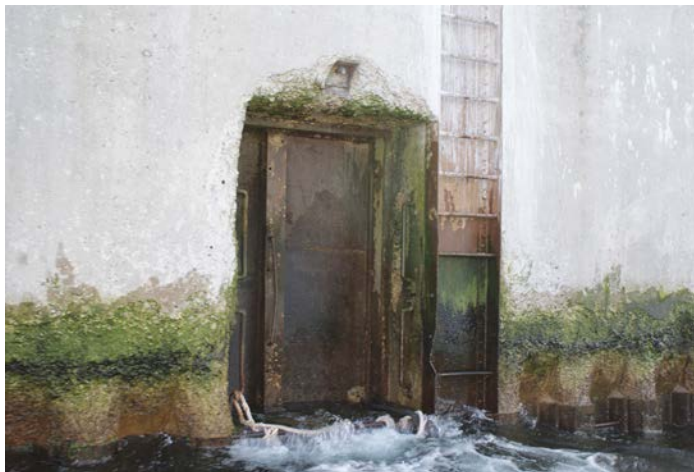
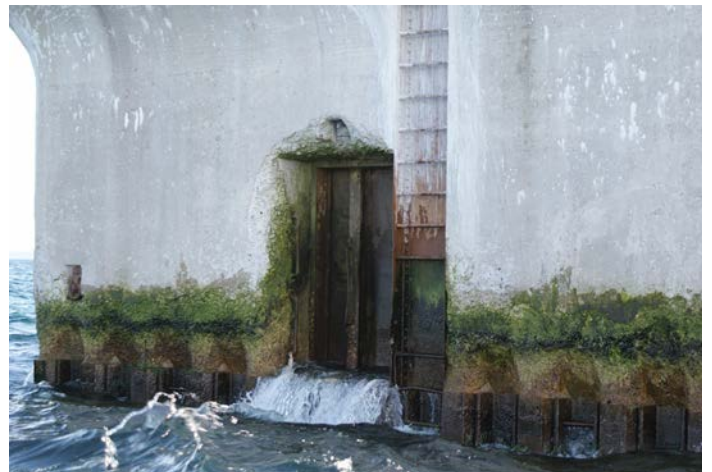
Figure 1D-107 Exterior view of the sea door on the north wall.

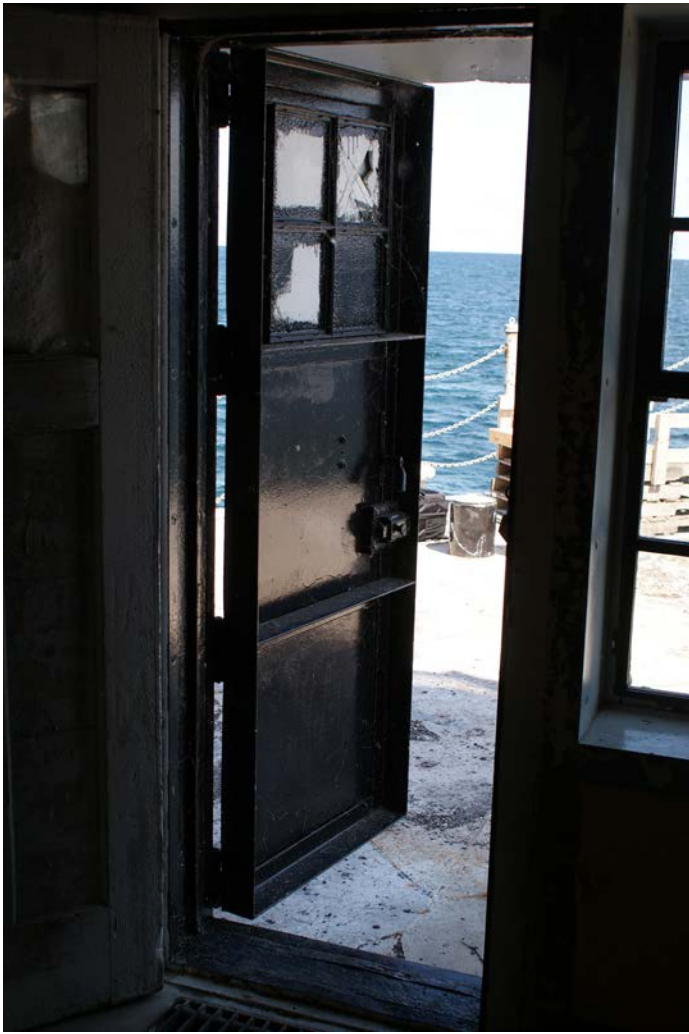
Figure 1D-110 Exterior, out-swinging metal door at entry from the Pier Deck.

four 10-inch x 10-inch glass lights in the upper portion of the door; one glass section is broken. This exterior door has been restored. The lever style hardware is in good operating condition. The in-swinging wood door, Figure 1D-111, is 1-¾ inch thick with two panels and a single 1'-8" x 1'-8" glass light. The glass is missing. The door and paint finish are in poor condition. Hardware consists of hinges and a lockset with cylindrical knob, all in poor condition. The door is bored for a deadbolt, which is missing.

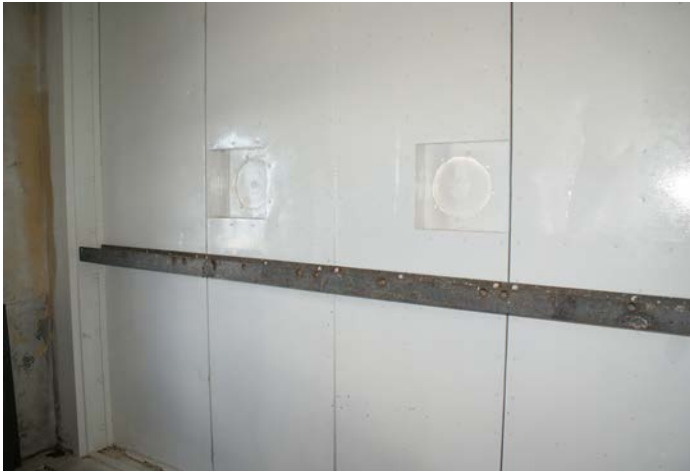
Figure 1D-113 Steel beam across the interior face of the Boat Room doors on the northeast wall.

1D-112. These doors have been secured by a steel beam bolted across the interior face, **Figure 1D-113**, and are non-operational. Two 10 inch diameter porthole windows are missing and covered with steel plate.

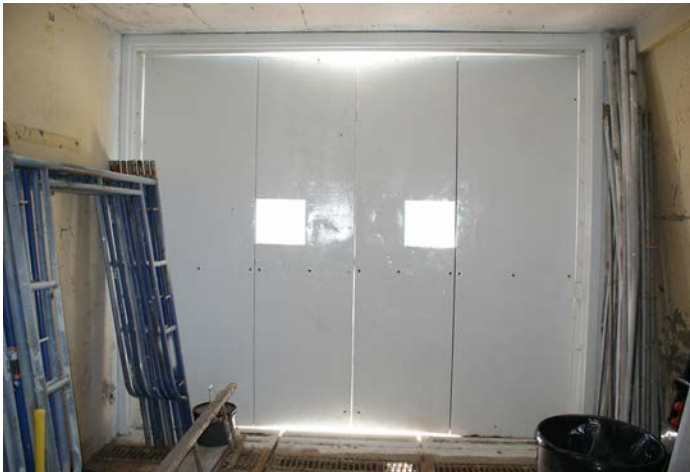
Figure 1D-114 Interior view of metal Boat Room doors on the southwest wall.

The Boat Room doors on the southwest wall are operational. The interior face is seen in **Figure 1D-114** and the exterior face in **Figure 1D-115**. The porthole windows are missing and are covered with plexiglass. Both sets of Boat Room doors have been painted as part of the recent restoration work and are in good condition. Door hardware includes large strap hinges and regular hinges and pull handles. One strap hinge on the door on the southwest wall is broken loose from the door leaf, as seen in **Figure 1D-116**. Some interior hardware to secure the doors appears to be missing.
