MANAGEMENT SUMMARY

Executive Summary

Current Conditions

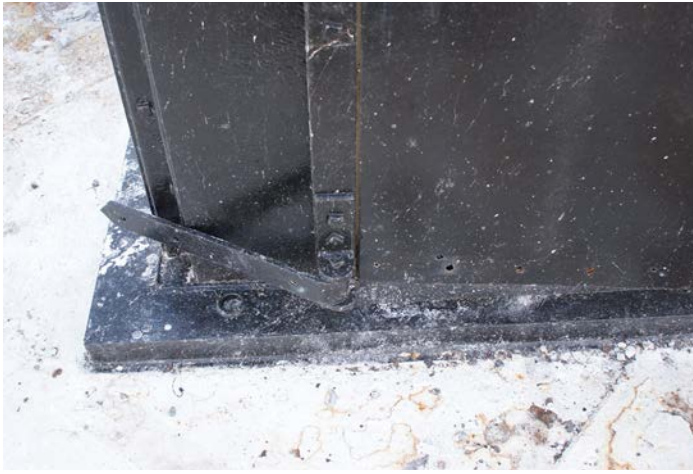
The Boat Room doors on the southwest wall are operational. The interior face is seen in **Figure 1D-114** and the exterior face in **Figure 1D-115**. The porthole windows are missing and are covered with plexiglass. Both sets of Boat Room doors have been painted as part of the recent restoration work and are in good condition. Door hardware includes large strap hinges and regular hinges and pull handles. One strap hinge on the door on the southwest wall is broken loose from the door leaf, as seen in **Figure 1D-116**. Some interior hardware to secure the doors appears to be missing.

Figure 1D-116 Damaged strap hinge on the Boat Room doors, southwest wall.

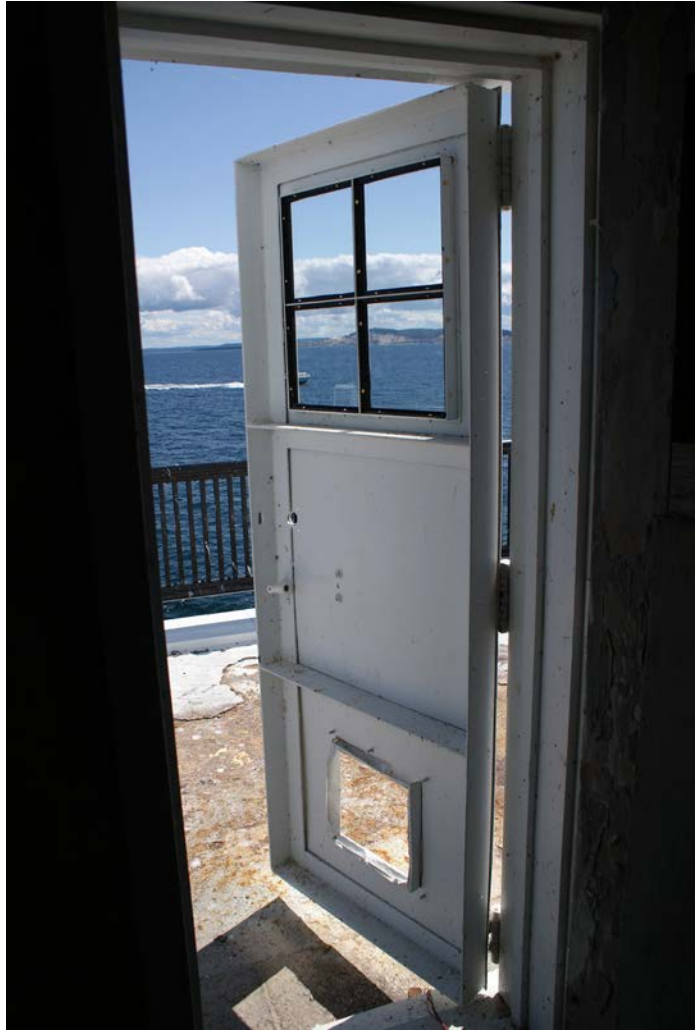
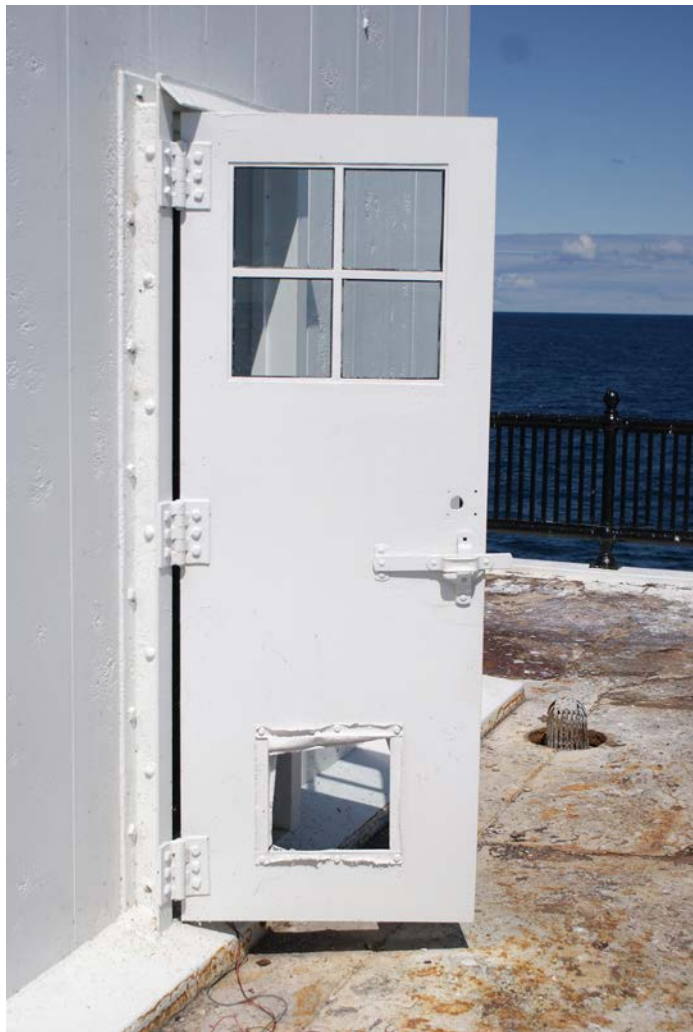
Figure 1D-117 Exterior metal door at the Watch Deck on Level 3.

The door at Level 3 on the southeast wall at the base of the tower that provides access onto the exterior Watch Deck also includes an in-swinging wood door and an outward-swinging storm door. The storm door is seen in **Figures 1D-117** and **1D-118**. This door is 2 feet 6 inches wide by 6 feet 8 inches high and is constructed of 1/8 inch steel plate and a 3-1/2 inch steel angle frame. There are four 10 inches by 10 inches glass lights at the top of the door and an opening for a ventilation louver near the bottom. The louver is missing. Hardware consists of hinges and a lever-type handle. Except for the missing louver, this door is in good condition. The in-swinging wood door is a 2 feet 6 inches wide by 6 feet 8 inches high x 1-3/4 inch thick two-panel door with a 1 foot 8 inches by 1 foot 8 inches glass light. This door is seen in **Figure 1D-119**. Hardware consists of hinges, a cylindrical lockset and deadbolt, **Figure 1D-120**. The door and hardware are in poor condition.

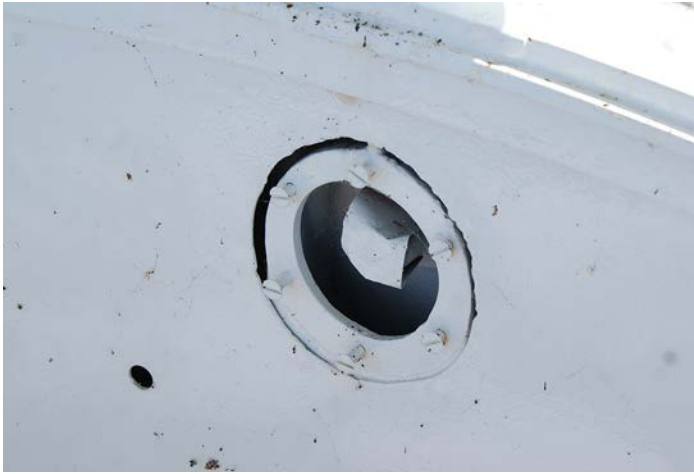
Figure 1D-124 Vent opening in the Lantern wall. The vent cover is missing.

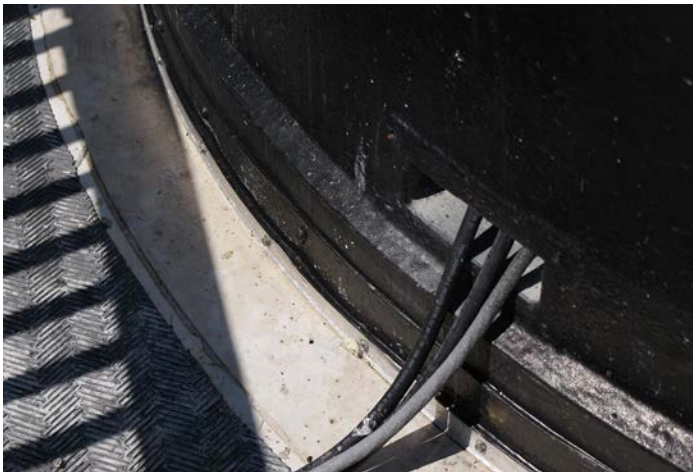
Figure 1D-136 Ventilation opening used as a wiring raceway.

openings at the base of the lantern are covered with metal screen. Based upon the presence of screw holes, metal hoods, similar to those on the upper wall, may have once covered these openings. A typical ventilation opening is seen in Figure 1D-135. One ventilation opening at the base of the Lantern is used as a wiring raceway. Refer to Figure 1D-136.

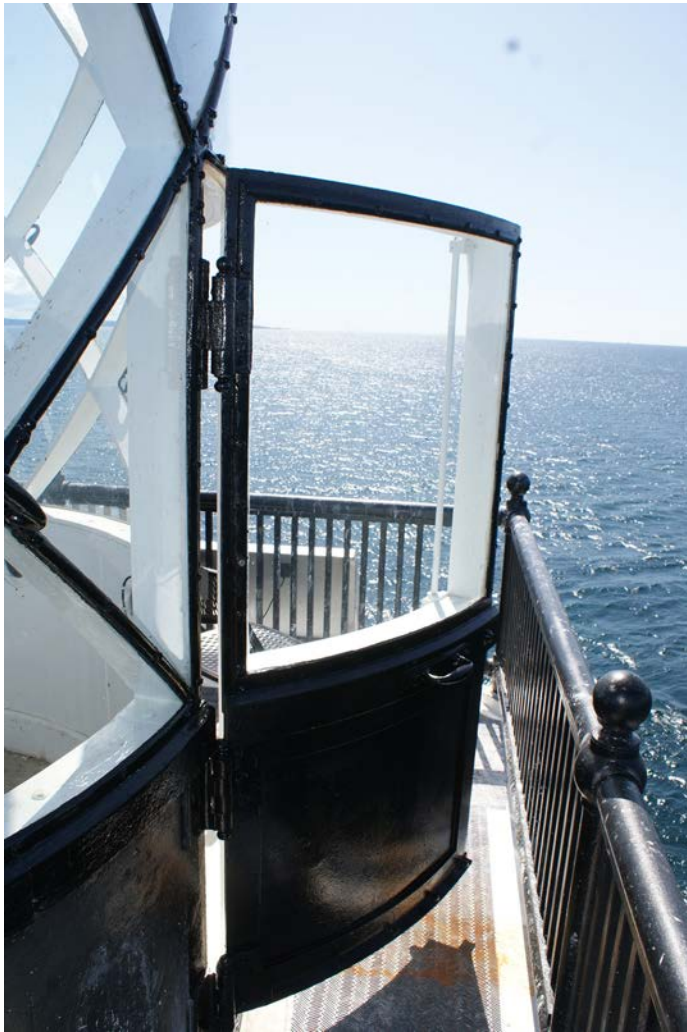
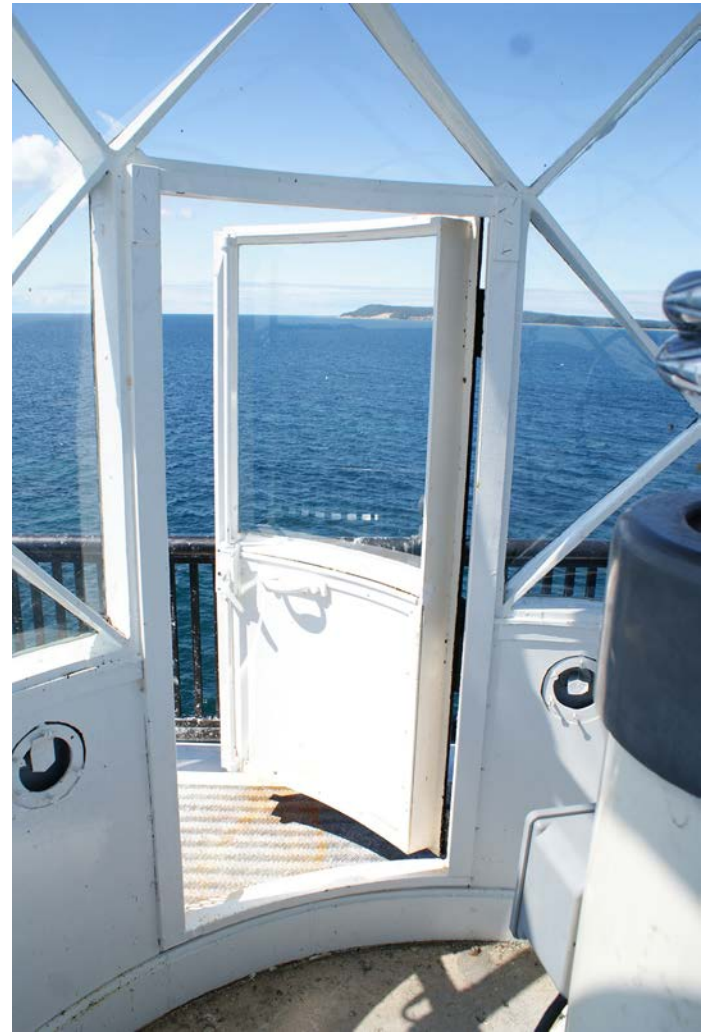
Figure 1D-137 Exterior view of metal door from Lantern to the Lantern Deck and metal guardrail.

A 2 feet 4 inches wide by 5 feet 4 inches high curved metal door, with a single panel of curved glass provides access from the Lantern to the Lantern Deck. This door is seen in Figures 1D-137 and 1D-138. The door and hardware are in very good condition, however, it was not possible to adequately lock the door and it is secured by a heavy strap fastened to the stair.

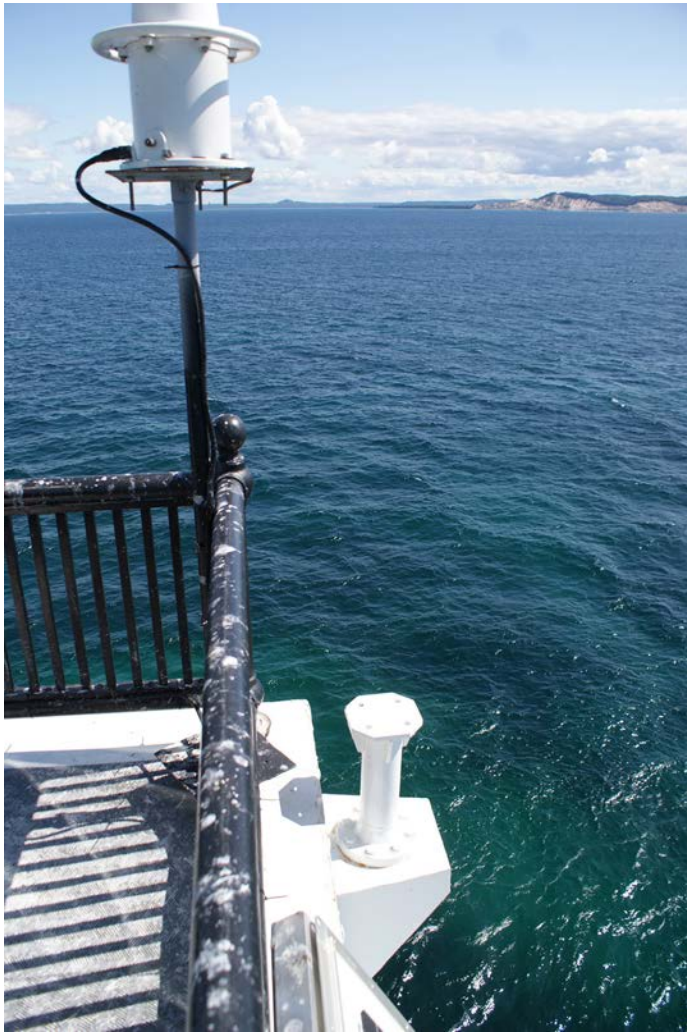
Figure 1D-143 Unused metal bracket for previous navigation equipment.

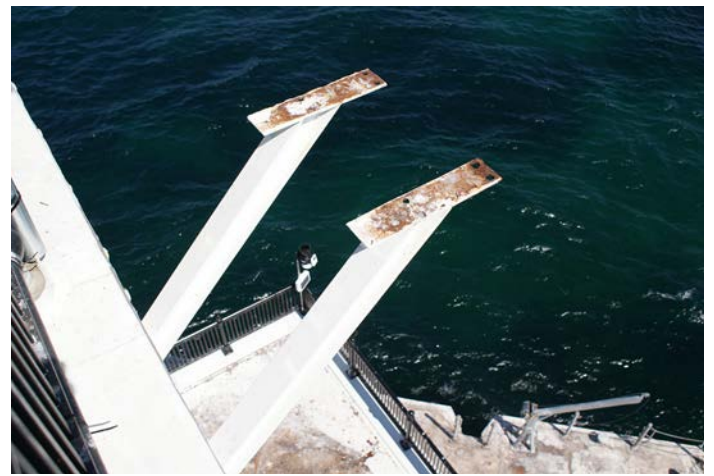
Figure 1D-144 Unused metal beams for previous equipment mounting.

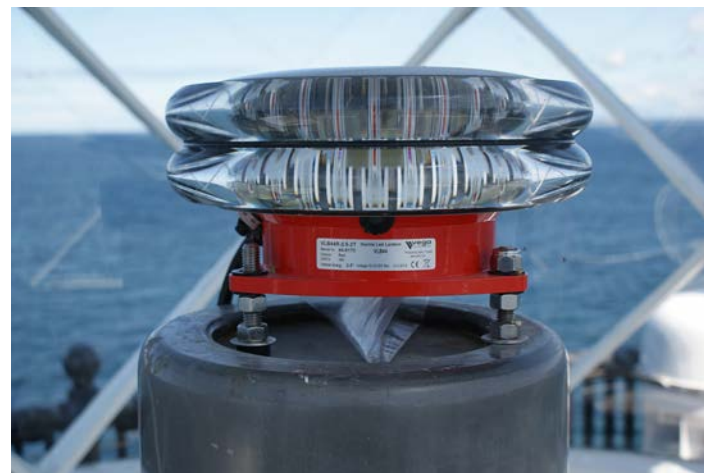
Figure 1D-145 VEGA Marine LED navigation light.

The active navigation light is a VEGA Marine LED Lantern #VLB44R-2.5-2T. This light, [Figure 1D-145](#), is mounted on a small pedestal that rests on a 9 inch square steel pedestal, as seen in [Figure 1D-146](#).

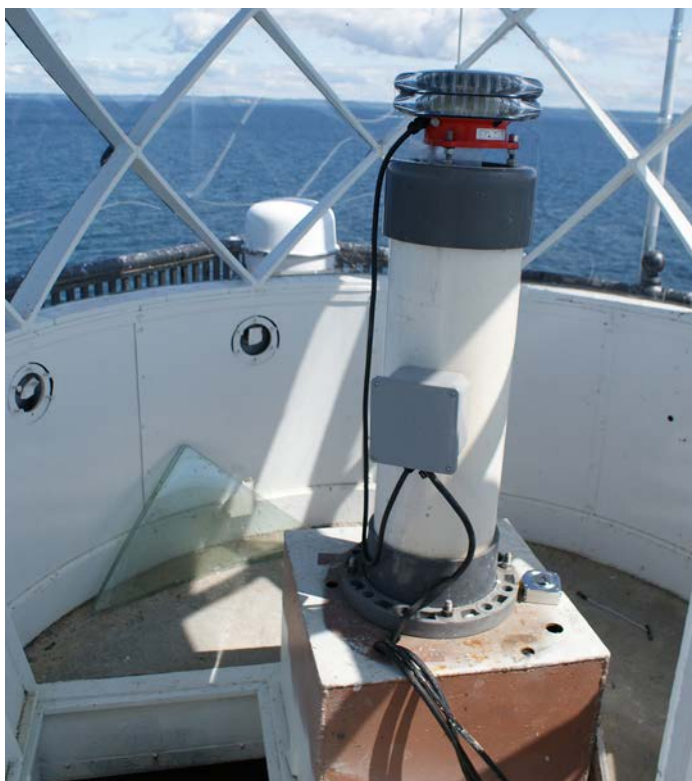
Figure 1D-146 Navigation light and pedestal base.

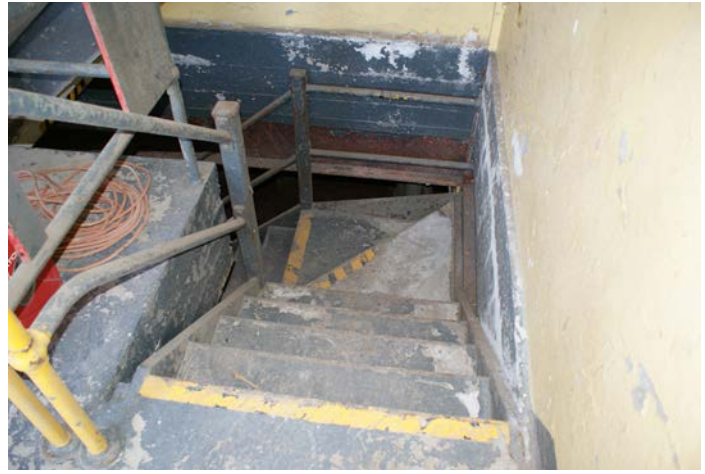
[Figure 1D-147](#) Upper run of stairway to Basement.

construction is metal pan with concrete treads and landings with steel C-channel stringers. The stair has 1-5/8 inch O.D. steel pipe railings and 3 inch square steel newel posts. The upper section of the stair, at Level 1, is seen in [Figure 1D-147](#), and a view down the middle run is seen in [Figure 1D-148](#). The stair terminates in the Basement in a large open equipment room, seen in [Figures 1D-149 and 1D-150](#). All components of the stair are in good condition; the paint finish is in poor condition.

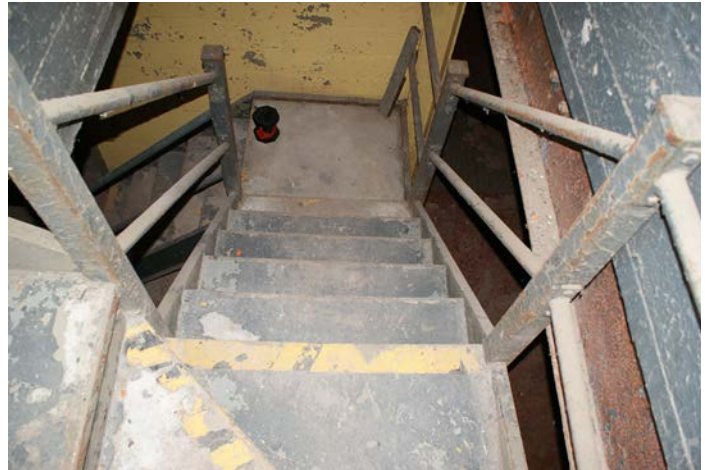
[Figure 1D-148](#) Lower run of stairway and landings to Basement.

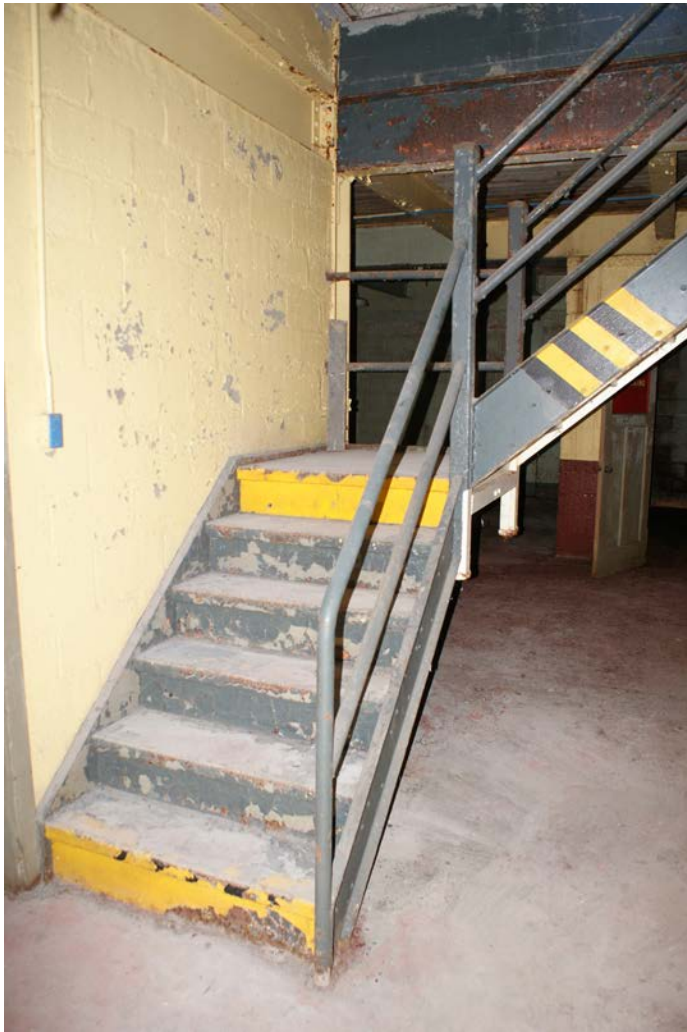
Figure 1D-149 Lower run of stairway at Basement.

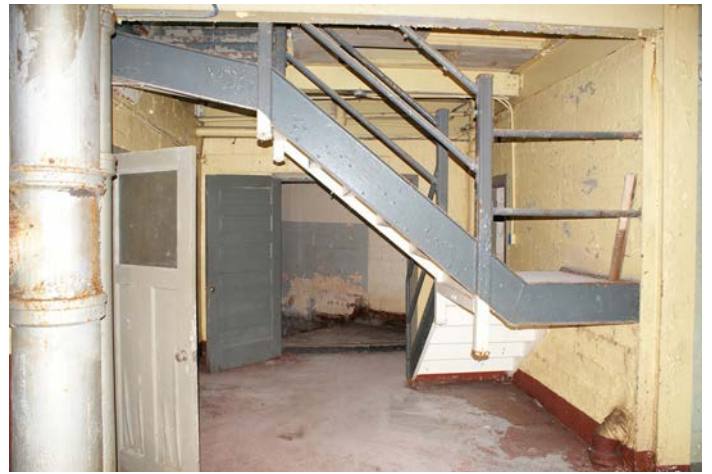
Figure 1D-150 View of open stair and open space in Basement.

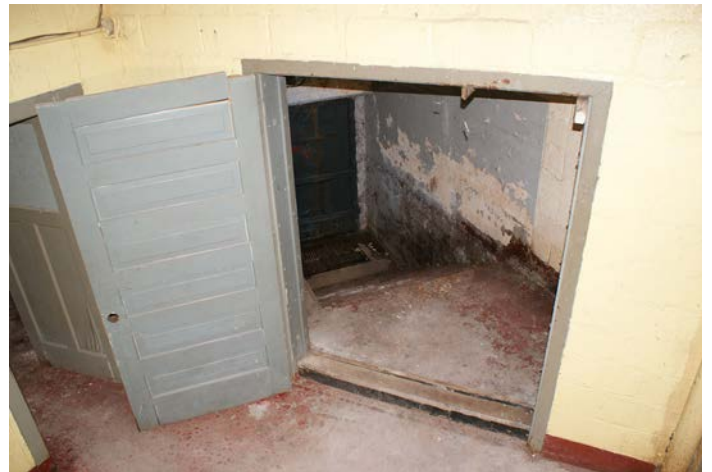
Figure 1D-151 Door leading into room at the sea door.

At the base of the stair there is a 5 feet 4 inches wide by 6 feet 10 inches high door opening that leads into the sea door access room. This door opening is seen in Figure 1D-151. There is one six-panel wood door 3 feet 4-½ inches wide by 6 feet 10 inches high by 1-¾ inches thick in place; a second smaller leaf is missing. The door knob and latchset are missing; the door and paint finish are in poor condition.

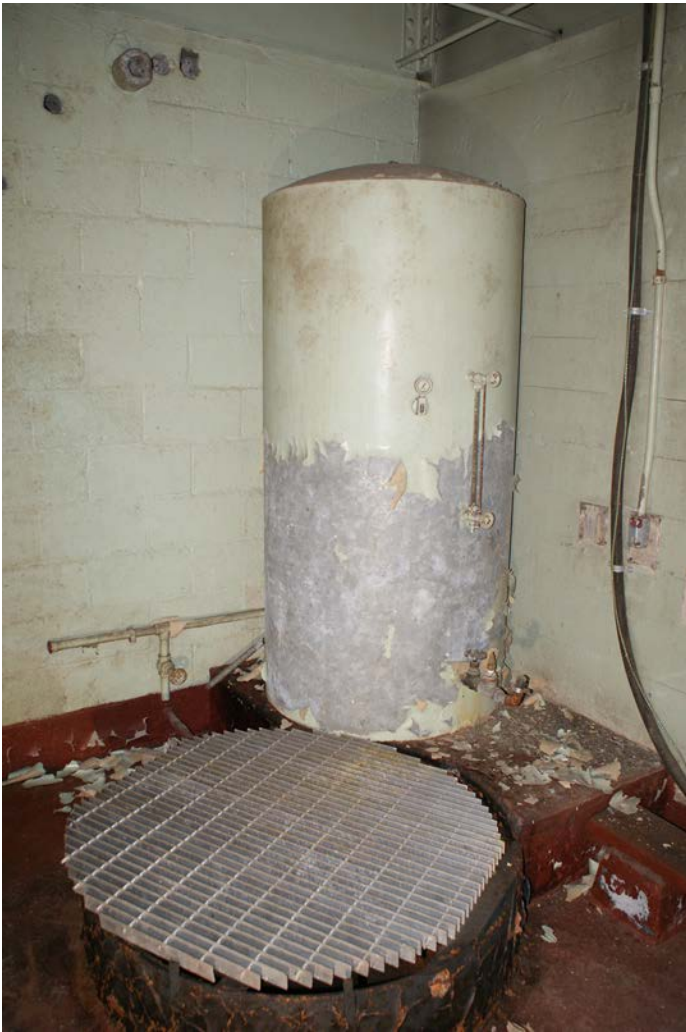
Figure 1D-152 Water tank in the Water Room.

Adjacent to this room is a small room where the water well and a water storage tank are located, as seen in Figure 1D-152. This room is also identified as a laundry room on some original drawings. The water well is a 4 feet diameter opening in the floor covered with a steel grate mounted to a circular steel frame that rises one foot above the floor. Refer to Figure 1D-153. At the time of this site inspection, open water in the well was observed approximately 4 feet 10 inches below the basement floor level. The water storage tank is on a 12 inch high raised concrete pad. The poor condition of the painted concrete floor surface is seen in these photographs.

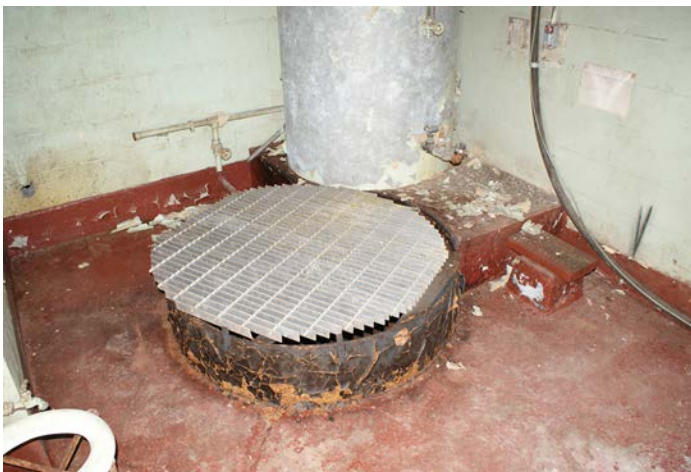
Figure 1D-153 Steel grate cover over the open water well in the Water Room.

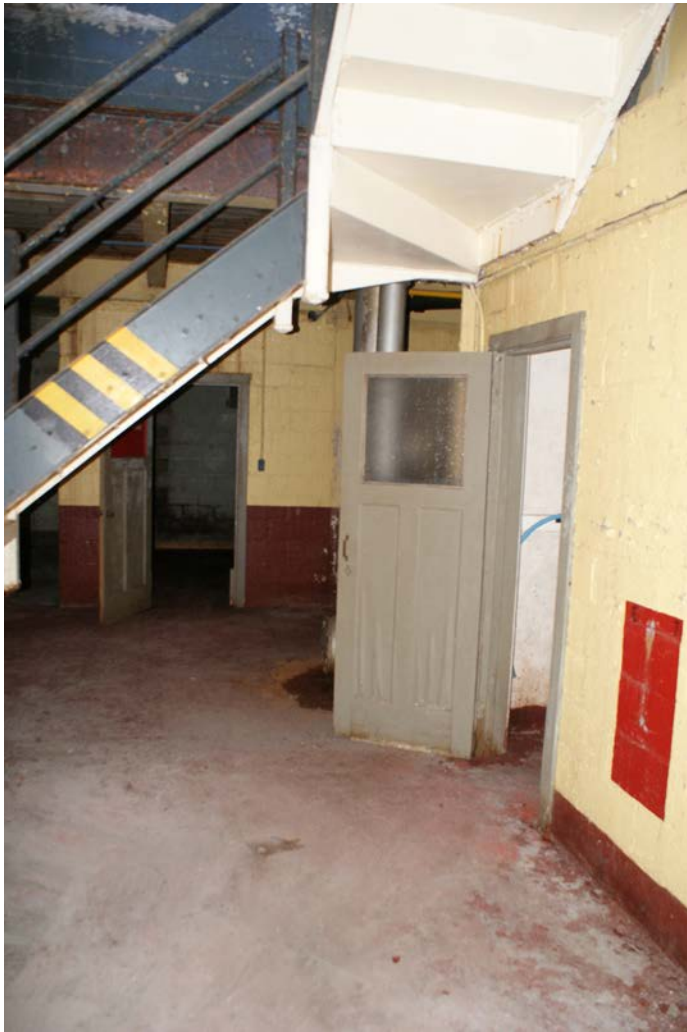
Figure 1D-155 Bathroom door with glass panel.

A corner of this Laundry Room has been partitioned off to form a small, 4 feet by 5 feet Bathroom. These walls are 3-½ inch wood studs with a plaster finish on each side. Plumbing piping indicates where the fixtures were placed but all plumbing fixtures are missing, as seen in Figure 1D-154. The wood door into this small Bathroom, seen in Figure 1D-155, is a 2 feet 6 inches wide by 6 feet 8 inches high by 1-3/8 inches thick two-panel door with a large glass light. The door and paint finish are in poor condition.

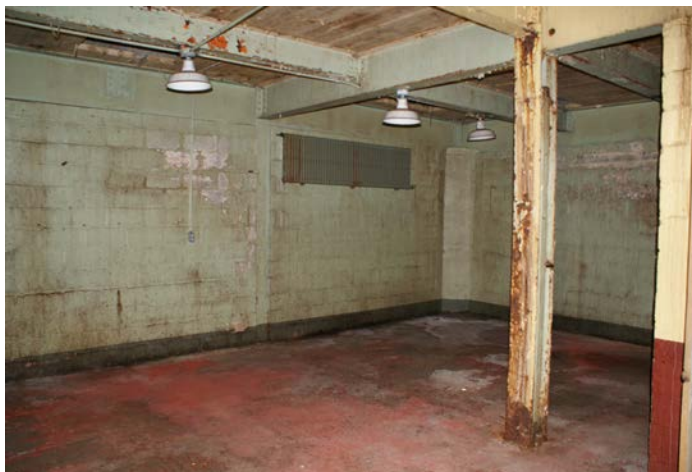
Figure 1D-156 General open rooms in the Basement.

Other large open rooms are seen in Figures 1D-156 and 1D-157. Paint finishes are in generally poor condition throughout. A 2 feet 8 inches by 6 feet 8 inches by 1-3/8 inches thick wood door with 2 panels and a large glass light leading into another small room is seen in Figure 1D-158.

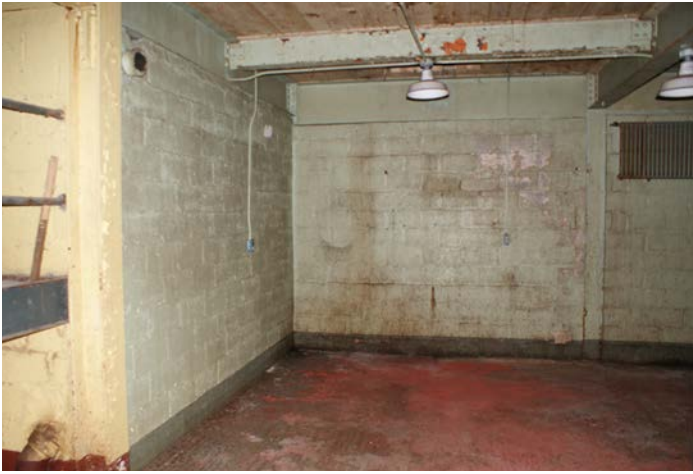
Figure 1D-157 General open rooms in the Basement.

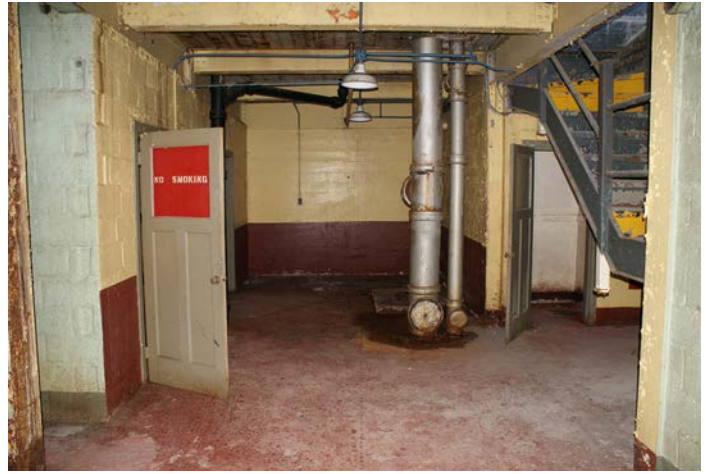
Figure 1D-158 Wood door and general view of Basement.

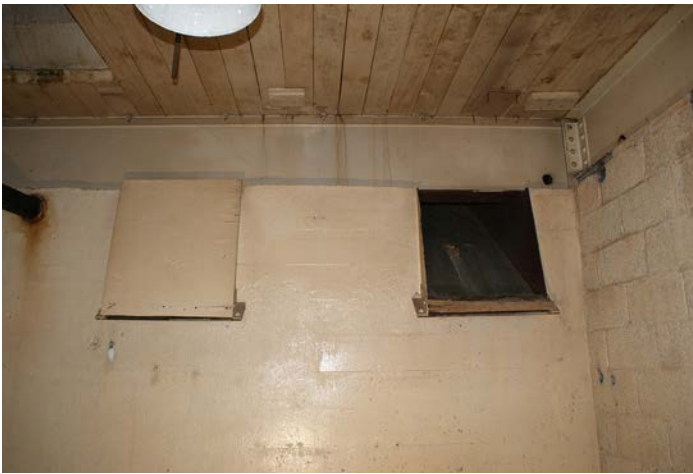
Figure 1D-159 View of the Coal Room and coal chutes.

In the west corner of the Basement there is one room that measures 11 feet 10 inches by 11 feet 6 inches and was formerly the Coal Room. Interior walls are constructed of 8 inch thick concrete masonry units. Two coal chutes are located in the northwest wall as seen in [Figures 1D-159](#) and [1D-160](#) that extend down from manholes in the Pier Deck. A 2 foot diameter manhole is also located in the opposite corner. A view of this manhole is seen in [Figure 1D-161](#). These manholes and covers are not visible from the Pier Deck because of the steel plate that covers the entire surface of the deck and are presumed to be in poor condition. A 2 feet 8 inches by 6 feet 8 inches door opening leads into the Coal Room, but the door is missing.

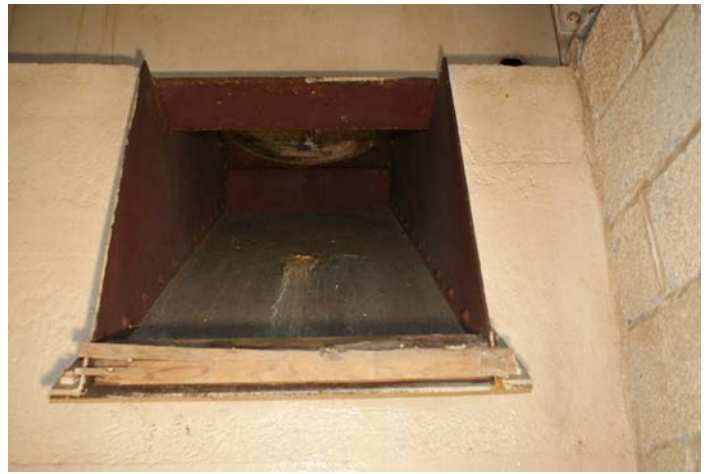
Figure 1D-160 View of a coal chute and partial view of the hatch cover at the Pier Deck.

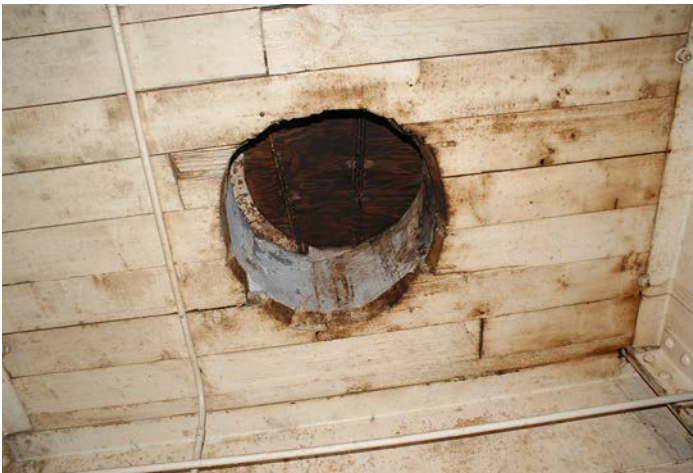
Figure 1D-161 View of the underside of a second manhole hatch from the Pier Deck.

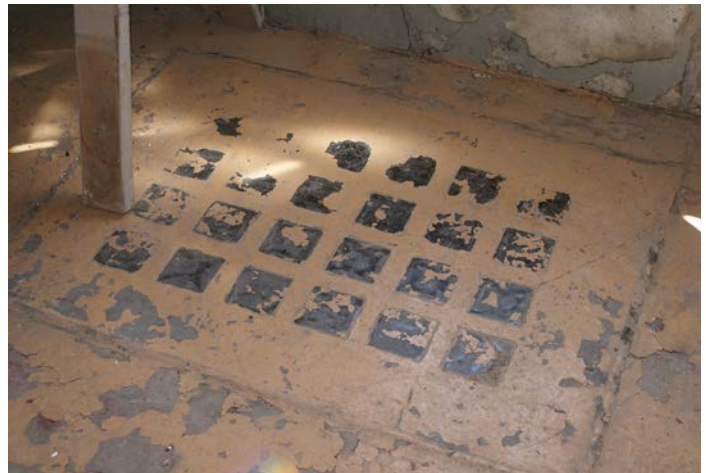
Figure 1D-162 Precast concrete and 24 glass block deck light as seen from Level 1.

that is cast into the concrete floor structure. The deck lights are located below the windows on Level 1 allowing light to filter into the basement for natural daylighting. The deck lights have different configurations with 16, 24 and 64 individual glass blocks. The glass blocks are 3-½ inches square. A 24 glass block unit is seen from above, [Figure 1D-162](#), and from below, [Figure 1D-163](#). The large 64 glass block unit deck light is located near the main entry door, as seen in [Figure 1D-164](#), and allows light to filter around the Basement stair. A 16 unit deck light is seen in [Figure 1D-165](#). The deck lights appear to be in fairly good condition, however, some individual glass blocks are damaged.

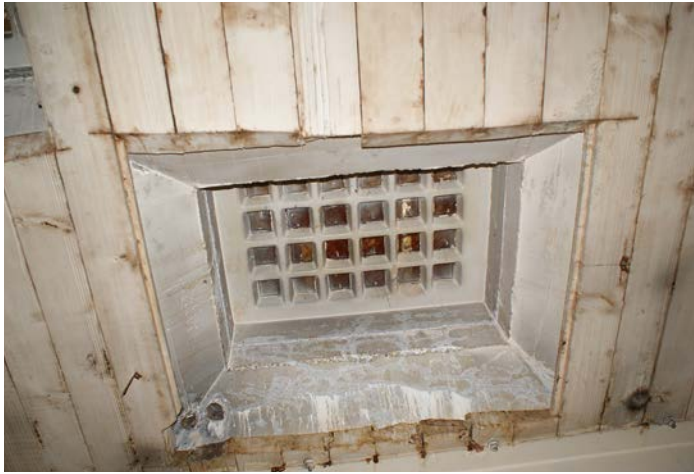
Figure 1D-163 Underside of a deck light as seen from the Basement.

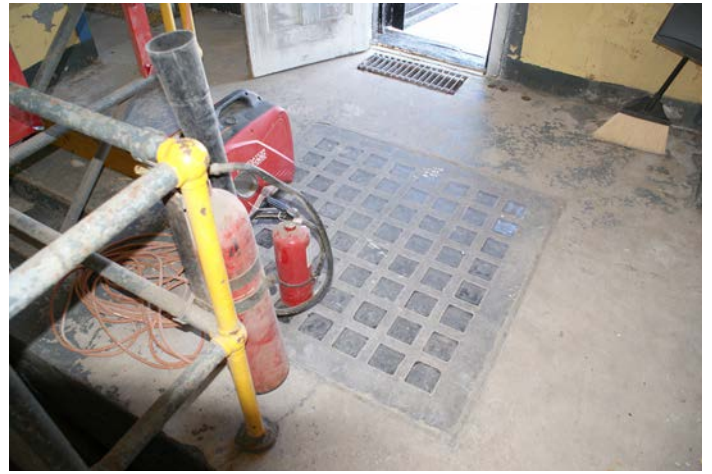
Figure 1D-164 Large deck light adjacent to the main entry door at Level 1.

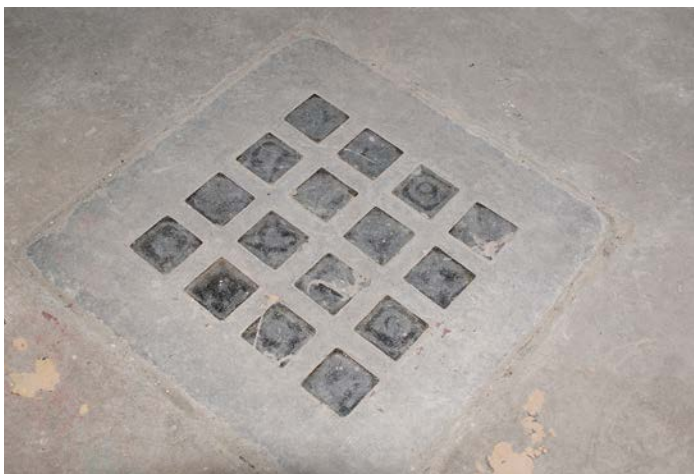
Figure 1D-165 Smaller deck light with 16 glass blocks.

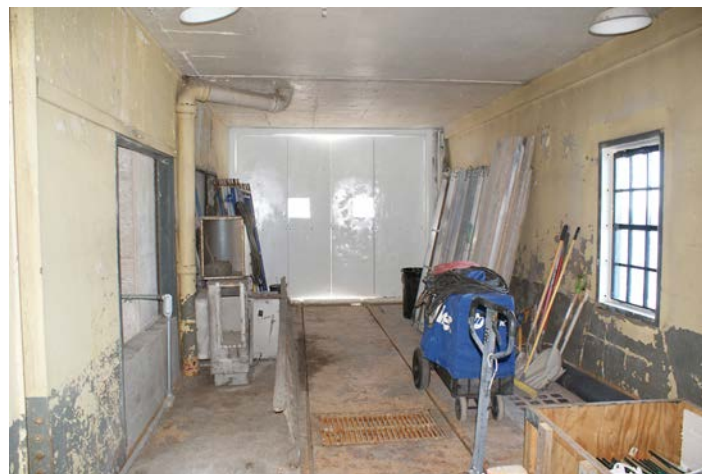
Figure 1D-166 View of the Boat Room on Level 1.

Views of the Boat Room are seen in [Figure 1D-166](#) and [1D-167](#). A 7 inch thick by 2 feet high poured concrete wall was constructed across the entire width of the Boat Room at the north end, as seen in [Figures 1D-167](#) and [1D-168](#). A 7 inch thick by 2 feet high concrete wall was also constructed across two 5 feet 6 inches wide by 6 feet 10 inches high door openings, as seen in [Figure 1D-169](#). The doors have been removed. It is not known when the second large opening into the Boat Room was created, but this opening, located near the south corner of the room, does not appear on the original building plans. The opening is rough cut into the concrete wall with no casing or trim. The top of the opening is seen in [Figure 1D-239](#), to the right of the roof drain lines. These walls were constructed for spill containment when the station was automated in 1980, and a 10,000 gallon diesel tank was placed in the Boat Room to power the generators during winter.

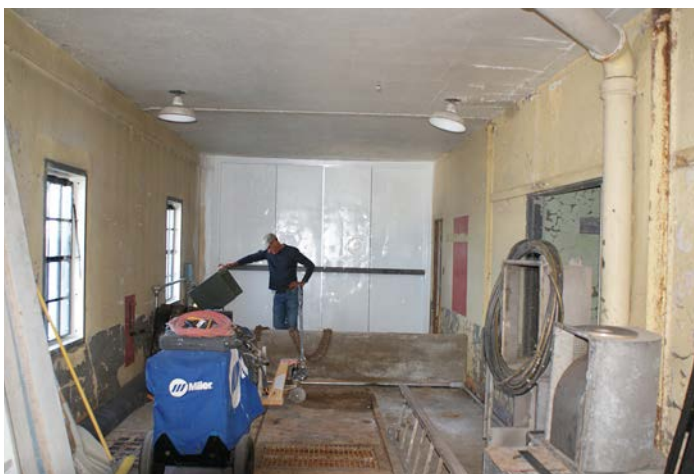
Figure 1D-167 View of the Boat Room on Level 1.

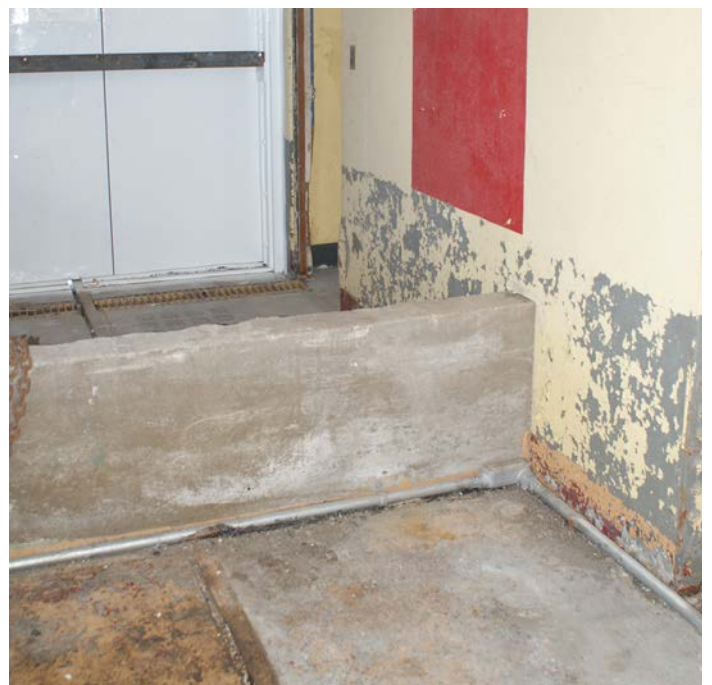
Figure 1D-168 Poured concrete containment wall in the Boat Room.

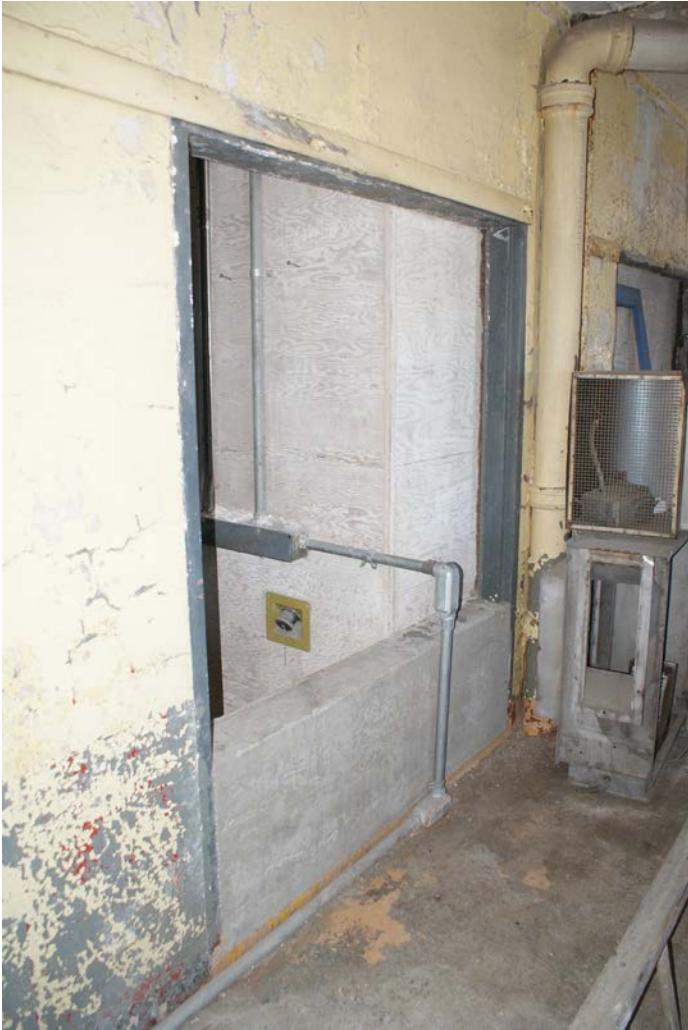
Figure 1D-169 Poured concrete containment wall across a door opening leading to the Boat Room.

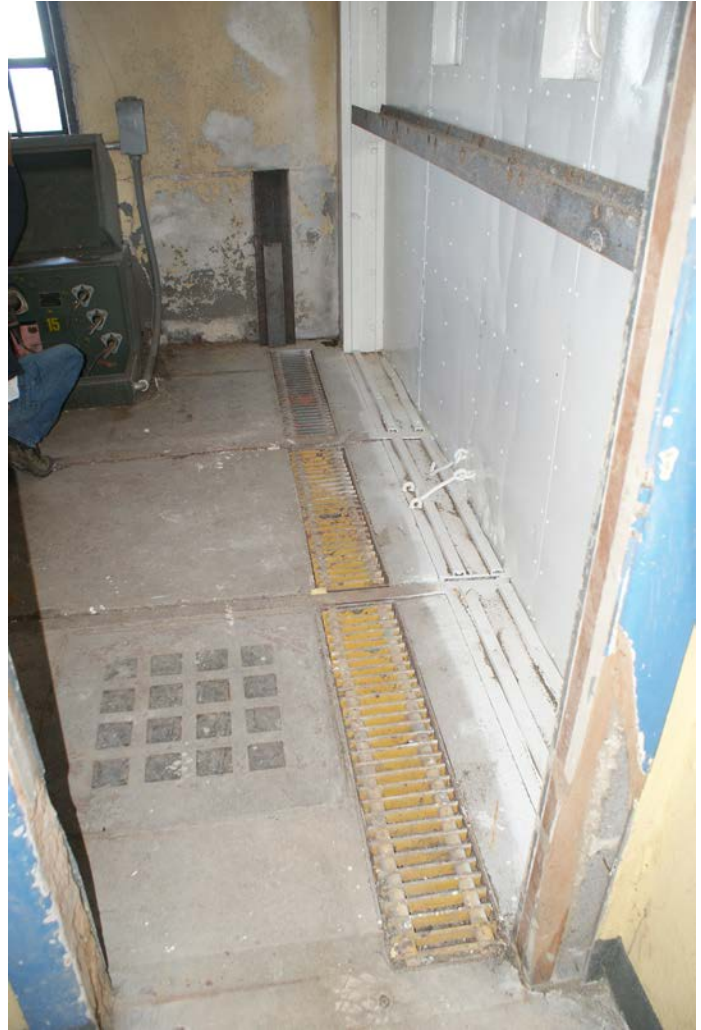
Figure 1D-170 Trench drain across the Boat Room door opening with adjacent deck light.

A large floor drain is located at each exterior door, [Figure 1D-170](#). One of the deck lights previously discussed is also seen in this photograph. Two 2-¼ inch wide embedded steel angles spaced 3 feet 6-½ inches apart for a track for a boat cart run the length of the room. Refer to [Figure 1D-171](#). Original drawings indicate that these boat rails extend out onto the Pier Deck, however, the steel plate conceals this condition. An electric transformer, to be discussed later in this report, is located at one end of the room. The floor in the Boat Room is concrete with a paint finish. The concrete substrate is in reasonably good condition; all paint finishes are in poor condition. Walls and ceiling are cement plaster and are in fair condition. The ceiling height in the Boat Room is 9 feet 9 inches.

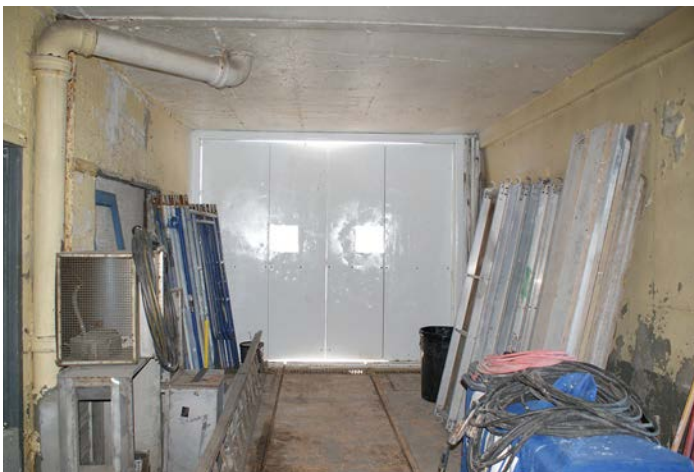
Figure 1D-171 View of the steel angle boat rails in the floor of the Boat Room.

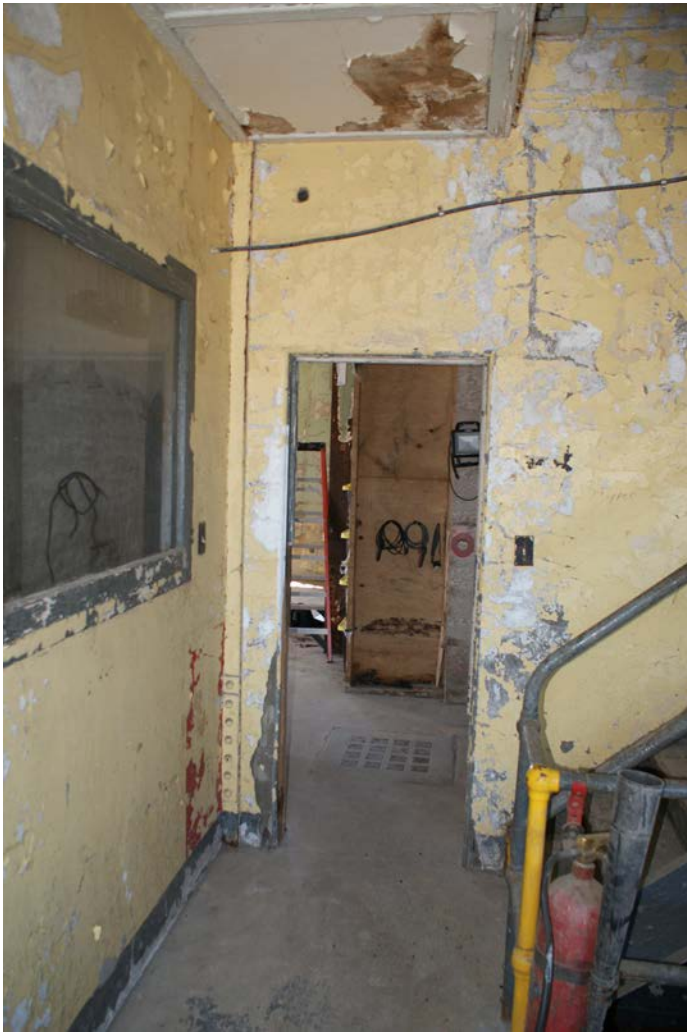
Figure 1D-172 View of door opening and main entry room at Level 1.

The Entry contains the stairs to the Basement and to the living quarters on the second level. Views of this room are seen in [Figures 1D-172 and 1D-173](#). The stairs are seen in [Figure 1D-174](#). A steel pipe guardrail protects the stair opening. A 4 feet wide by 3 feet 1 inches high borrowed light is located on one interior wall, [Figure 1D-175](#). There are two door openings from this room, both 2 feet 6 inches wide by 6 feet 8 inches high. The doors are missing. Two walls are 5-½ inch thick wood stud walls with a plaster finish; the wall common with the Boat Room is a concrete wall. Previously discussed, there is a large deck light in the floor of this room. The plaster surface is in poor condition and all paint finishes are in poor condition. There are some painted wood ceiling panels in this room that are also in poor condition.

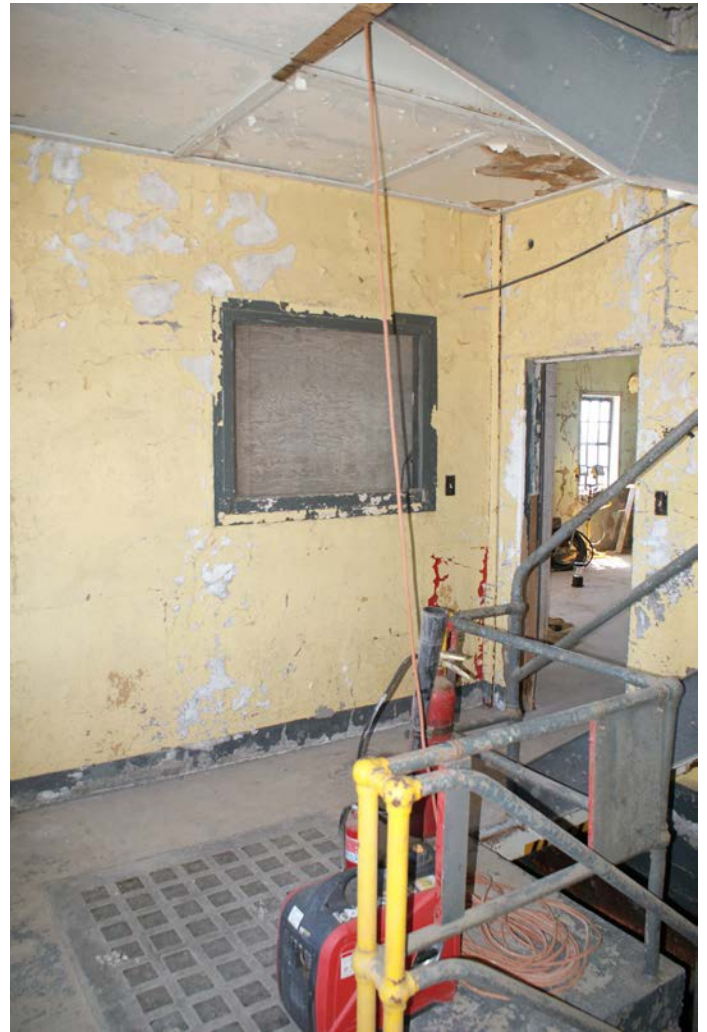
Figure 1D-173 View of borrowed light and partial view of deck light in the main entry room at Level 1.

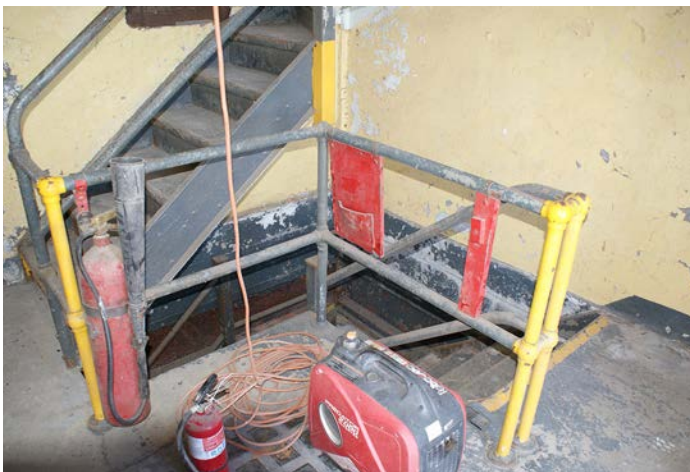
Figure 1D-174 View of the open stairway at Level 1 showing the steel pipe guardrail.

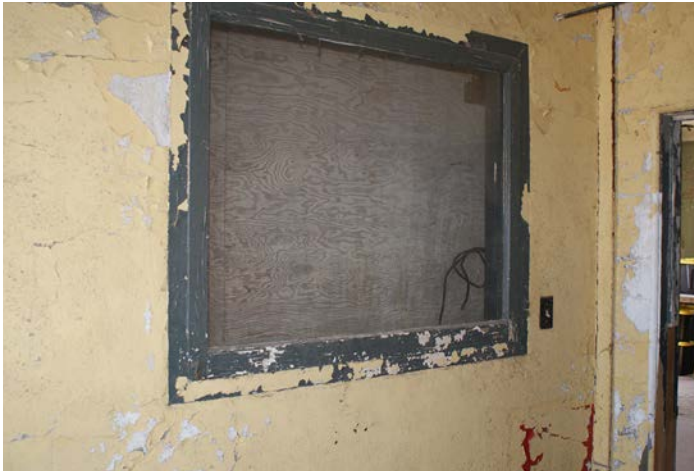
Figure 1D-175 Close-up view of the borrowed light at Level 1.

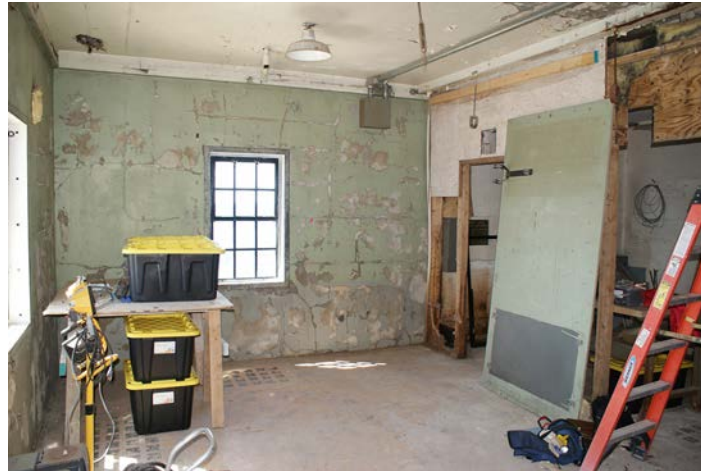
Figure 1D-176 View of general work/equipment rooms on Level 1.

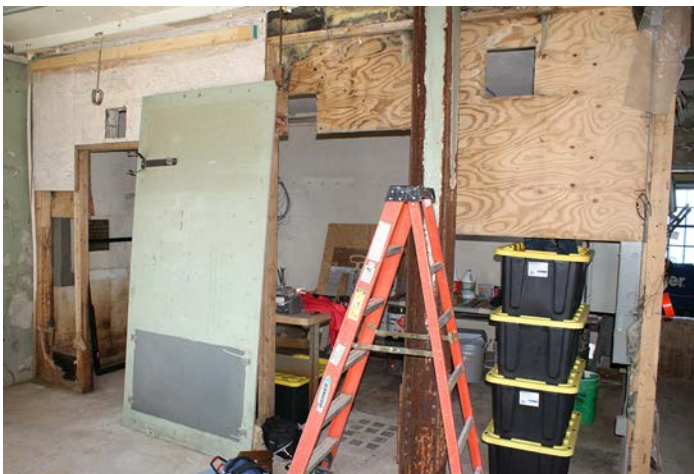
Figure 1D-177 View of general work/equipment rooms on Level 1.

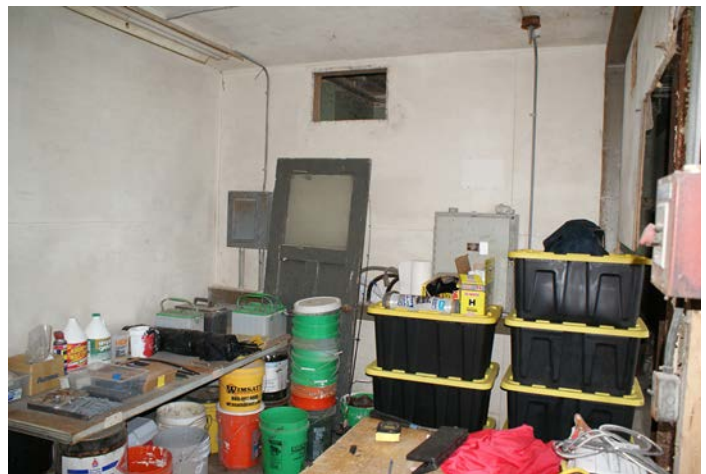
Figure 1D-178 View of general work/equipment rooms on Level 1.

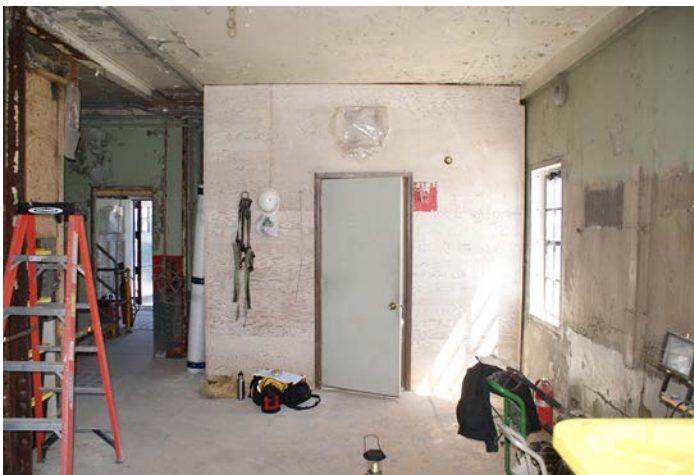
Figure 1D-179 Doorway leading into a small equipment room on Level 1.

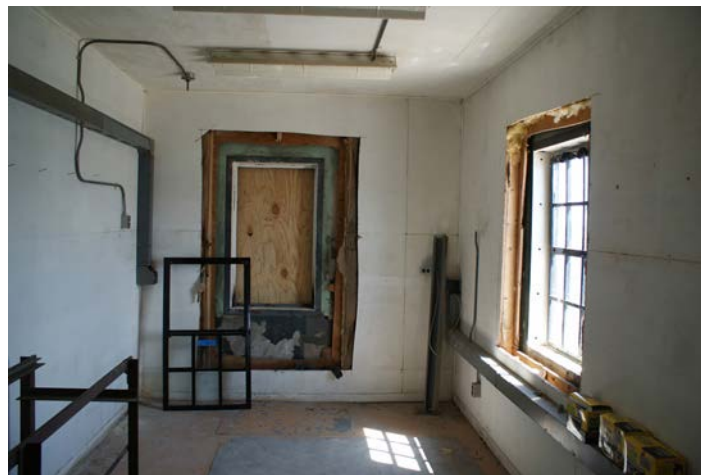
Figure 1D-180 Interior view of the small equipment room on Level 1.
