MANAGEMENT SUMMARY

Executive Summary

Current Conditions

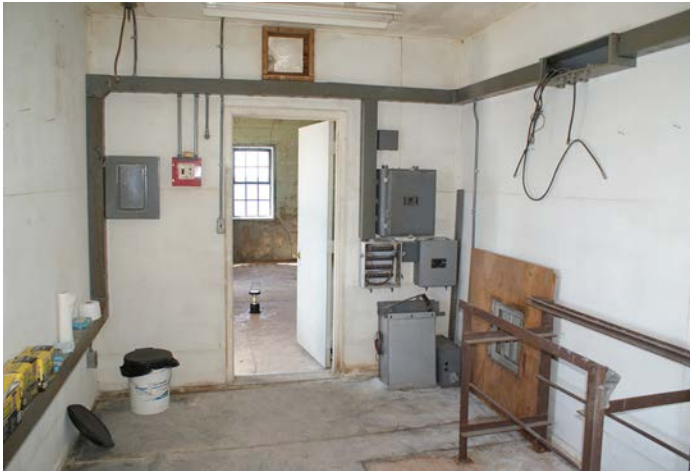
Figure 1D-181 Interior view of the small equipment room on Level 1.

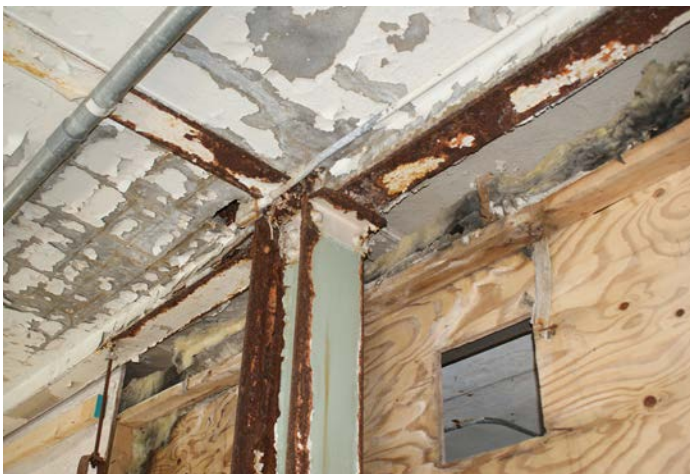
Figure 1D-183 Generally poor condition of interior paint and plaster finishes on Level 1.

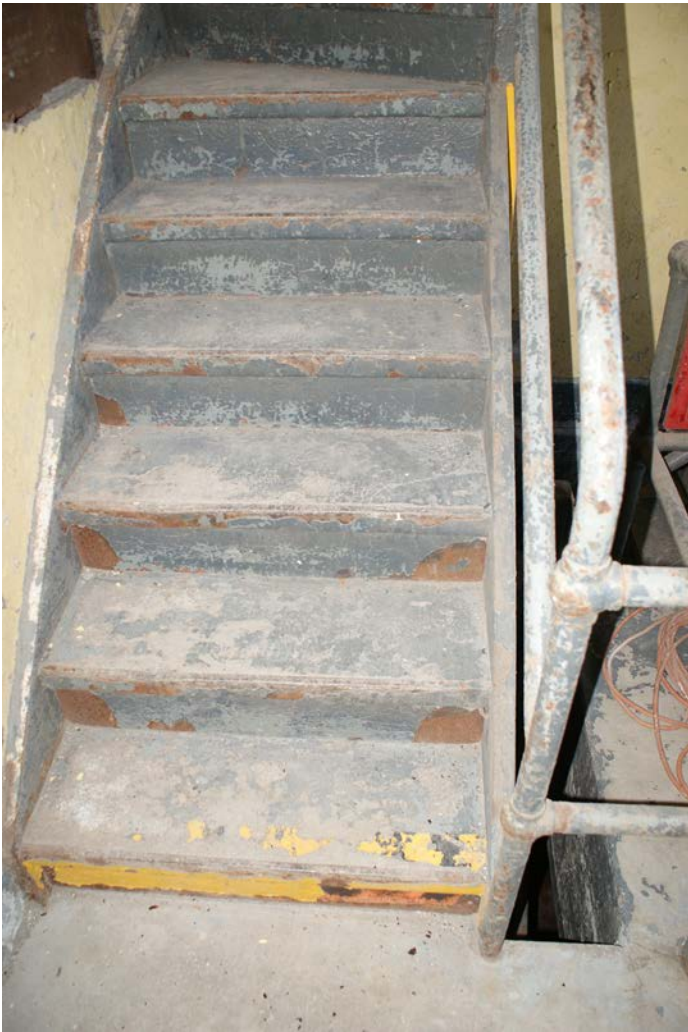
Figure 1D-184 Metal pan and concrete stair leading up to Level 2.

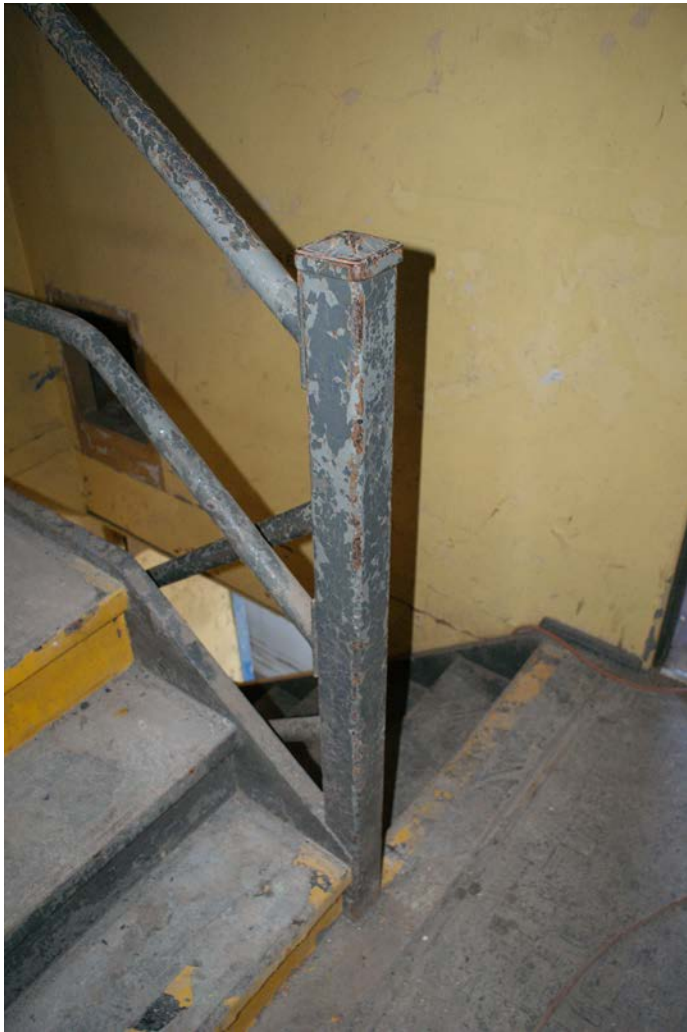
Figure 1D-186 Square steel newel post at Level 2.

The stairway from Level 1 to Level 2 is also a metal pan stair with concrete treads and steel C-channel stringers. The 2 feet 9 inches wide stair, seen in [Figures 1D-184 and 1D-185](#), also have 1-5/8 inch O. D. handrails and 3 inch square steel newel posts, [Figure 1D-186](#). On Level 2, immediately at the top of the stair is a very small Bathroom. The bathtub, [Figure 1D-187](#), is the only remaining plumbing fixture. A recessed medicine cabinet remains on the wall where the lavatory was located, as seen in [Figure 1D-188](#).

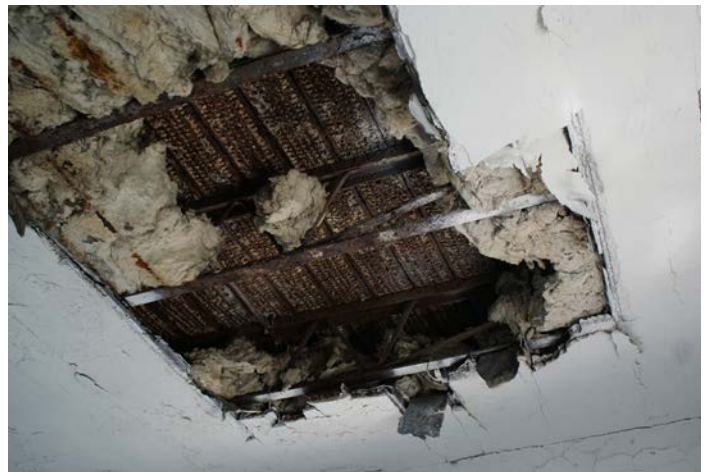
There is a significant section of damaged ceiling plaster and metal lath where roof leaks from the Level 3 Watch Deck have occurred. Refer to [Figure 1D-190](#). Adjacent to the Kitchen is a large room, identified as the Radio Watchroom on original drawings. Historic photos show this room was also used as a Dining and Living Room. This room is seen in [Figure 1D-191](#) and also shows a large section of damaged ceiling. A loose fill, poured insulation material is seen in these damaged ceiling areas.

Figure 1D-190 Extreme damage of the plaster ceiling and metal lath in the Kitchen on Level 2.

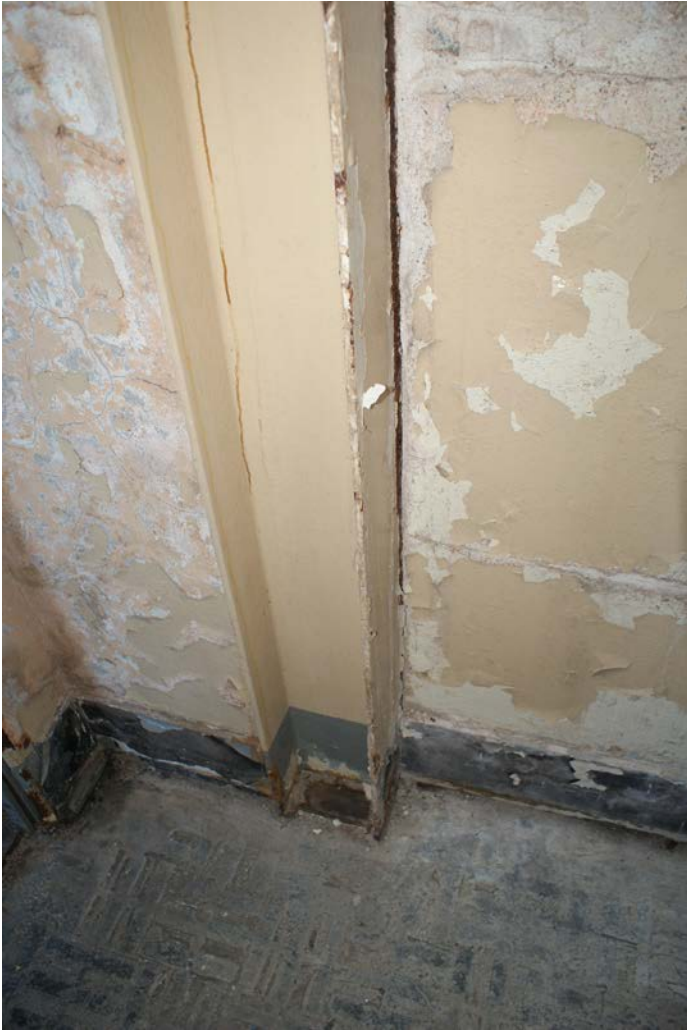
Figure 1D-204 View of exposed steel column on Level 2 and poor interior finishes.

In some locations the steel columns and beams are exposed and there is significant rust due to roof leaks. Refer to [Figures 1D-204](#), [1D-205](#) and [1D-206](#). Some steel beams are wrapped with metal lath and plaster and there is also substantial damage, as seen in [Figure 1D-207](#).

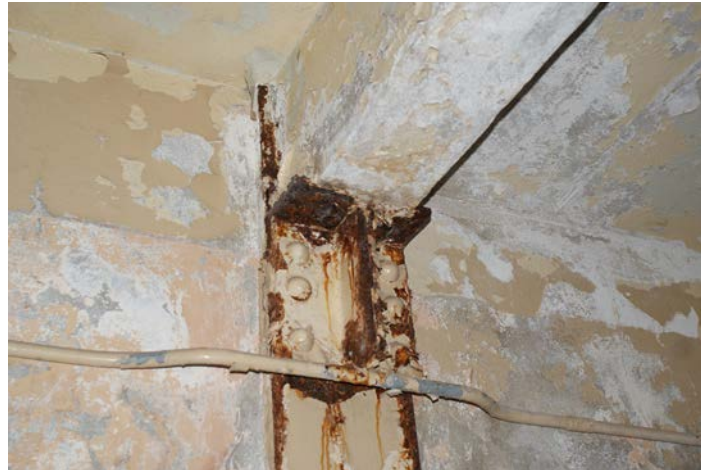
Figure 1D-205 View of exposed steel beam and column on Level 2.

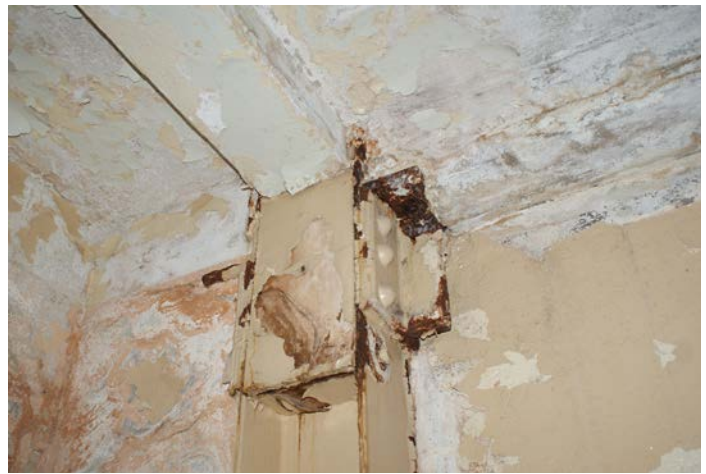
Figure 1D-206 View of exposed steel beam and column on Level 2.

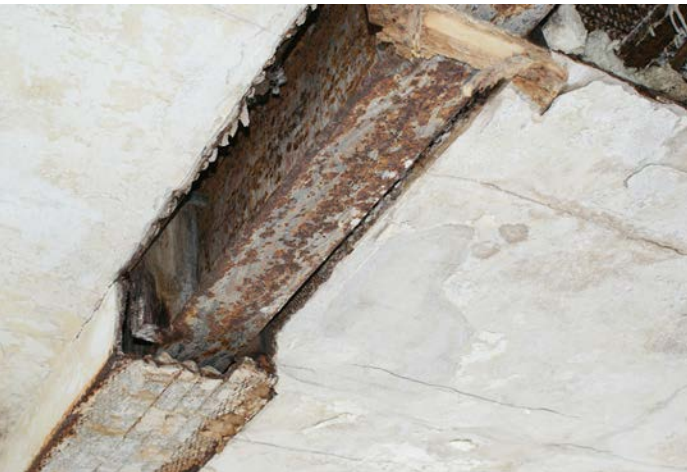
Figure 1D-207 Rusty steel beam and missing and damaged metal lath and plaster on Level 2.

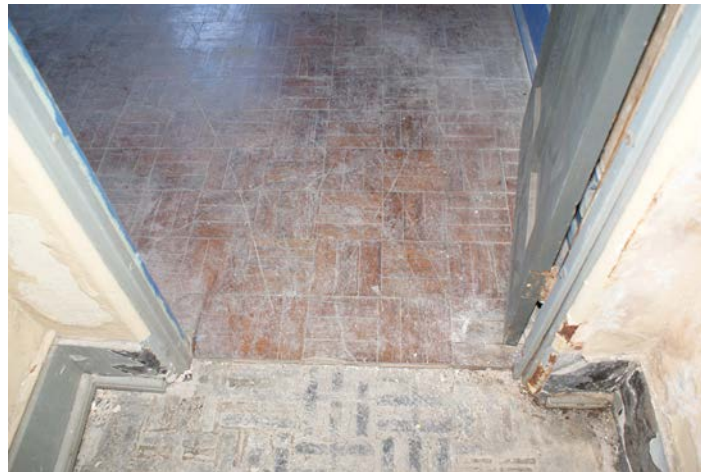
Figure 1D-208 Wood parquet flooring in a Bedroom on Level 2.

Flooring on Level 2 includes 9 inches by 9 inches tile in the Bathroom and remnants of wood parquet flooring in other rooms. Wood parquet flooring in one of the Bedrooms is seen in [Figure 1D-208](#). All finishes on Level 2, including the plaster on walls and ceilings, are in extremely poor condition throughout.

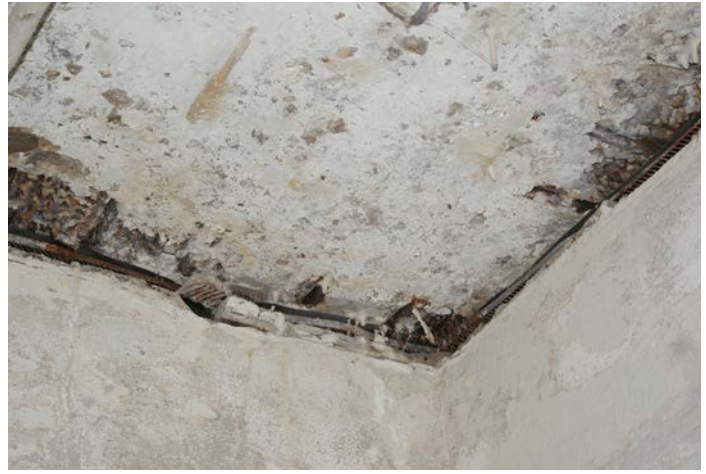
Figure 1D-223 Poor condition of exposed steel beams and concrete surfaces on Level 5.

In the three levels of the tower, the concrete floor and wall surfaces are in generally good condition. At the roof of Level 5, which is also the Lantern and Lantern Deck floor, there is deterioration of the concrete, Figure 1D-223, and rusting of the exposed steel beams, Figures 1D-223 and 1D-224. Paint on all surfaces is in very poor condition.

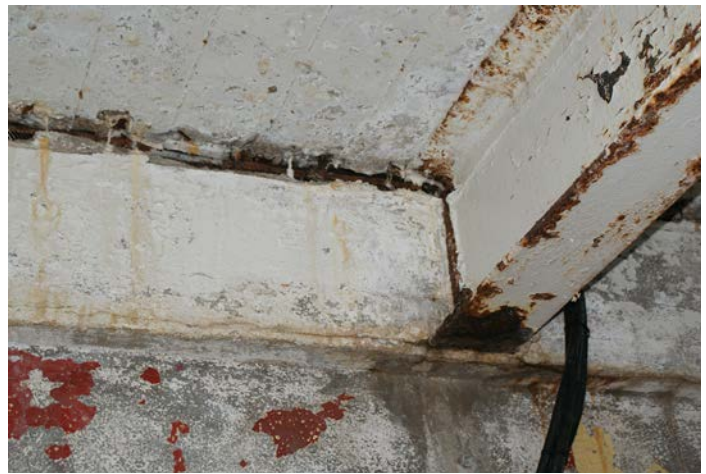
Figure 1D-224 Poor condition of exposed steel beams and concrete surfaces on Level 5.

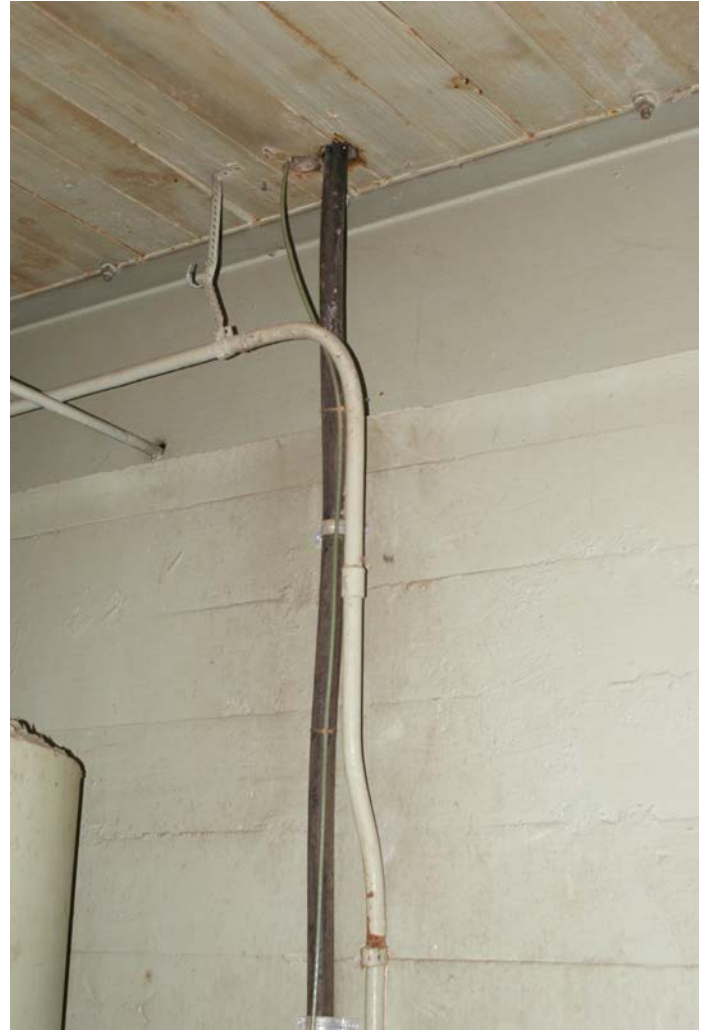
Figure 1D-227 Main electric cable running up the wall in the Basement Water Room.

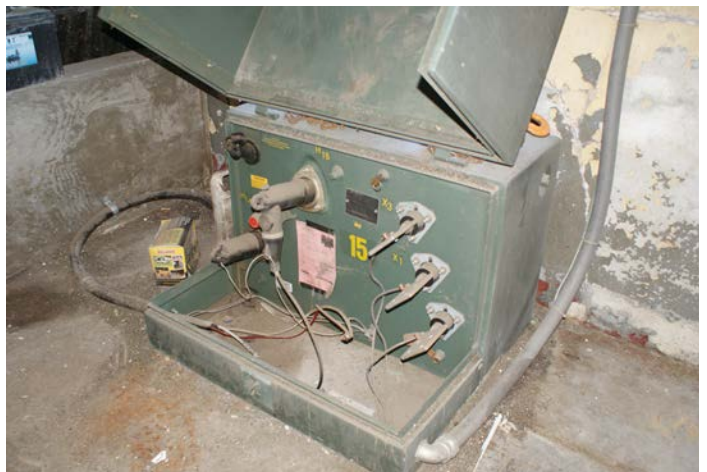
Figure 1D-228 Electrical transformer in the Boat Room on Level 1.

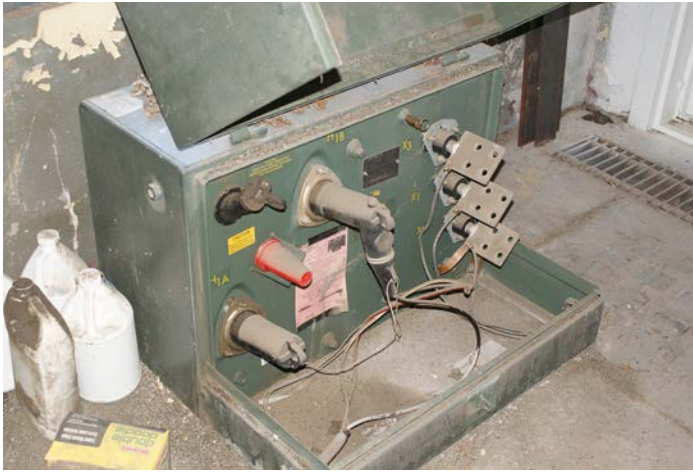
Figure 1D-229 Electrical transformer in the Boat Room on Level 1.

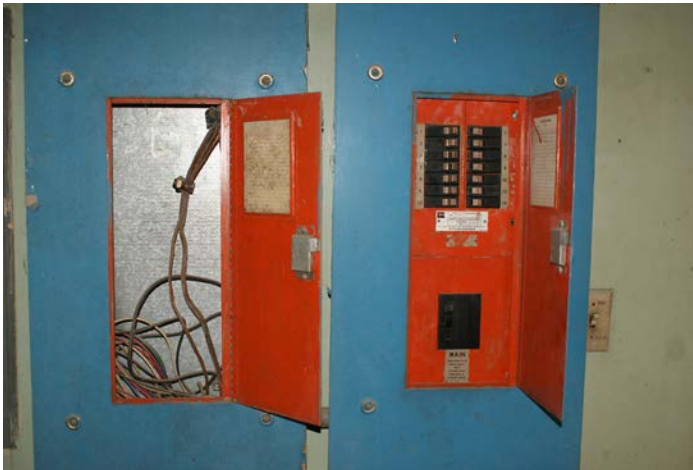
Figure 1D-230 Electrical panels on Level 1.

All electrical elements including wiring, receptacles, lighting and panels are in very poor condition.

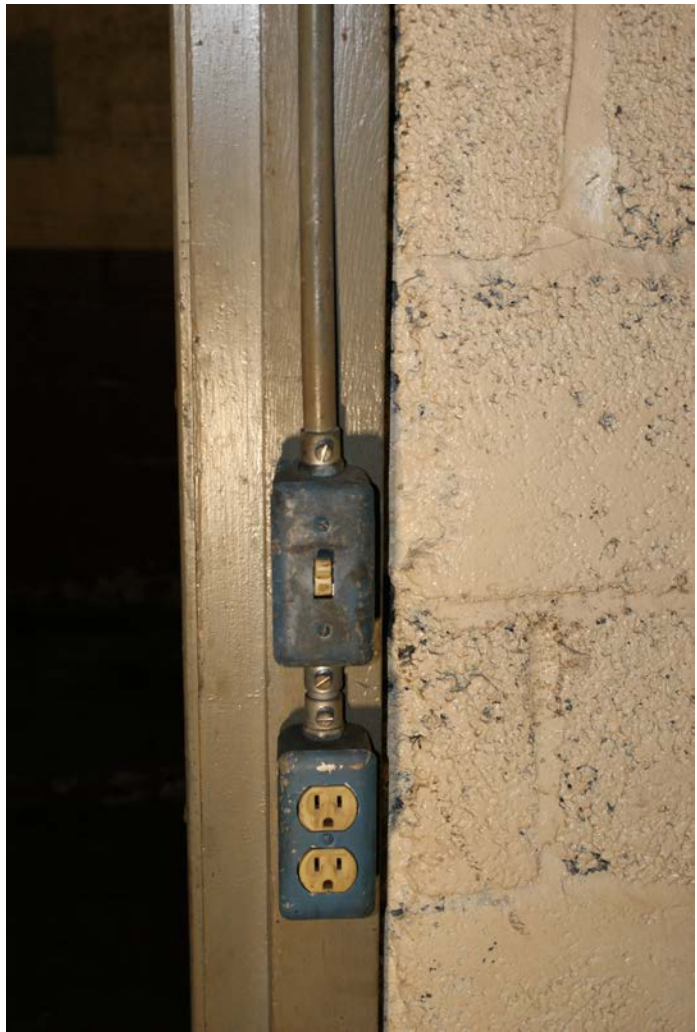
Figure 1D-232 Typical surface mounted electrical devices.

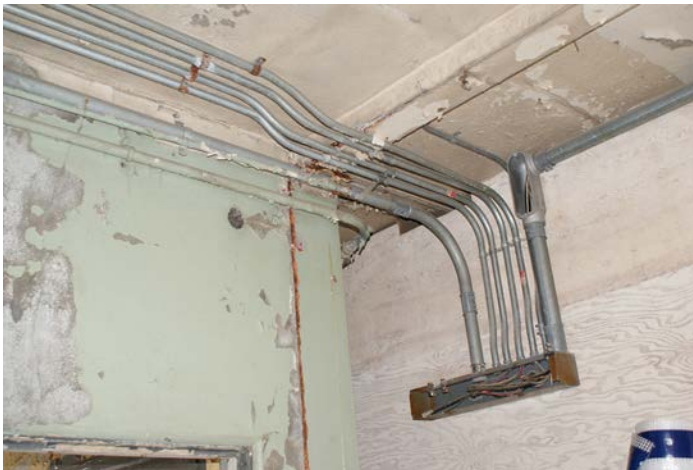
Figure 1D-231 Surface mounted electrical conduit on Level 1.

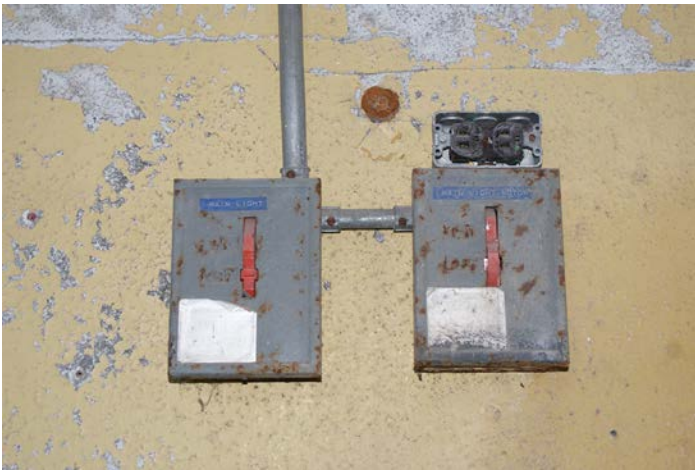
Figure 1D-233 Electrical equipment panels in tower Level 5.

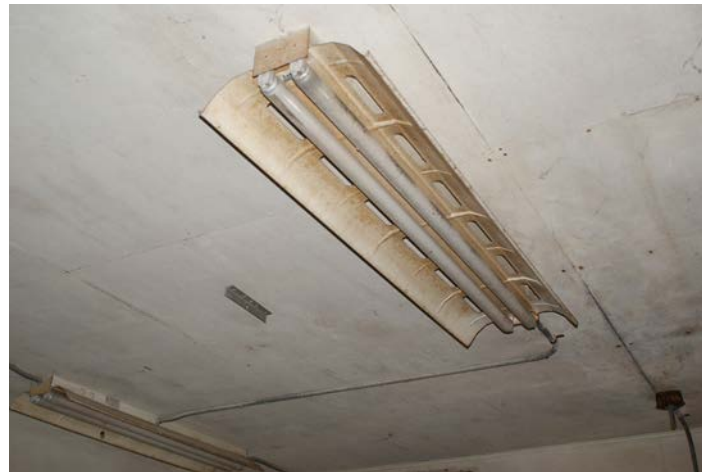
Light fixtures in the light station include surface mounted, industrial fluorescent fixtures, [Figure 1D-234](#), and various incandescent fixtures, [Figure 1D-235](#) and [1D-236](#). There are no remaining light fixtures on the exterior of the structure, however, there are some wall openings with conduit indicating the past presence of exterior wall mounted lighting. Although somewhat difficult to see, it appears there was a light fixture above the sea door, semi-recessed into the concrete structure.

[Figure 1D-234](#) Surface mounted fluorescent light fixture.

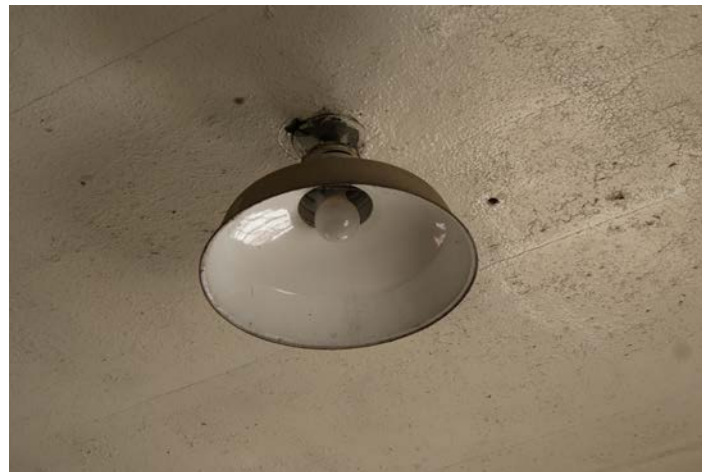
[Figure 1D-235](#) Surface mounted incandescent light fixture.

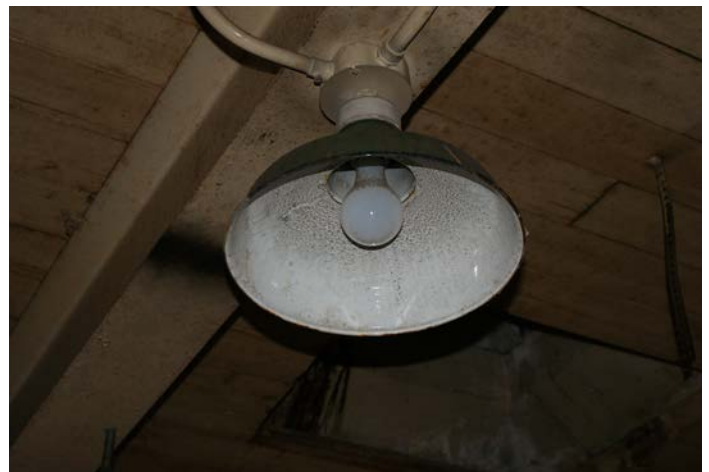
[Figure 1D-236](#) Surface mounted incandescent light fixture.

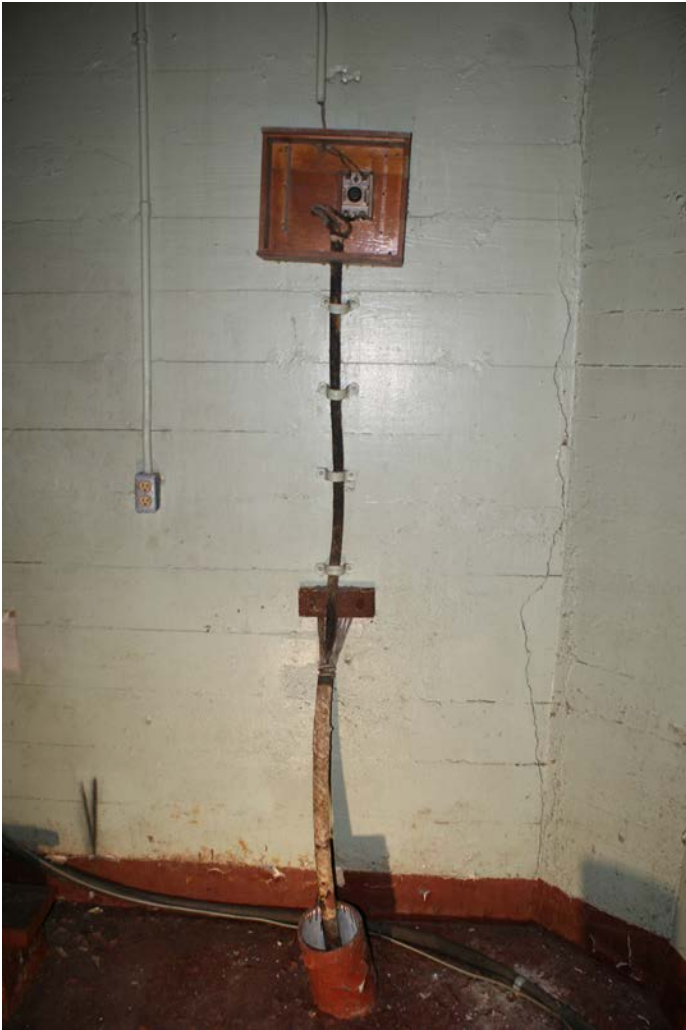
Figure 1D-237 Wiring in Basement Water Room from telegraph signaling system.

Dave McWilliam with North Manitou Light Keepers, Inc. indicated that a large wire located in the Basement Laundry Room, is a remnant of a telegraph signaling system from the light station to the life-saving station located on North Manitou Island. This wire is seen in [Figure 1D-237](#). Details of this system are not known.

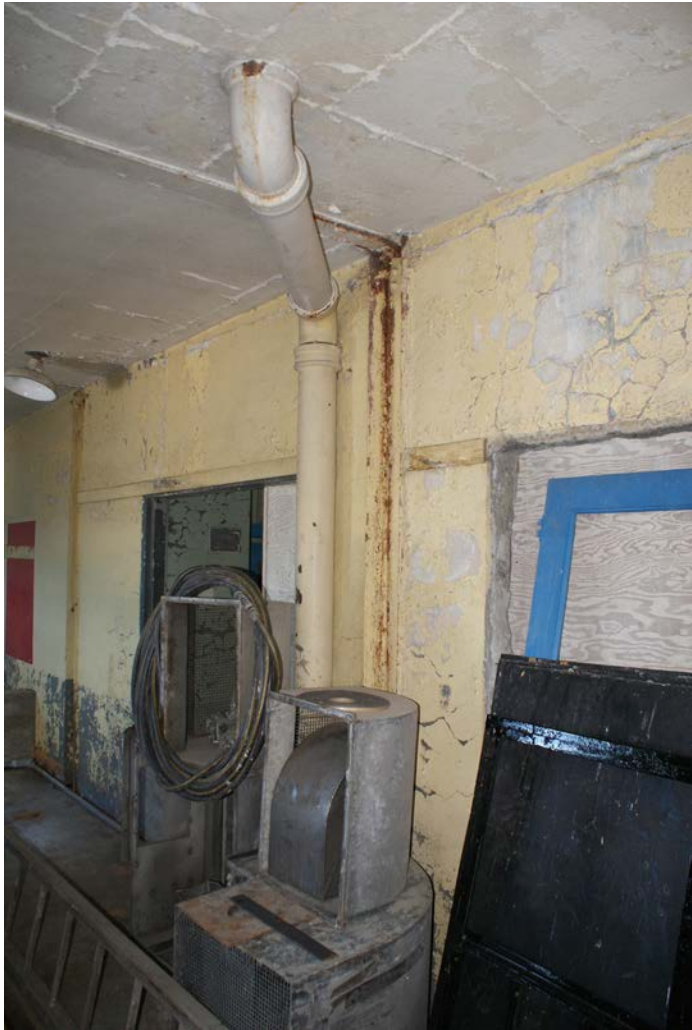
Figure 1D-239 Cast iron roof drain line exposed in the Boat Room on Level 1.

Some large 6 inch diameter cast iron pipes are exposed on Level 1, such as this one seen in the Boat Room, [Figure 1D-239](#), and on Level 2. These pipes serve the roof drains located on the Watch Deck on Level 3. These drain pipes were cleaned in 2017-2018 and are presumed to be operational.

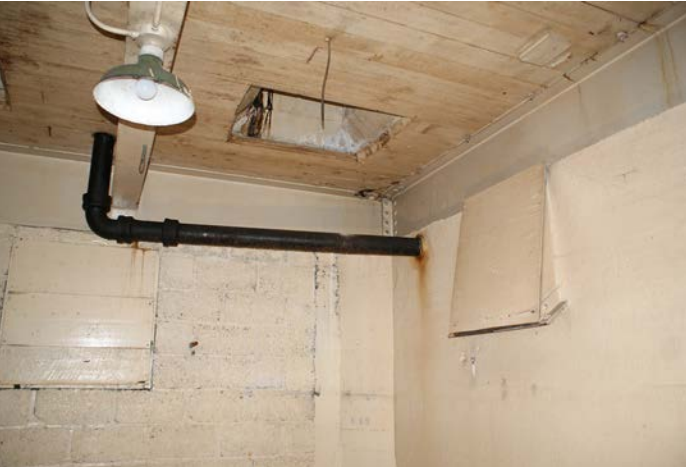
Figure 1D-238 Cast iron sanitary waste line exposed in the Basement.

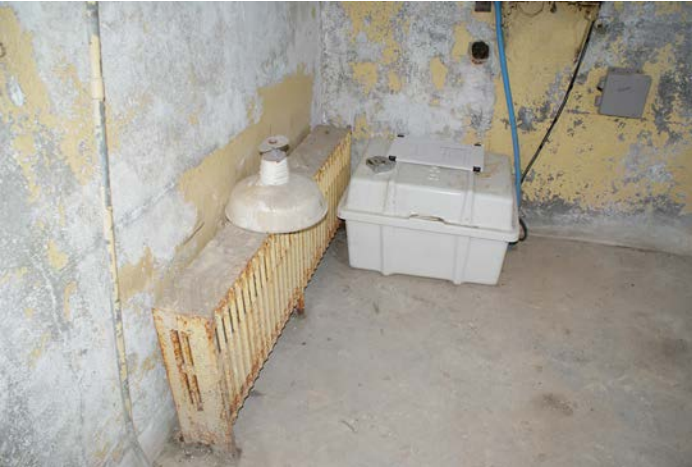
Figure 1D-240 Abandoned cast iron radiator located on tower Level 5.

There is no heating system in the light station and few remnants of a heating system, including a single section of cast iron radiator located in the tower on Level 5 and a wall mounted cast iron radiator in the Basement. Refer to [Figure 1D-240](#). Two chimney pipes were previously discussed and shown as they pass through the three tower levels. In the Basement these chimney pipes are cast iron, 12 inches and 6 inches in diameter. Refer to [Figures 1D-241, 1D-242](#) and [1D-243](#). A small raised concrete pad 4

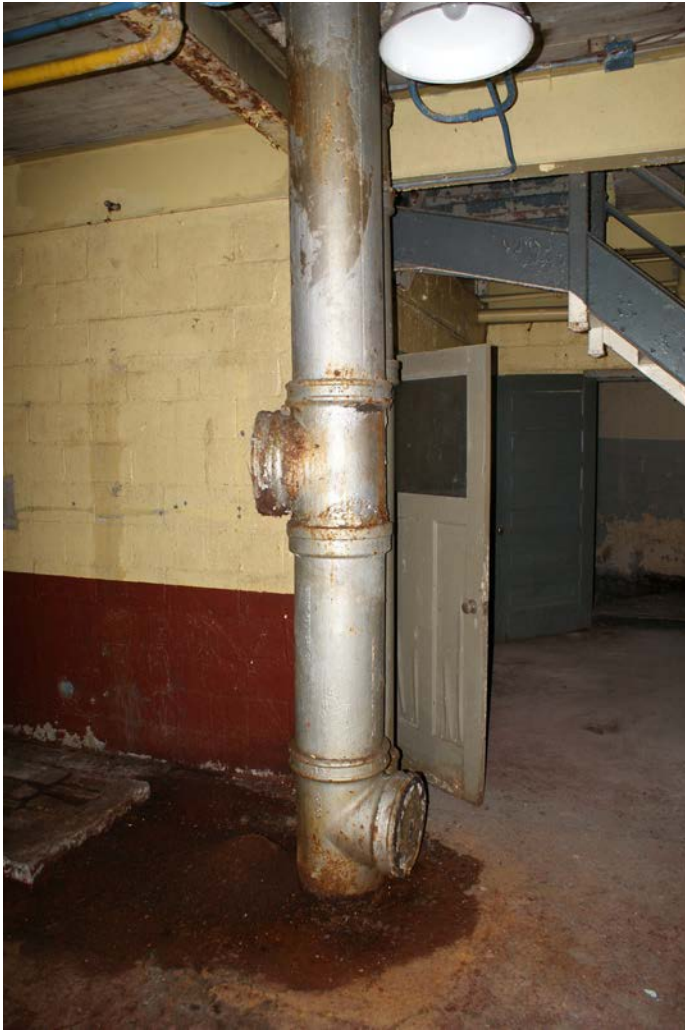
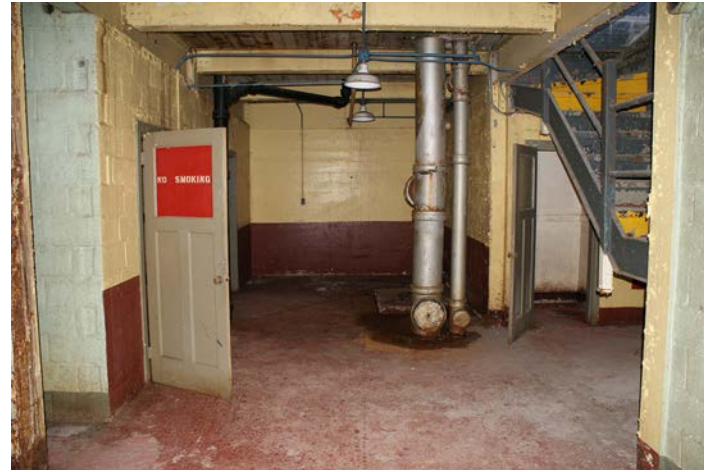
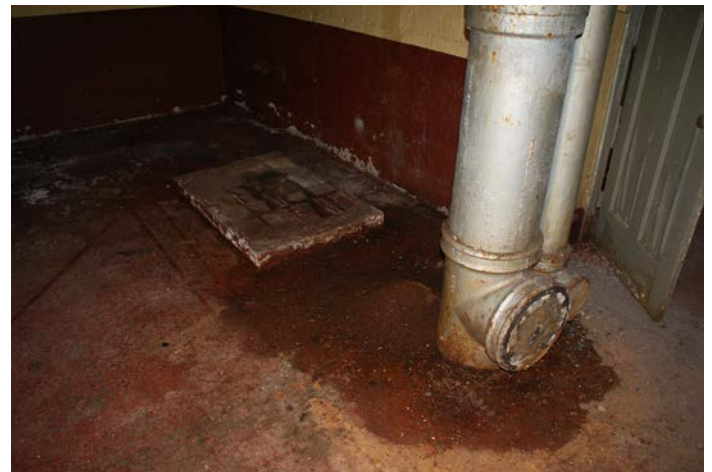
Figure 1D-241 Large chimney pipes located in the Basement.

Figure 1D-242 Large chimney pipes located in the Basement.

Figure 1D-243 Large chimney pipes located in the Basement.

feet by 2 feet 8 inches by 4 inches high is adjacent to these pipes. Original drawings indicate this was the location of a boiler.

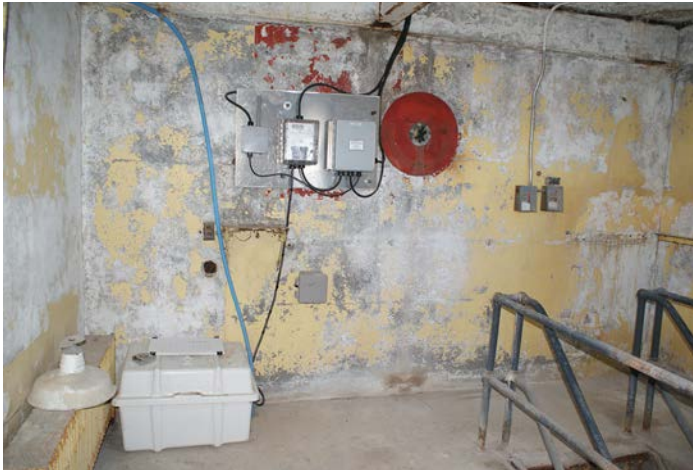
Figure 1D-244 Aids-To-Navigation equipment in tower Level 5.

In addition to the aids-to-navigation noted in the section on the Lantern, there are some aids-to-navigation components in the tower on Level 5. These items are seen in Figure 1D-244 and 1D-245.

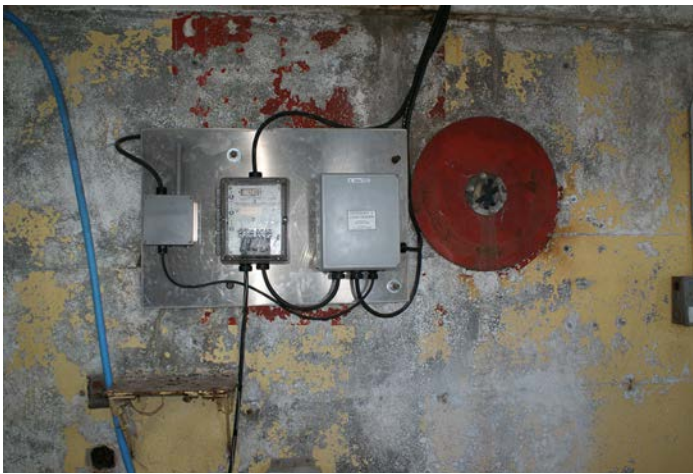
Figure 1D-245 Aids-To-Navigation equipment in tower Level 5.

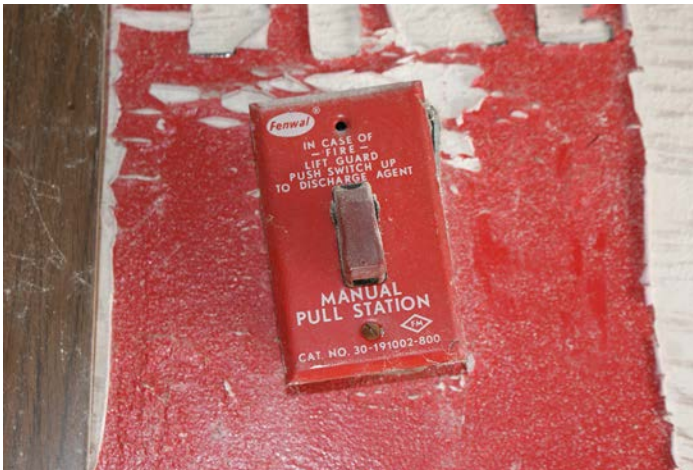
There are remnants of an alarm or fire protection system located on Level 1, as indicated by this pull station seen in Figure 1D-246. The details of this system are not known and there are no other life safety alarms, devices or systems in the structure.

Figure 1D-246 Fire alarm pull station located on Level 1.
